**APPLICATIONS OF ADVANCED
COMPOSITES TO STEEL BRIDGES:
A CASE STUDY ON THE
ASHLAND BRIDGE
(DELAWARE-USA)**

MARCH 2005

**Delaware Center for Transportation
University of Delaware
355 DuPont Hall
Newark, Delaware 19716
(302) 831-1446**

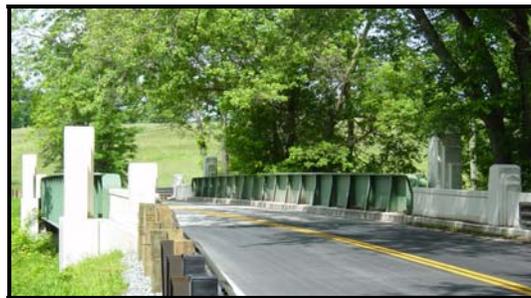
Fig. 1 – Ashland Bridge

The Ashland Bridge carries State Route 82 over Red Clay Creek in Delaware. The steel through girder bridge with a 100-foot (30.5 m) simple span is shown in Fig. 1. The concrete deck is supported on 19 floor beams (W24 X 100 sections) that are spaced 6 feet (1.83 m) on center and span 27 feet (8.23 m) between through girders.

The Delaware Department of Transportation (DelDOT) determined that the concrete deck and floor beams showed significant deterioration, and as such the bridge was deemed structurally deficient. Prior to rehabilitation in June of 2002, UD conducted load tests to document the baseline behavior of the bridge. Two floor beams were retrofitted with CFRP plates on the bottom of the tension flange, and the concrete deck was replaced in two sections on November 25 and December 2 [7]. CFRP plates were bonded to the floor beams after the concrete deck was removed and before a new deck was cast. As such, the CFRP plates help the floor beams resist both dead and live loads. In June of 2003, a post-test was performed to evaluate the effectiveness of the rehabilitation, specifically the performance of the CFRP plates for improvements in stiffness and load distribution.

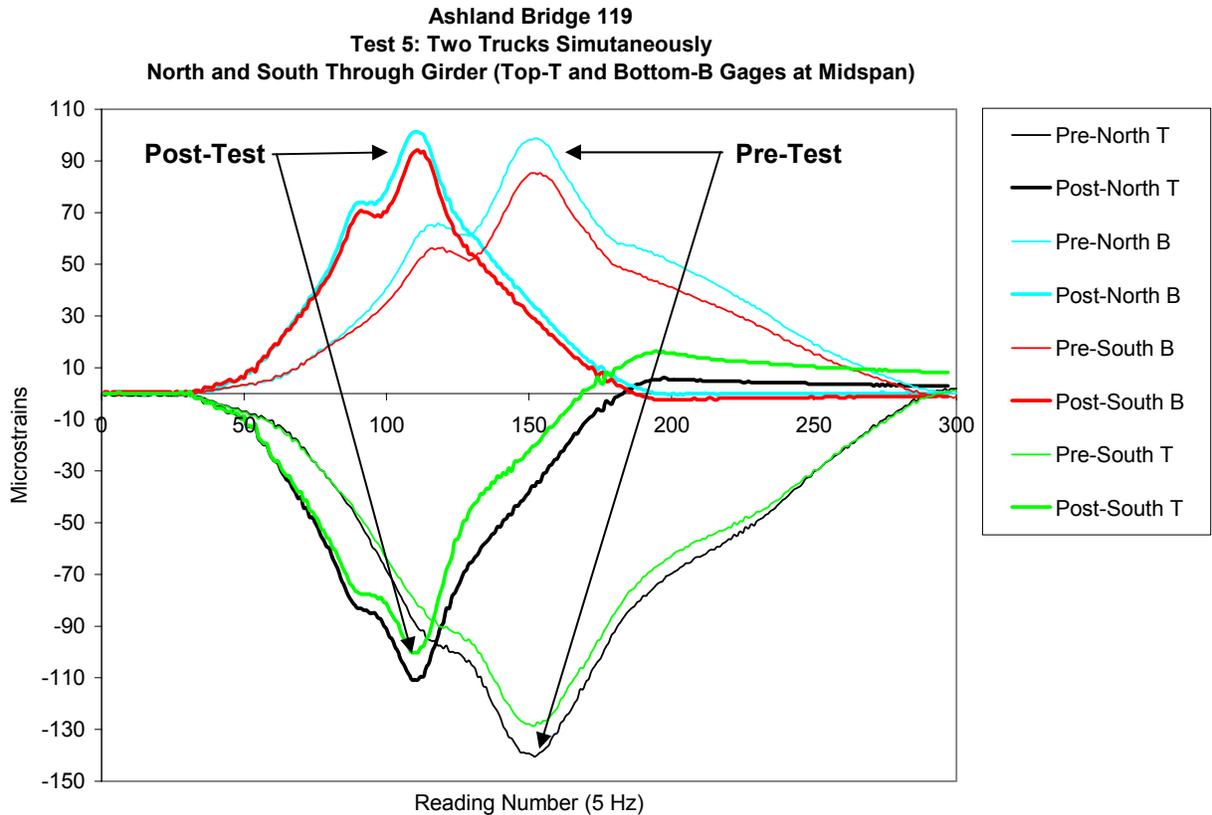
Fig. 4 – Comparison of Through Girder Response for Pre- and Post-Rehabilitation Testing.

The through girder behavior was similar for both the pre-test and post-test. The largest compression and tensile strain on the through girder in both tests occurred at mid-span. The strain gages were on the top and bottom flanges of the through girder, and the peak strains occurred during the test when both trucks were on the bridge. The peak strains for the pre-test were -140.5 and 98.7 $\mu\epsilon$. Peak strains for the post-test were -110.7 and 101.3 $\mu\epsilon$. These strains correspond to live load steel stresses ranging from 3.3 to 4.7 ksi. Fig. 4 shows a comparison of the through girder response for the two tests (in this all future plots, B and T signify bottom and top flange gages respectively). This plot shows a typical time-strain history for the through girder when both trucks crossed the bridge simultaneously. From this figure it is apparent that the trucks were traveling faster during the post-test. It also shows that the neutral axis changed slightly. This could be due to the deck replacement.

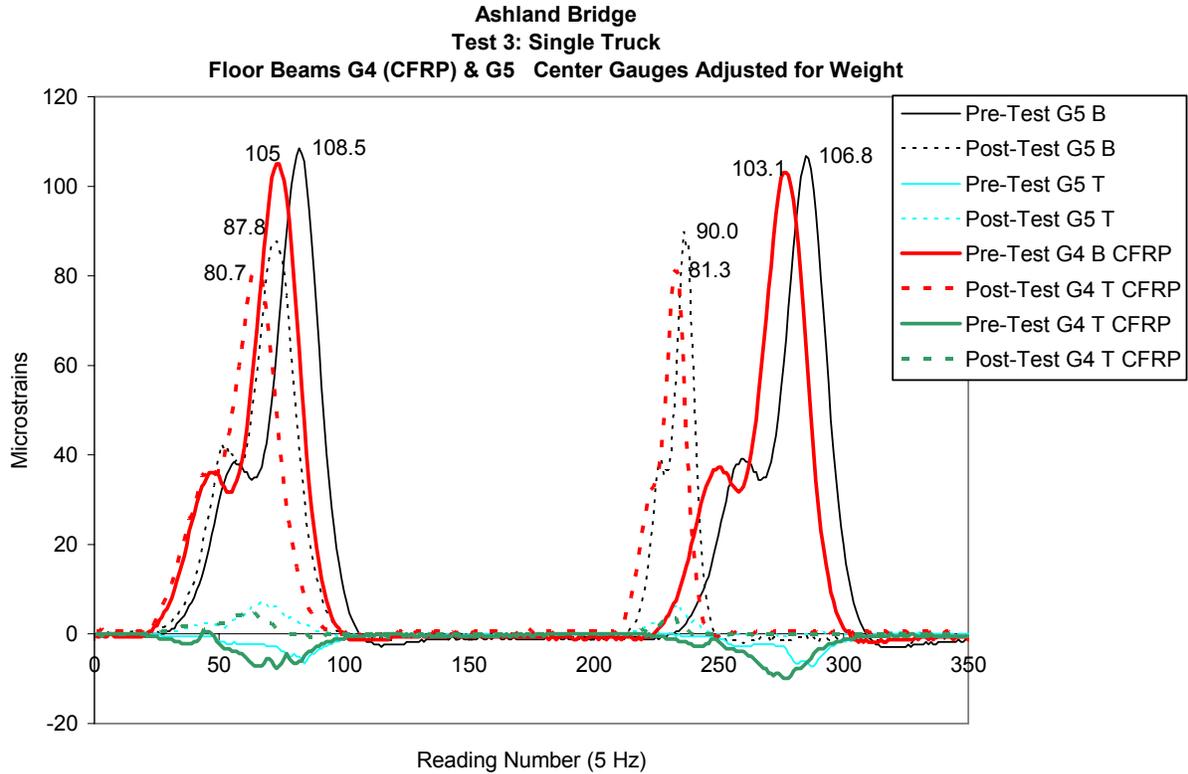
Fig. 5 – Comparison of Pre- and Post-Rehabilitation Test Behavior, Test 3.

One initial intent of the Ashland Bridge rehabilitation was to create composite behavior between the floor beams and the concrete deck. Prior to rehabilitation, the deck and floor beams were not designed compositely (i.e., no shear studs were used). However, based on the pre-test behavior, unintended composite action was observed. During the rehabilitation, shear studs were installed to ensure post-rehabilitation composite action. Fig. 5 shows a comparison plot of pre- and post-rehabilitation behavior for Test 3, as single trucks pass over the center of the bridge (note that this is a typical plot, but not the one for maximum recorded strains). Shown are the results for the retrofitted floor beam G4 and the control floor beam G5. The time histories plotted are for gages located in the center of the beam on both the top and bottom flanges. The thin curves represent the pre-test, while the thick curves represent the post-test. As can be seen in the figure, both the pre- and post-tests show that composite action is present. The largest tensile strain occurring on the control floor beam G5 for the pre-test occurred during Test 5 (both trucks are on the bridge side-by-side) and was $154.6 \mu\epsilon$ and $119.5 \mu\epsilon$ for the post-test corresponding to 4.5 ksi (31 MPa) and 3.5 ksi (24 MPa) live load stresses. Corresponding strains occurring on retrofitted floor beam G4 were $149.1 \mu\epsilon$ and $109.4 \mu\epsilon$ for the pre- and post-tests respectively. These correspond to live load stresses in the steel floor beam ranging from 4.3 ksi (30 MPa) to 3.2 ksi (22 MPa), while the corresponding live load stress in the bonded CFRP plate ($E_{\text{cfpr}} = 16,000$ ksi (110,316 MPa)) during the post-test was 1.75 ksi (12 MPa). This CFRP stress is significantly lower than the 135 ksi (931 MPa) ultimate stress of the plates.

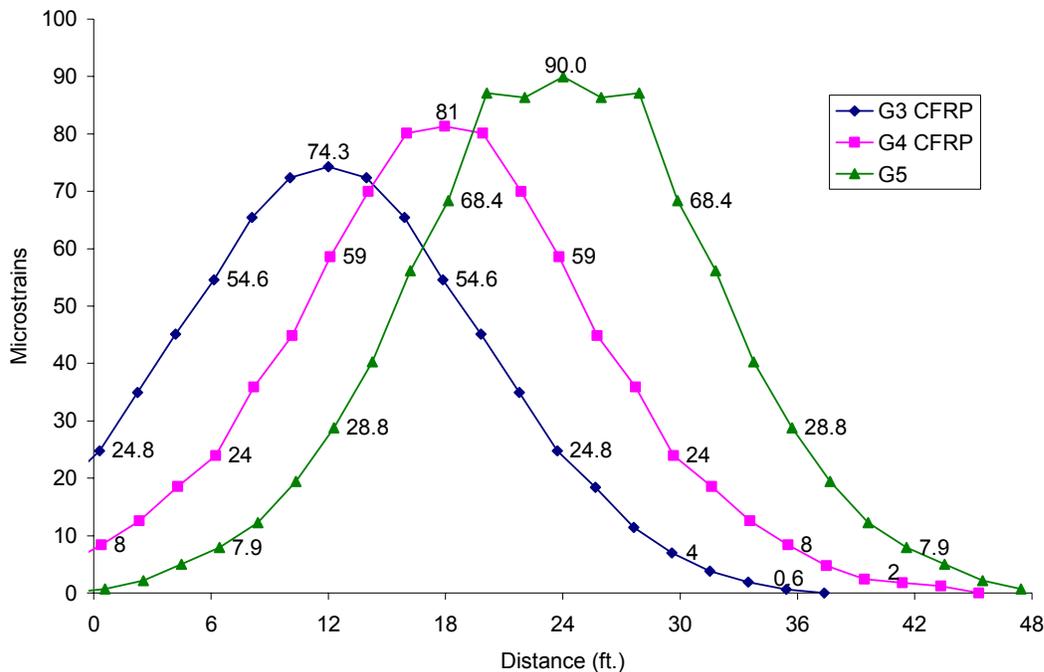
Fig. 6 – Load Distribution to Single Floor Beams (1 foot = 0.3048 m).

Fig. 6 shows the distribution of strain due to the weight from the rear axle group to individual floor beams as the test truck travels across the bridge (post-repair). Shown in this graph is the distribution for the three instrumented floor beams during Test 3. This distribution of strain was evaluated using only the rear axle group. To help to isolate the effect of the rear axle group, only the strain values collected after the peak strain value was reached were used for distribution calculations. The data was also shifted from a time-strain plot to a distance-strain plot. This method of determining strain distribution was found to be reliable and not significantly influenced by the presence of the front axle weight because the axle spacing is more than 14 feet (4.3 m).

From Fig. 6, the percentage of the peak strain from the total strain due to the rear axle group on individual floor beams was found to average 32% (i.e., a distribution factor of 0.32). During Test 3, retrofitted floor beams G3 and G4 peaked at $74.3 \mu\epsilon$ and $81.0 \mu\epsilon$ respectively. An idealized simply supported model was used to find the maximum moment due to an entire truck loading (rear tandem loads only). This moment was converted to strain using Hooke's Law and then scaled by 32%. This yielded $70.0 \mu\epsilon$, which is in close agreement with what the beam actually experienced. In general, rehabilitated floor beams G3 and G4 increased in stiffness, and their load distributions were slightly higher than for the control floor beam G5. Similar analyses conducted for Tests 4 and 5 yielded similar results. A distribution factor was also found for the post-test bridge condition. In this case, the distribution factor was found to be 0.40. Since the deck of Ashland Bridge was replaced, it is likely that the new deck would distribute load more efficiently to the floor beams (as is the case).

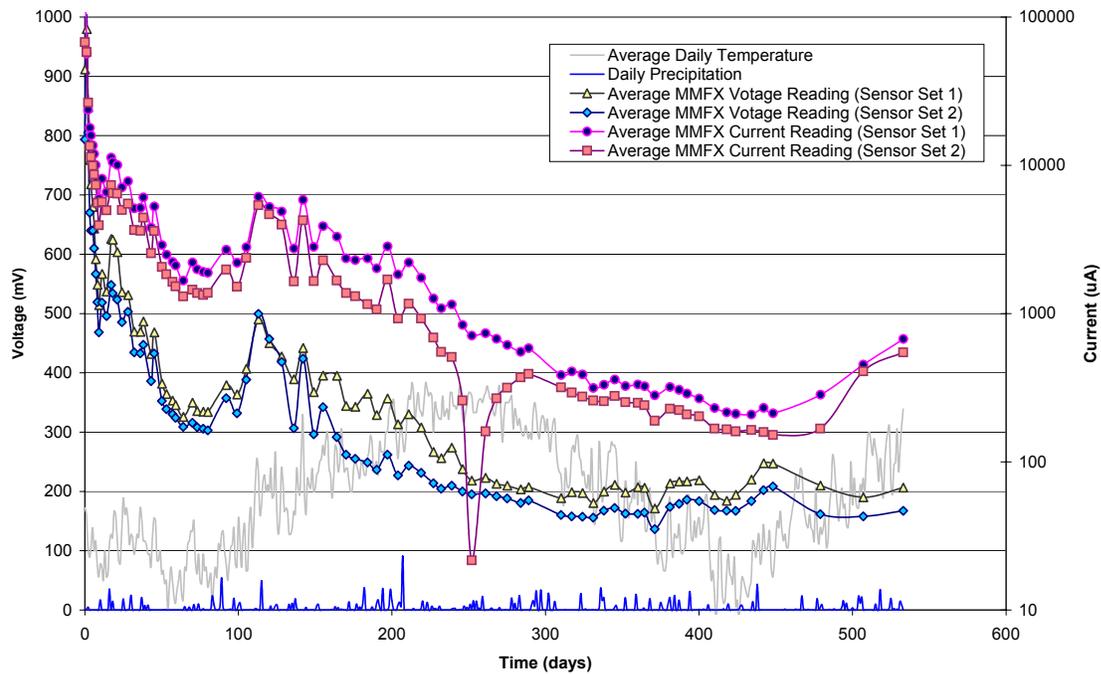
Fig. 10 – Average voltage and current readings as functions of time. Also shown in the figure are the daily average temperature and precipitation.

Readings were very high immediately after the pour, indicating active surface corrosion (as expected). Both voltage and current decreased steadily until finally reached into a stable region. The readings were affected by ambient temperature but showed basically not dependence on ambient moisture or precipitation.

At around 250 days after the pour, the average current of sensor set 2 decreased dramatically and went back to normal in about a month while everything else, including voltage from the same set of sensors, appeared to be normal during that time. There is no definite explanation for this phenomenon. But it was suspected that an electrical connection went bad, i.e. introduced a large connection resistance, during that time. The current measurement depends strongly on the internal resistance of the circuit while voltage does not.

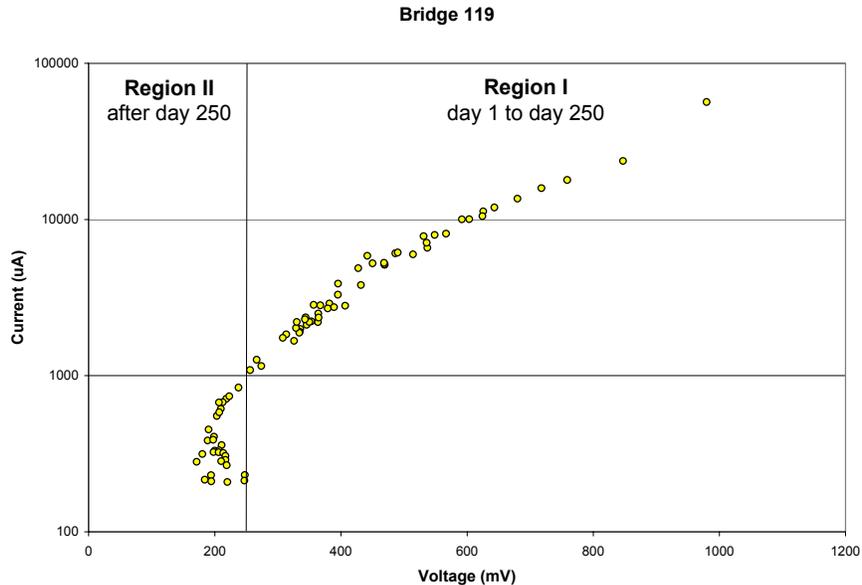
Fig. 11 – Current as a function of voltage for sensor set

An exponential relationship between current and voltage was observed during the first 250 days when the voltage was higher than 250mV, as shown in the Region I in Figure 11. After 250 days, voltages reached into a stable range (defined as less than 250mV) and fluctuated with ambient temperature, while currents kept decreasing and then settled into a wider fluctuating range. This result suggests that the critical voltage indicating active corrosion is about 250mV for MMFX in this particular concrete. There is no corrosion activity when voltage is lower than 250mV. Note that the critical voltage depends not only on the type of steel but also on the concrete. A similar study of MMFX rebars used on Bridge 712 gives a lower critical voltage of 100mV.

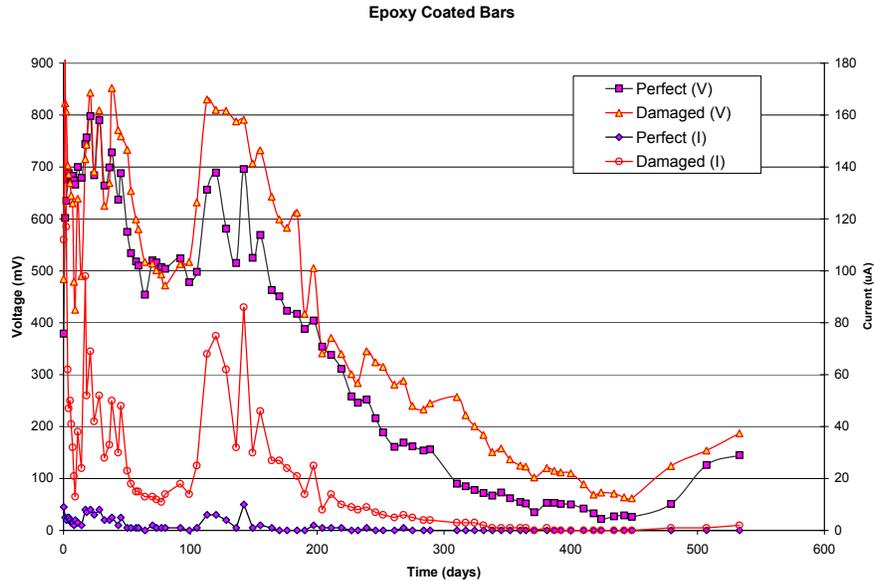
Fig. 12 – Comparison of a perfect epoxy-coat bar and a damaged one. The result shows that the epoxy-coated bar is vulnerable to corrosion when its coating is damaged.

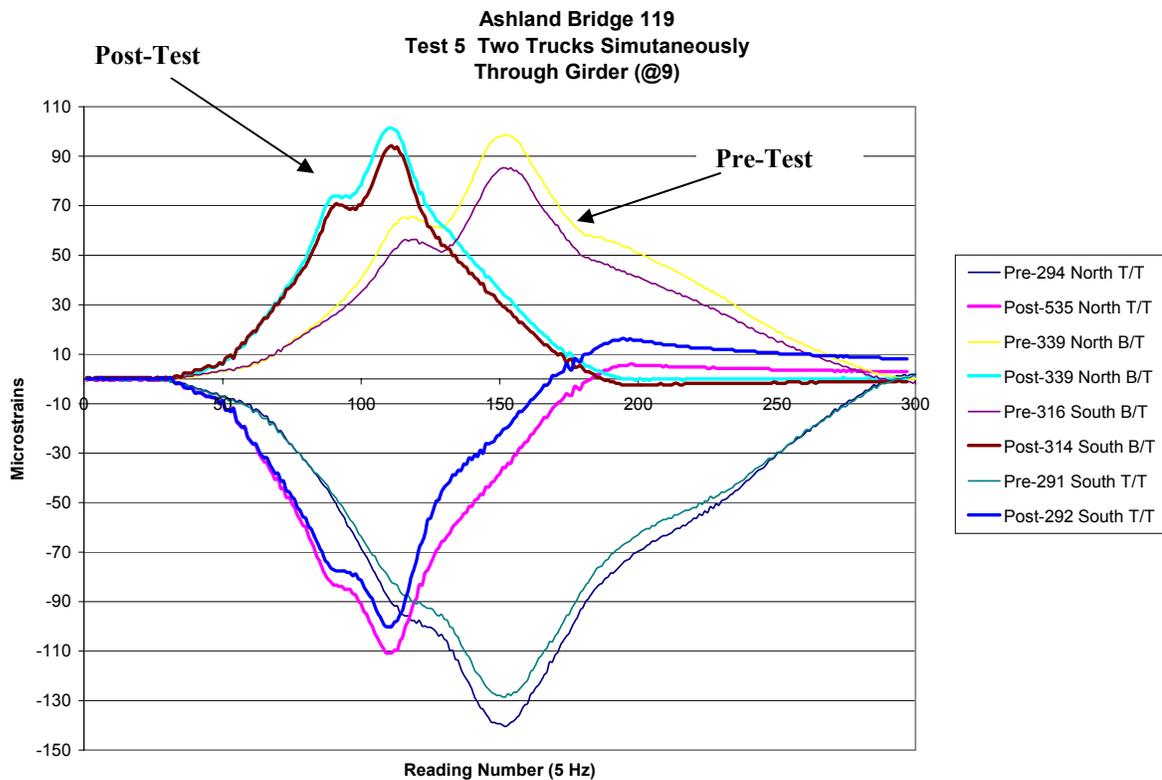
Figure 9. Comparison of through girder response for pre- and post testing.

The through girder behavior was similar for both the pre-test and post-test. The largest compression and tensile strain on the through girder in both tests occurred at mid-span. These strain gages were on the top and bottom flanges of the through girder and the peak strains occurred during the test when both trucks were on the bridge. The peak strains for the pre-test were -140.5 and $98.7 \mu\epsilon$. Peak strains for the post-test were -110.7 and $101.3 \mu\epsilon$. These strains correspond to live load stresses ranging from 3.3 to 4.7 ksi. Figure 9 shows a comparison of the through girder response for the two tests. This plot shows a typical time-strain history for the through girder when both trucks crossed the bridge simultaneously. From this figure it is apparent that the trucks were traveling at a faster speed during the post-test than in the pre-test. It also shows that the neutral axis changed slightly. This could be in part due to the deck replacement. The post-test also showed a reduction in maximum compression strain (from $-140.5 \mu\epsilon$ to $-110.7 \mu\epsilon$).

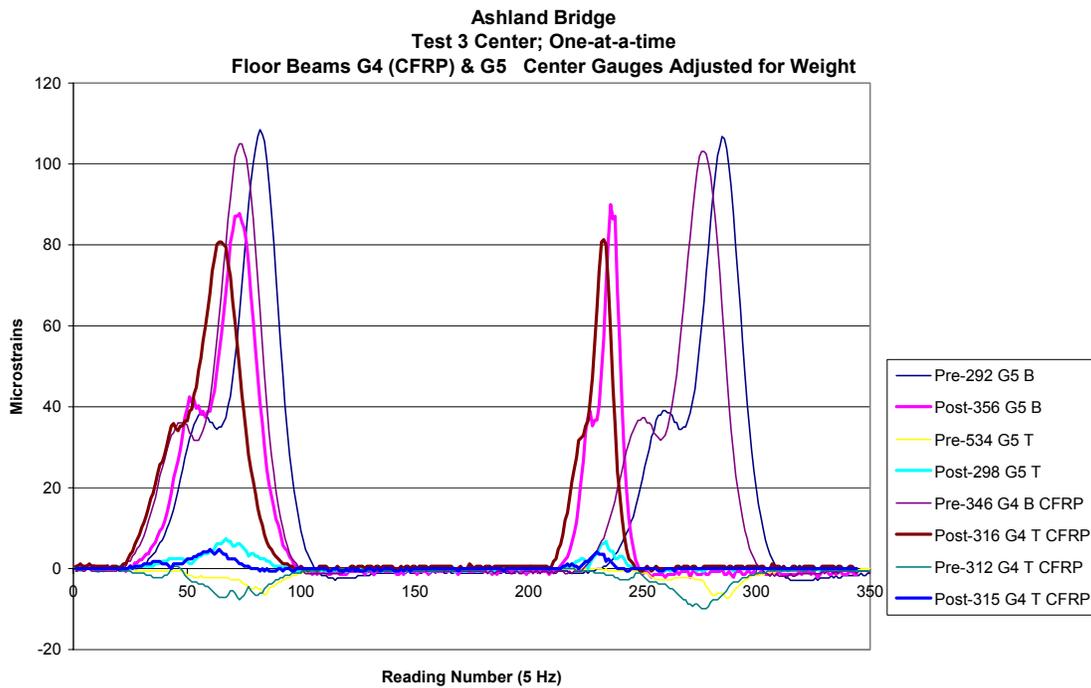
Figure 10. Comparison of pre- and post test behavior, Test 3.

The largest tensile strain occurring on the control floor beam G5 for the pre-test was 154.3 $\mu\epsilon$ and 119.5 $\mu\epsilon$ for the post-test corresponding to 5.1 ksi and 4 ksi live load stresses. Those strains occurring on retrofitted floor beam G4 were 149.1 $\mu\epsilon$ and 109.4 $\mu\epsilon$ for pre- and post-tests respectively. These correspond to live load stresses in the steel floor beam ranging from 5 ksi to 3.9 ksi while the live load stress in the CFRP plate ranged from 9.3 ksi and 6.8 ksi for the pre- and post-tests. These stresses in the CFRP plates are significantly lower than the ultimate stress of the plates. These occurred during Test 5 when both trucks are on the bridge side-by-side.

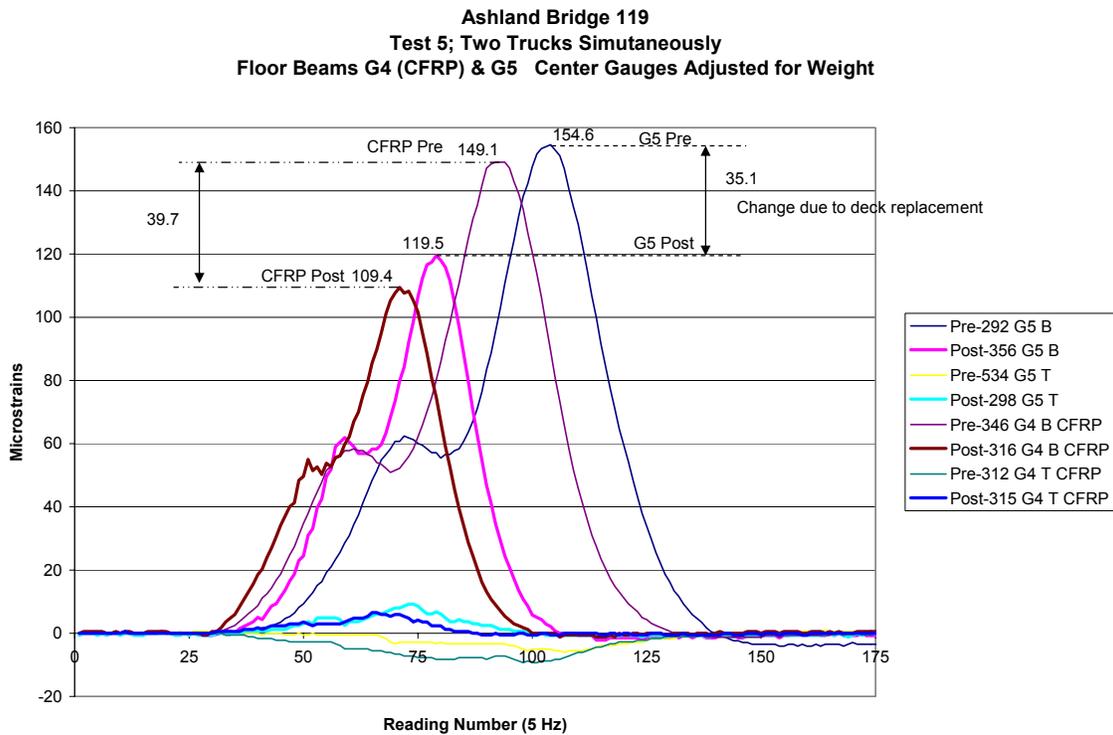
Figure 14. Comparison of change in strain from pre- to post- tests.

Figure 14 shows a comparison plot of the change in strain for the un-repaired and repaired floor beams G4 and G5. This figure shows results from Test 5 (both trucks side by side on the bridge) for both the pre-and post-tests.
