Winterthur/University of Delaware  
Program in Art Conservation  
Conservation Report

**Accession #:** 2001.0017.0001

**Object:** [Portrait of an unidentified woman]

**Materials:** Albumen cabinet card print

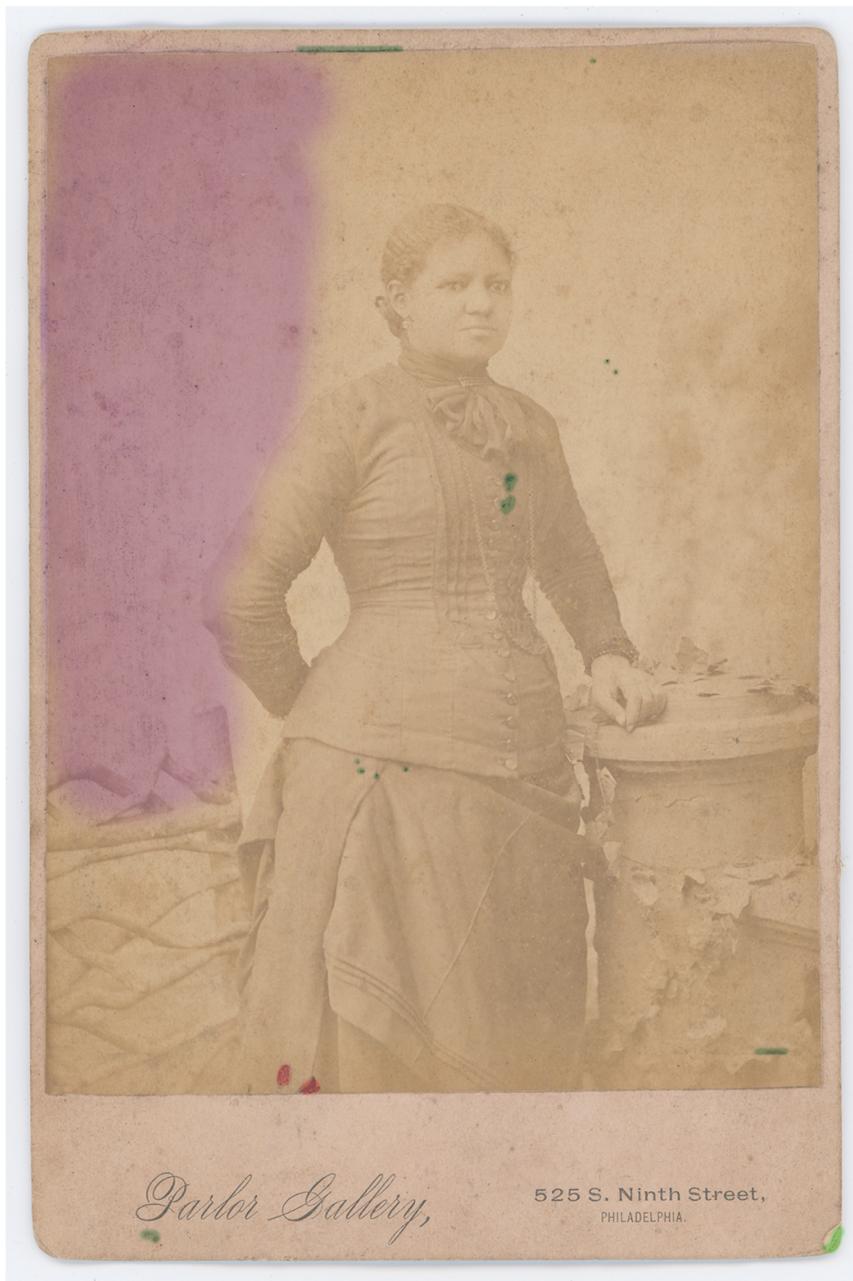
The image is in overall fair, stable condition. It appears to have fading and discoloration overall with a yellowed cast. The surface has a thin layer of dust and grime, with the greatest concentration of dirt deposition on the left half. The print is not well adhered to the mount and is delaminating along the left, upper, and right edges. There are two losses to the surface along the lower edge, which appear to be discolored by embedded dirt or darkened paint from previous in-painting. An accretion located on the unidentified woman's bust appears similar to copper corrosion when viewed under magnification.

The verso of the laminated board has purple discoloration, likely resulting from mold staining. Fly specks and dirt are visible, as well as an orange-red stain of unknown origin. There are several losses near the bottom edge and abrasion to the corners has resulted in minor losses. The surface exhibits micro-cracking when viewed under magnification.

■ Damage to image, binder, and/or lacquer due to loss, abrasion, flaking, cracking, crazing, and planar distortion

■ Mechanical damage to primary or secondary support resulting in tears, folds, creases, and planar distortions

■ Discoloration due to material off-set, acid migration localized discoloration and staining, and tide lines

■ Silver Image deterioration such as localized fading, mirroring, and yellowing

■ Iron corrosion

■ Tape and/or tape adhesive

■ Accretions and localized surface dirt

■ Mold and/or mold damage

■ Complete loss of primary and secondary supports, binder, and image

1. The recto and verso were cleaned overall using cosmetic sponges.
2. Testing was carried out to determine appropriate solution for cleaning. The photograph was cleaned with a dilute enzymatic solution on rolled cotton swabs under magnification.
3. After cleaning, the surface was cleared with rolled cotton swabs dampened with deionized water.
