Winterthur/University of Delaware
Program in Art Conservation
Conservation Report

Accession #: 2001.0017.0047

Object: [Studio portrait of unidentified woman wearing hat]

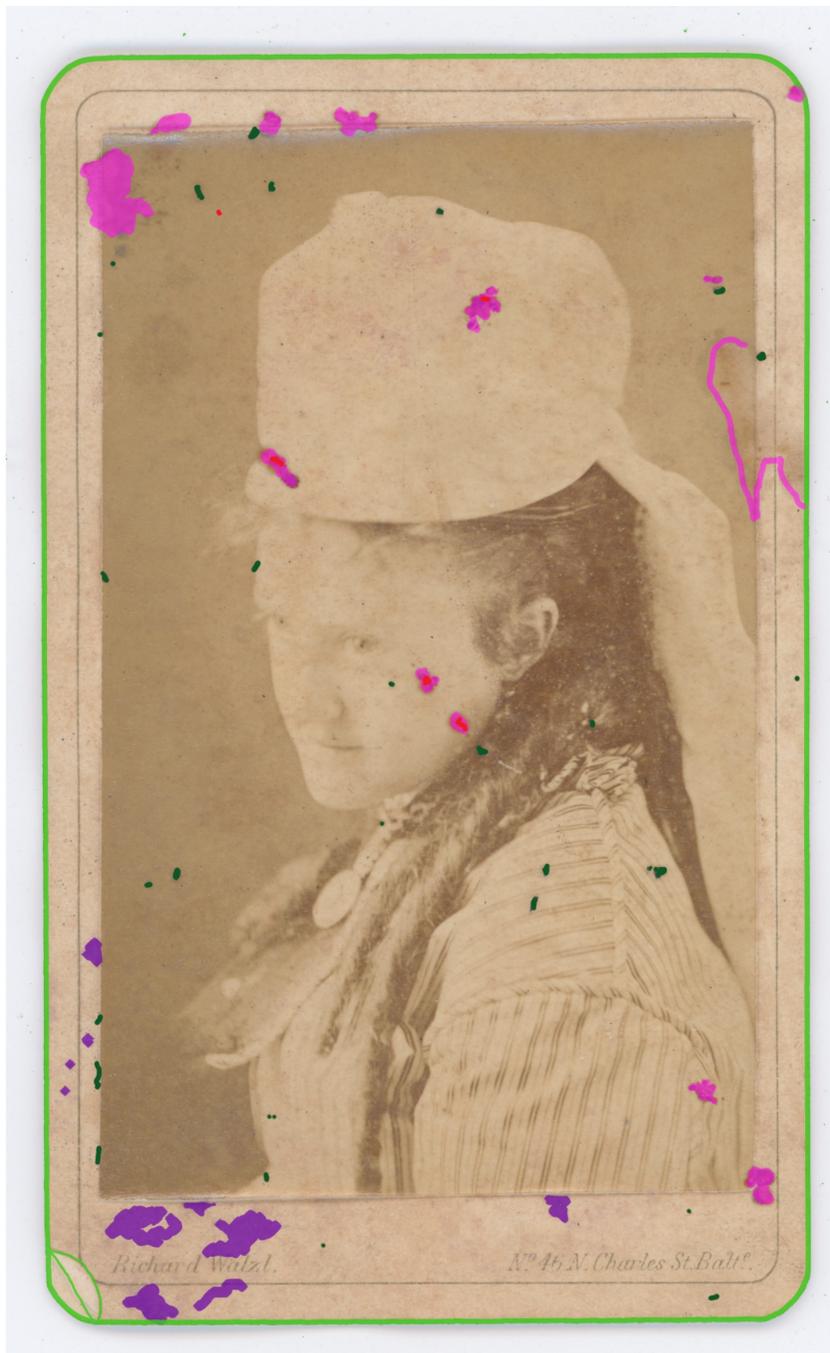
The image is in a bad condition. The deterioration causes discoloration overall. It degrades badly on the upper and bottom edge of the image. Grime and dust deposited on the surface. There is also mold damage on the surface, both image and mounting card, resulting in the purplish staining. Several small specks and corrosive accretions resulted in the brown staining and loss of binder and image. Some of them located on the figure's face, decreasing the aesthetic value of the portrait. The abrasion, crackles, and loss of the binder material are visible. There is also abrasion on the edge of the mounting card, which tends to be delaminated. The dissociation of the photo and mounting card leaves adhesive residue and dust deposit underneath the edge of the image.

On the verso, there are mold damage and staining overall. Dust deposition, specks and accretions contribute to the dirty surface. Mounting paper degraded, appearing to be yellowing. Abrasion was probably caused by handling.

Surface dry cleaning was done with cosmetic sponge.
