**Winterthur/University of Delaware
Program in Art Conservation**

Conservation Report

Accession #: 2001.0017.0024

Object: [Portrait of an Unidentified Woman with Cut Bangs Curled About the Forehead]

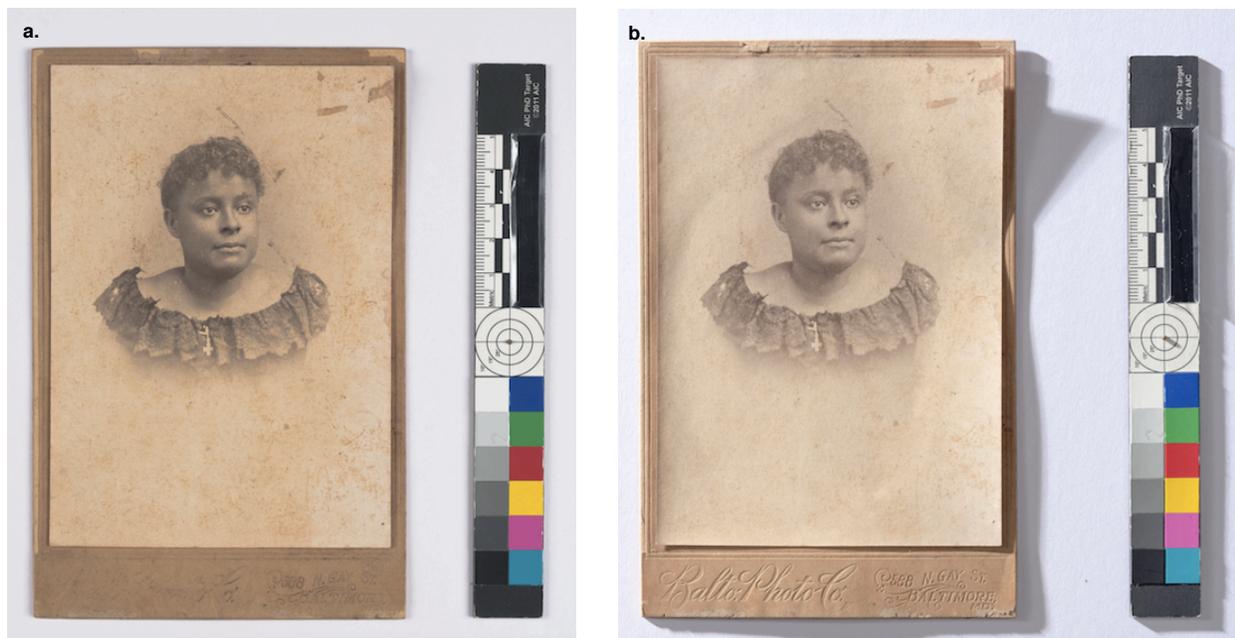
The photographic print and its jacket are both in fair condition (Figure 3). They are stable to routine handling and transportation, however there is much physical evidence to attest to severe water damage in the past. The surface on both objects has considerable dirt/grime accumulation, which, on the jacket, is more pronounced in areas of water damage (left side on front, and right side on back). The print is also delaminating from its mount on all corners, particularly in the top right corner (Figure 3b); there is an imminent risk that the entire print will detach itself from the mount.

Figure 3 – a) normal and b) raking light photos of the photographic print.

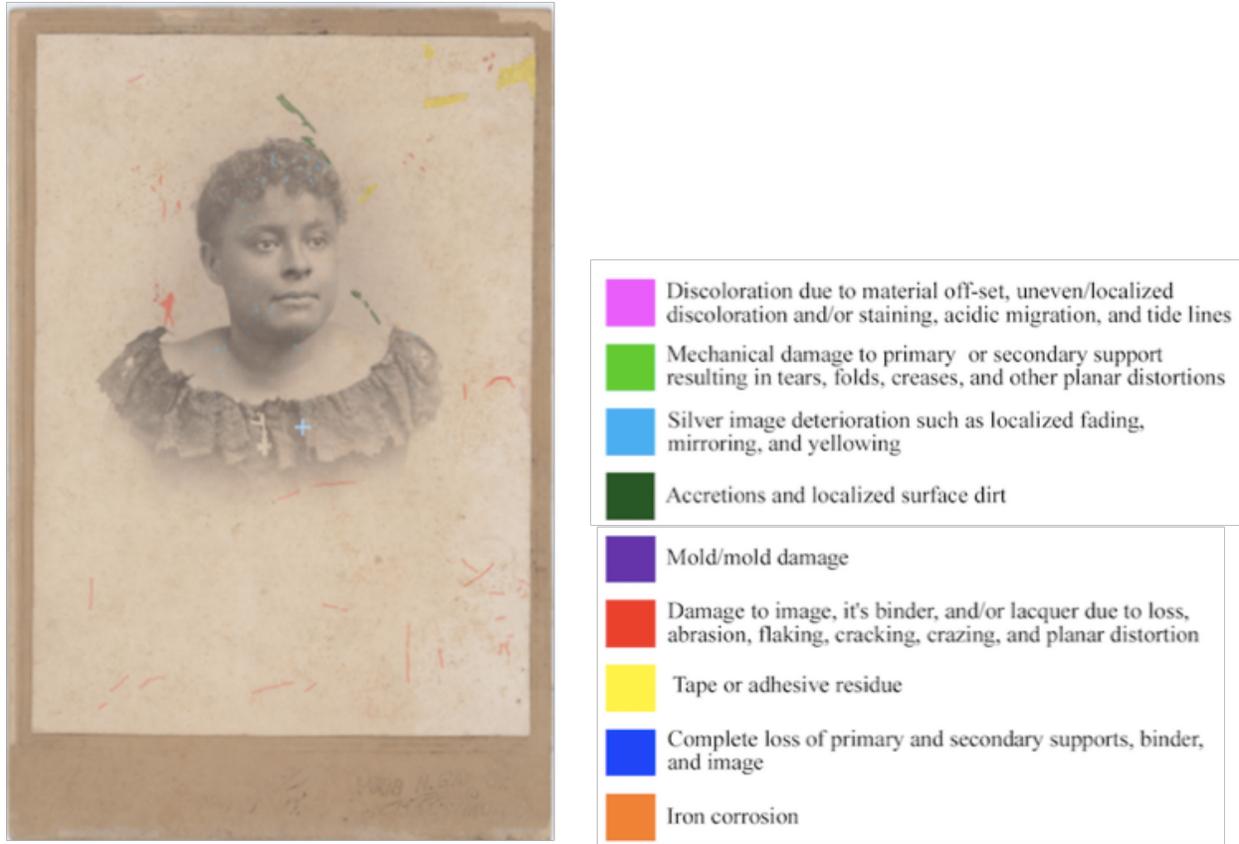
Many scattered spots of discoloration, likely from redox events leading to formation and subsequent migration of silver ions (Hendriks 1991), are present throughout the dark tones (her hair, chin area, and neckline (teal, Figure 4). These spots are all <1 mm in diameter, but are readily noticeable due to their white color, which stands in stark contrast to the dark tones. Microscope evaluation reveals the surface morphology in these areas is consistent with the surrounding dark tones indicating these light spots are not a result of mechanical damage to the image.

Readily visible to the naked eye are three dark lines that appear like scratches with embedded blackened grime. However, microscope analysis shows the albumen surface is not indented, indicating these dark lines are caused simply by grime/dirt.¹ These scratch-like areas are located 5.1 cm from left/1.5 cm from top (1 cm long diagonal slash), 5.5 cm from left/2.3 cm from top (0.7 cm long diagonal slash), and 6.5 cm from left/5.3 cm from top (0.9 cm slash deepest at left end) (dark green, Figure 4).

Sections of missing binder are present in the top right corner (yellow, Figure 4). Remnants of adhesive residue along highly crisp, linear borders indicates the likely cause of binder loss was application of a tape that was then removed, pulling binder with it. The largest section is located along right-hand border and has mold growth present in the interior. The mold spots are near perfect circular black spots embedded in the paper fibers. Smaller areas of loss include a horizontally oriented thin rectangular section located 8.1 cm from left/1.2 cm from top borders and a smaller circular section located 7.7 cm from left/0.3 cm from top. The exposed paper support for all these sections are considerably darker than its surroundings, presumably due to the acidic nature of adhesives that may have catalyzed yellowing in these areas (Smith 1983). In addition to the top right corner, removal of tape/adhesive appears to have resulted in a section of loss to the right of the sitter's head located 6.5 cm from left/3 cm from top. The exposed paper fibers here are blackened by grime.

Figure 4 – Color coded condition diagram for 2001.0017.0024.

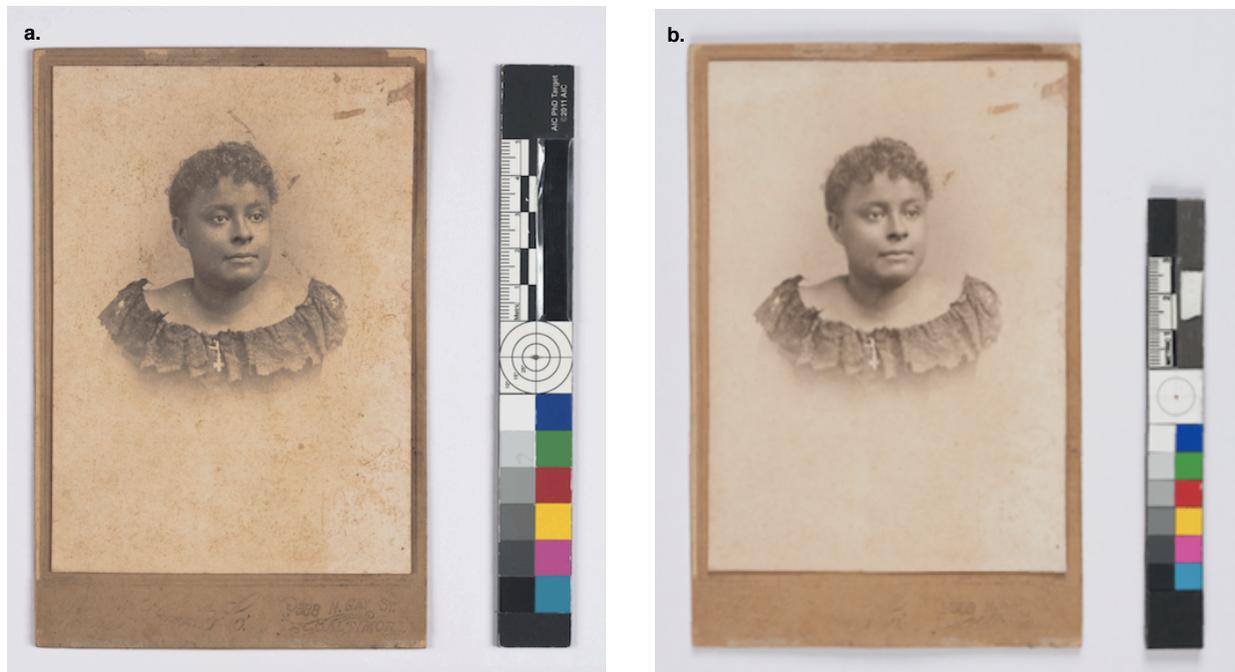
Figure 5 – a) Before and b) after treatment photos of 2001.0017.0024.

1. Dirt and grime removed using cosmetic sponge (approximately 5 rounds before sponge no longer picked up grime).

2. Surface grime removed by action of natural enzymes from saliva with gentle rubbing with a cotton swab, avoiding areas of exposed paper fiber in upper and lower right-hand corners.
3. Saliva cleared with deionized water by gentle rubbing with a cotton swab, avoiding areas of exposed paper fiber in upper and lower right-hand corners.

4. Areas of discoloration that required in-painting masked with an aqueous solution of 2% v/v methyl cellulose applied using a 000 brush.
5. Areas of discoloration in the darktones toned with Sennelier watercolor pigments.
