Tech Topic

Flexible Pavement Distresses

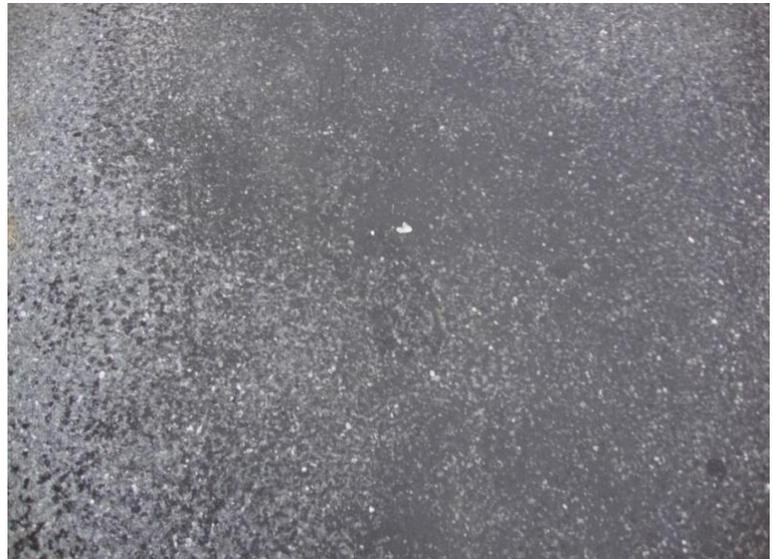
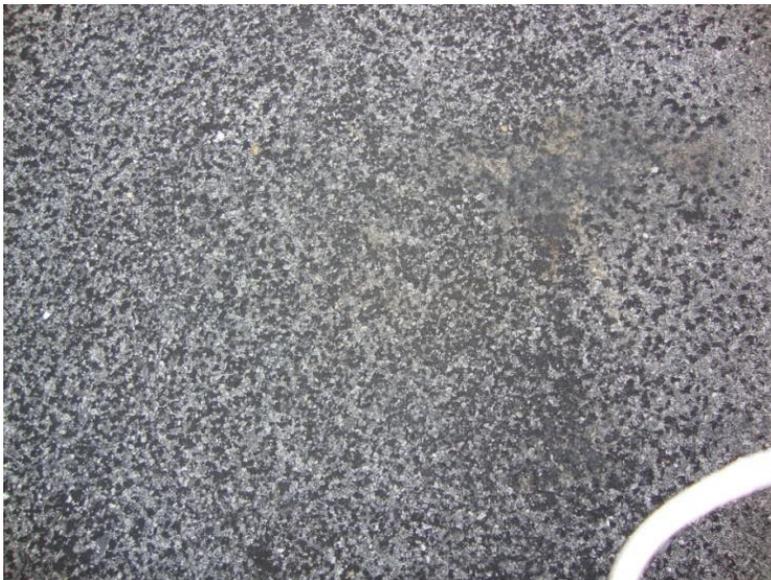
Description: A film of asphalt binder on the pavement surface, such that the surface will appear shiny and/or have black spots or blotchy areas.

Causes: Bleeding occurs when asphalt binder fills the aggregate voids during hot weather, then expands onto the pavement surface. Since bleeding is not reversible during cold weather, asphalt binder will accumulate on the pavement surface over time. This can be caused by an excess amount of asphalt binder in the flexible pavement mixture and/or low air void content. Bleeding typically originates from poor hot mix production or transportation (i.e., segregation of aggregate and binder).

Leads to: Bleeding reduces the friction characteristics of the road surface. As the skid resistance of the roadway decrease, the likelihood of crashes increases.

Typical Repair Methods: When bleeding is minor, coarse sand can be applied to the pavement in order to absorb the excess asphalt binder. When much of the pavement surface is affected by bleeding, the surface may need to be removed (i.e., milled) and the surface wearing course replaced.

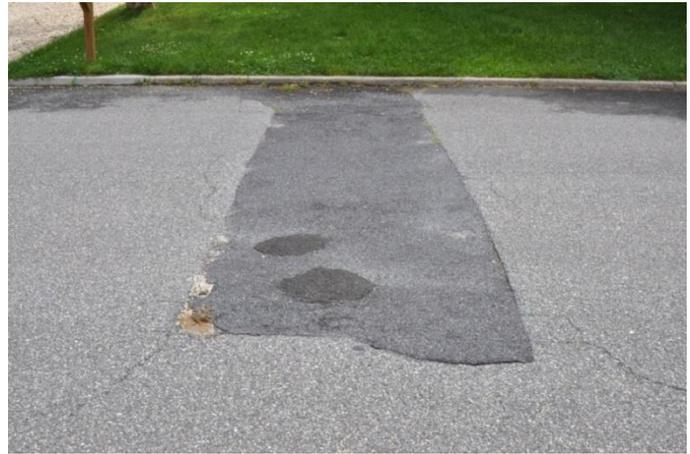
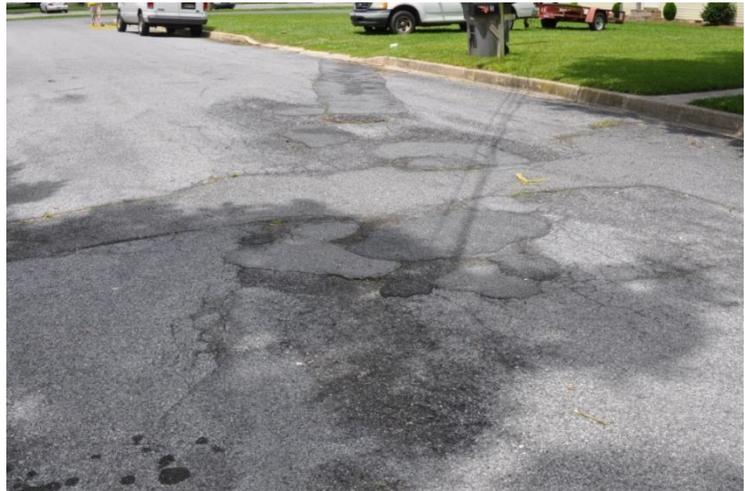
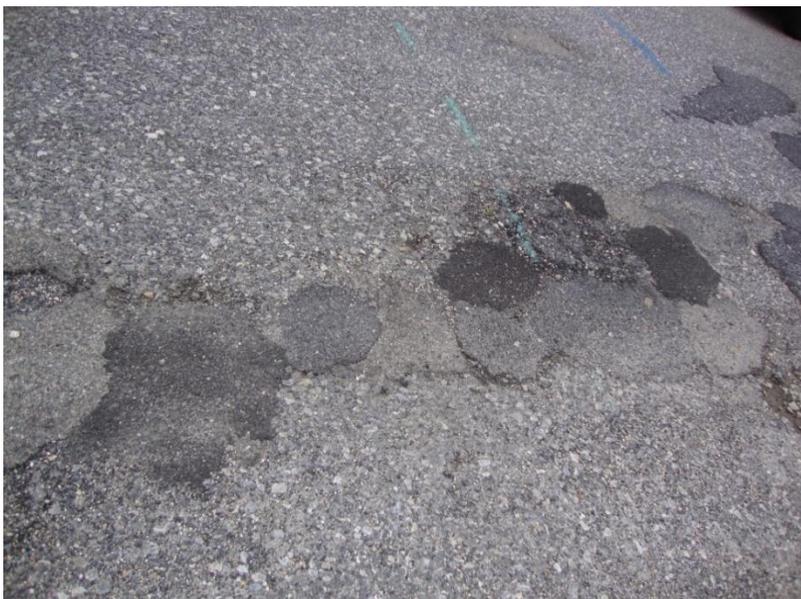
Description: Patches are localized areas of surface asphalt replacement related to utility work or repair of distressed areas.

Causes: Patches commonly are a reaction to localized pavement deterioration (potholes, alligator cracking, etc.) and are intended to be a short to medium term repair. Other times, patches are a response to utility excavations related to repairs or new installation.

Leads to: More long-term deterioration. Well-constructed patches will minimize water intrusion into the subbase stone (which leads to structural deterioration) and maintain an adequate ride condition, but can still be expected to deteriorate over time. A poorly constructed patch will more quickly deteriorate into additional cracking in the area (due to uneven resistance to forces from wheel loads), differential settlement of the surface, additional ponding, and ultimately, loss of structural strength, renewed cracking, and potholing.

Typical Repair Methods: Patching is a repair method itself, but no matter how well a patch is done, it is considered a defect, because it is, under the best circumstances, a discontinuity in the surface material and will allow water intrusion into the subbase.

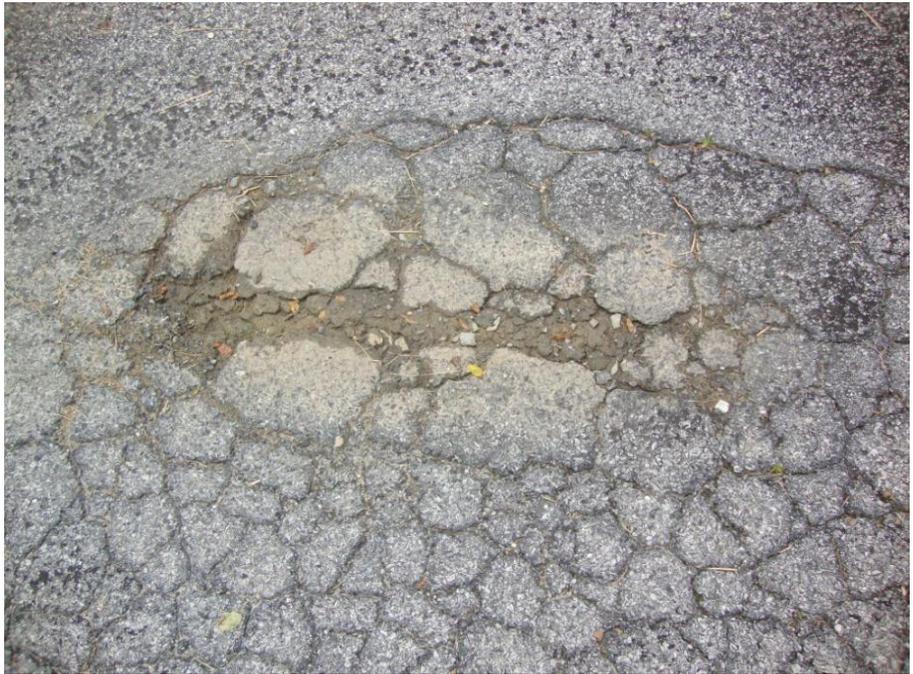
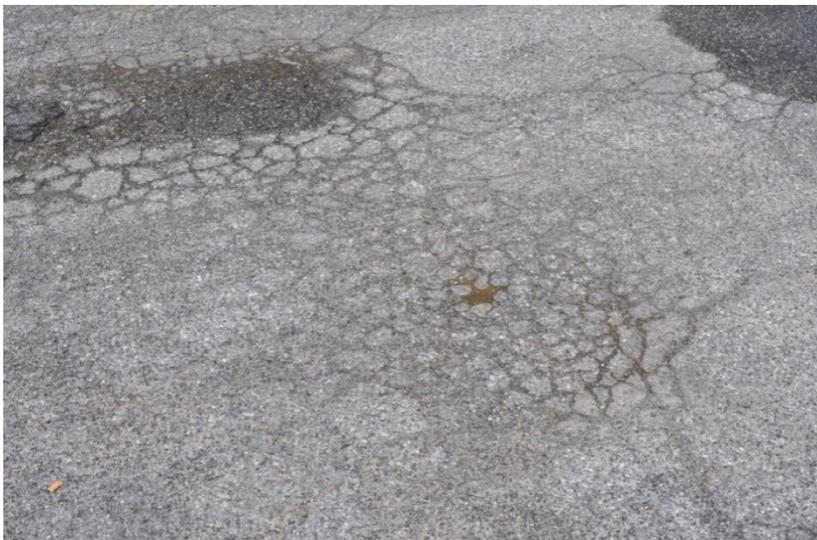
Description: A series of small interconnected cracks (often originates along wheel track areas). Usually the cracks are many sided and angled pieces with the longest side being less than 1 foot.

Causes: Alligator cracking usually occurs in high stress areas and is usually caused by repeated and/or heavy traffic loadings together with inadequate structural support from supporting layers underneath. Alligator cracking

results when the pavement cannot bear the required stress and flexes beyond its ability to self-heal because of a loss of base, subbase, or subgrade support. Stripping at the bottom of the pavement layer (where the asphalt bonds with the subbase aggregate) can limit the road cross section to act as a structural unit and allow cracking. The excess stress that causes alligator cracking may also be a result of heavier loads than provided for in the design of the road.

Leads to: Alligator cracking allows water intrusion, which then accelerates deterioration of the underlying subbase stone and subgrade layers. Ultimately, loss of subgrade strength spreads and creates more widespread cracking and potholes develop.

Typical Repair Methods: In order to be repaired correctly, the root problem of alligator cracking must be identified first. A small and localized area of alligator cracking indicates a loss of subgrade support. This can be repaired by removing the cracked pavement, replacing the poor subgrade area and fixing the drainage, then installing a patch back over this area. The long-term effectiveness of this will depend upon many factors, including the integrity of the subgrade and subbase and bonding of the

A large area of alligator cracking shows that there is structural damage to the pavement. This typically requires replacement of a larger area with a whole new flexible pavement overlay on the entire road.

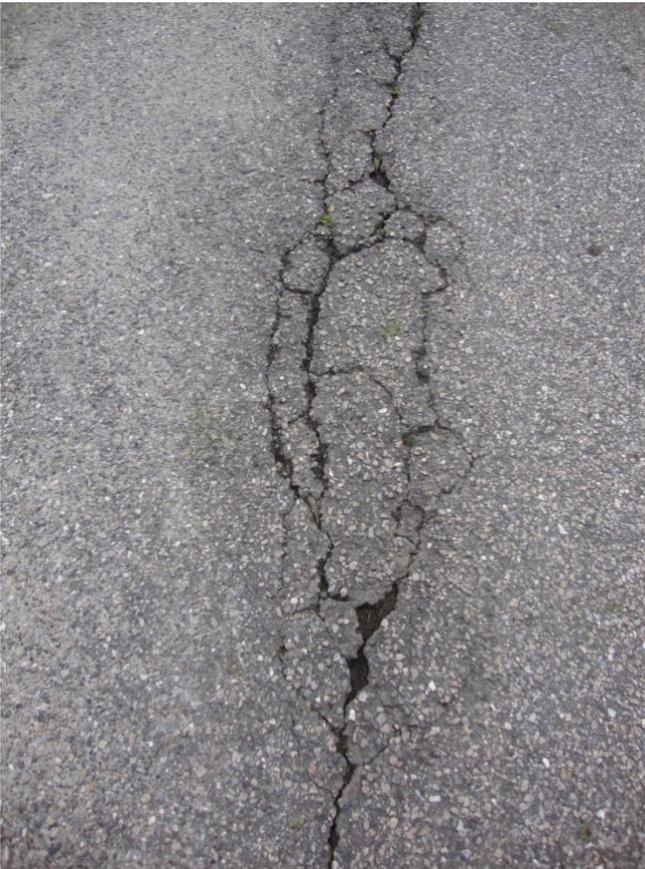
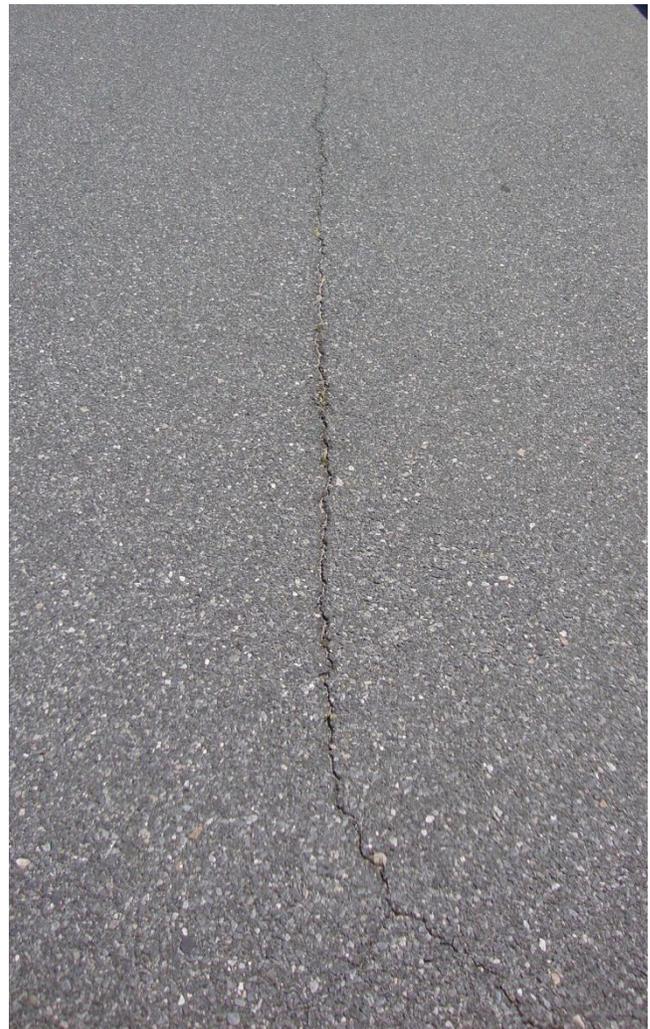
Description: Cracks that have developed and begun to expand unabated. These may be cracks that have been sealed before but are no longer effective in preventing water intrusion or they may be newer cracks that have never been treated.

Causes: Cracks, to some extent, are inevitable in pavements. Crack sealing deficiency is when cracks have been allowed to expand, unabated, in both length and width or have not been monitored for recurrence of open conditions or expanded reach.

Leads to: Cracks allow water intrusion into the pavement, which causes more cracks and debonding and allows accelerated development of

Typical Repair Methods: Crack seal large cracks in pavement periodically to maintain a sealed surface condition and minimize pavement rehabilitation costs over time.

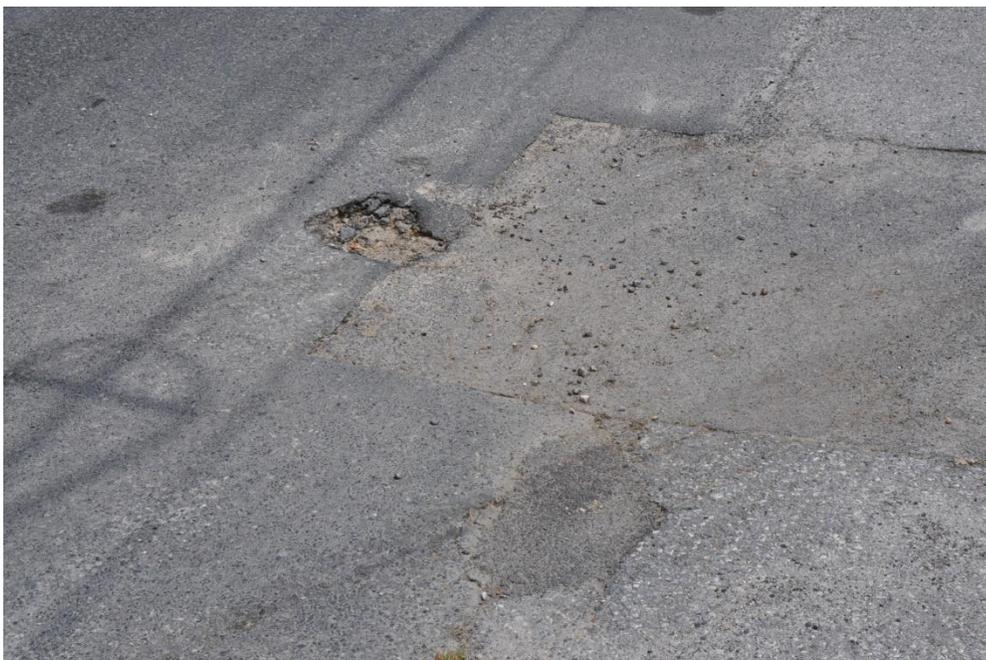
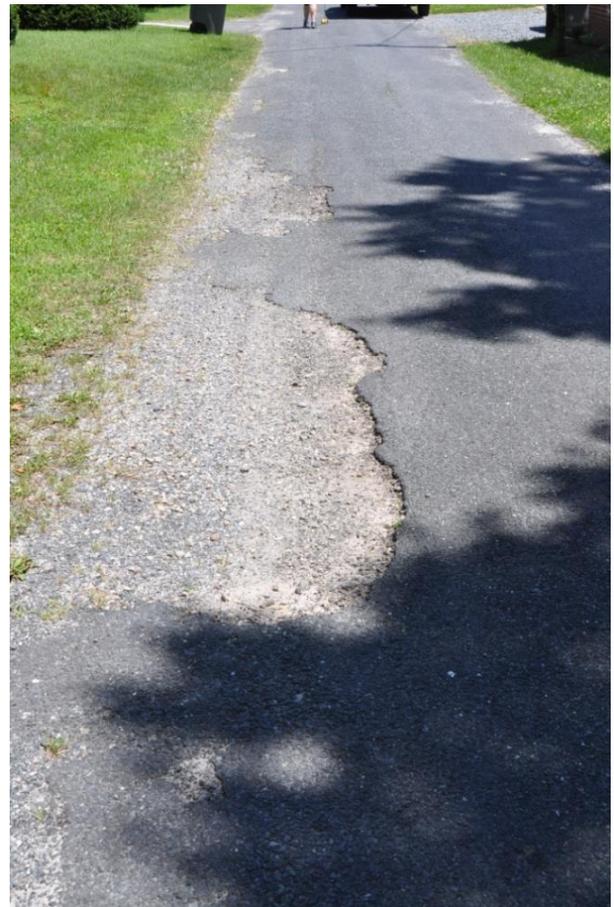
Description: Potholes are bowl shaped voids or depressions in the pavement surface. Debonding is when the surface layer separates from its underlying layer of asphalt.

Causes: Often, potholes begin as alligator cracking; the small cracks cause pieces of pavement to dislodge when cars drive over them causing the pothole to enlarge. However, potholes also result from local poor compaction, inadequate bonding between layers, or segregation of aggregate and binder during placement.

Debonding usually occurs from poor construction of pavement where a thin surface layer does not adequately bond with the underlying material or flexes excessively. Between asphalt layers, debonding is usually related to inadequate tack application, wet paving conditions, or dust/dirt on the underlying asphalt. Debonding between asphalt layers and underlying stone are more commonly a result of too thin an asphalt layer to withstand forces that cause it to flex. Freeze-thaw action can also be a factor with thinner pavement layers.

Leads to: Unsafe surface conditions, further deterioration, and subgrade failure due to water intrusion. Serious vehicular damage can occur, especially at high speeds.

Typical Repair Methods: A patch is usually done in order to help fix the problem of a pothole. It is

best to cut liberally around the entire cracking area in a rectangular shape, remove all loose material, tack seal the edge well, fill in with new asphalt, and crack seal the perimeter to avoid water intrusion. But sometimes potholes are just filled in with new asphalt without cutting around the entire problem area (“throw and go”).

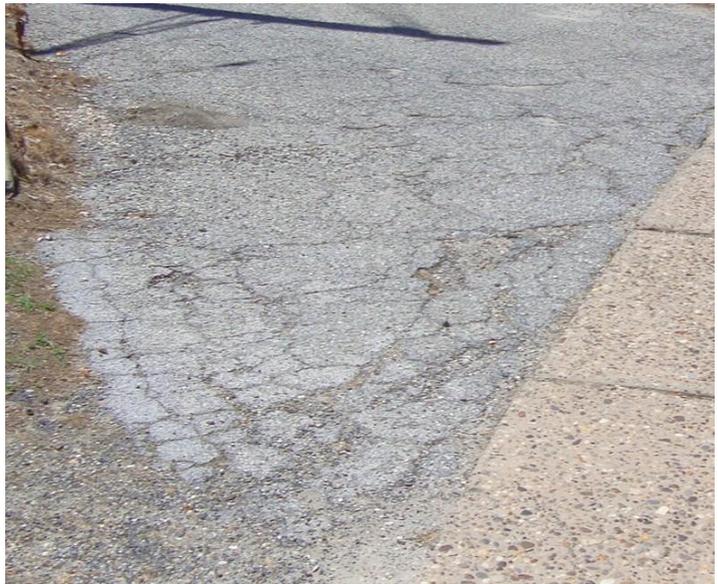
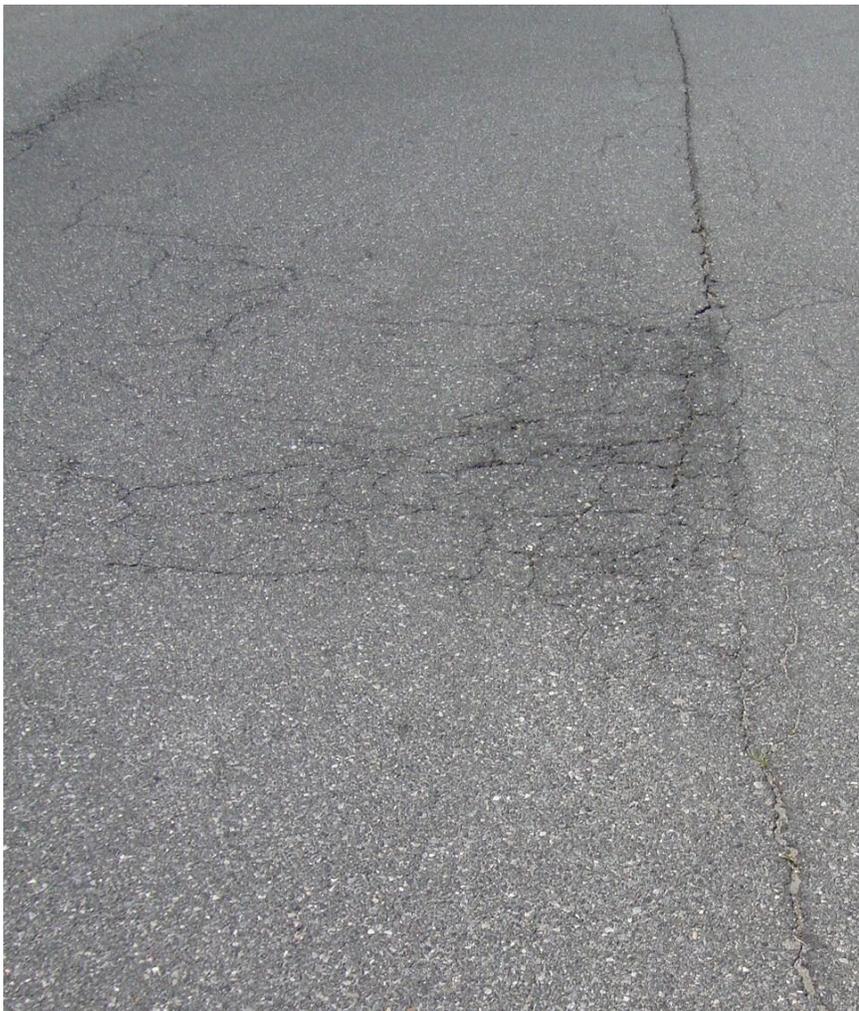
Description: Block cracking is characterized by interconnected cracks that break the pavement into large rectangular pieces. It is different than alligator cracking in that the crack areas tend to be larger, more rectangular, and generally without settlement of the surface material. Transverse cracking forms perpendicular to the centerline of the roadway and usually extends across one or all of the lanes of the road.

Causes: Block cracking occurs from a change in volume of the pavement surface because of temperature conditions, along with the hardening or oxidation of asphalt as the pavement ages. Transverse cracking results more specifically from longitudinal shrinkage of the asphalt surface.

Leads to: The cracks will allow water intrusion and the crack edges will deteriorate by raveling and erode the adjacent pavement. As water enters the underlying layers, the subbase and subgrade will

Typical Repair Methods: Low severity cracks should be crack sealed early to prevent water intrusion and further raveling of the crack edges. In advanced stages of block cracking, milling with an asphalt overlay is generally more effective.

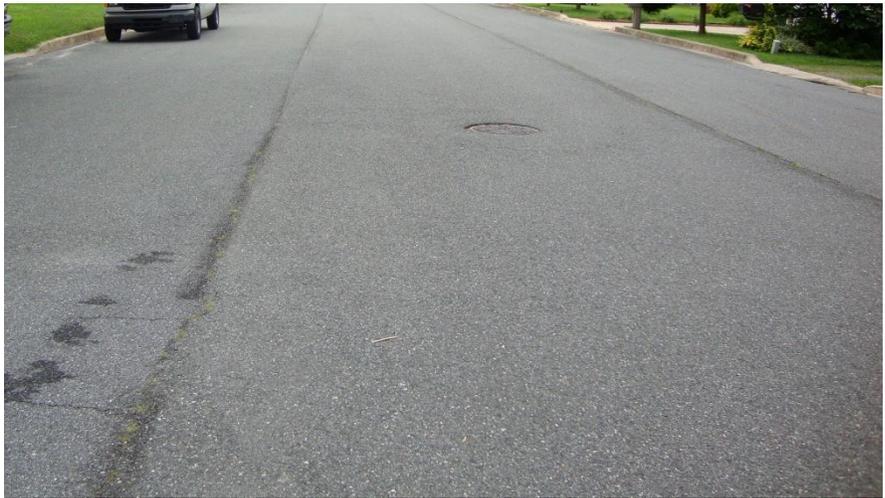
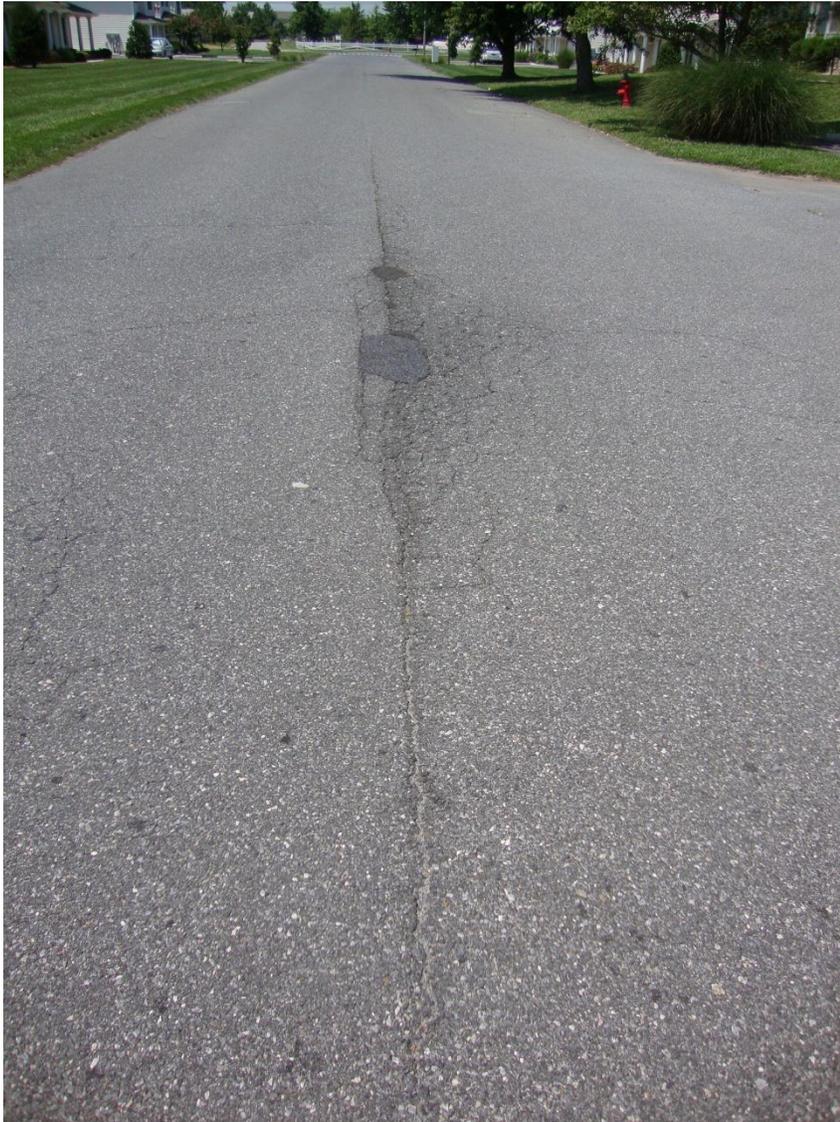
Description: Often seen at the centerline, this is any continuous or semi-continuous cracking that parallels the centerline.

Causes: Centerline cracking is usually associated with poor joint construction during the paving operation. However, fatigue can also be a cause, particularly when longitudinal cracking is seen near the edge of pavements where the structural strength of the subbase and subgrade are inadequate.

Leads to: The cracks will allow water intrusion, which damages the underlying support material and leads to crack widening and the erosion of the adjacent pavement. As water enters the underlying

Centerline joint cracks should be avoided to the extent possible through best construction practices during paving operations. When joint cracks do develop, early crack sealing can be an effective means of minimizing the spread of deterioration.
