Enhancements to the Bond Between Advanced Composite Materials and Steel for Bridge Rehabilitation

**Center for Composite Materials
University of Delaware**

December 2002

DELAWARE CENTER FOR TRANSPORTATION

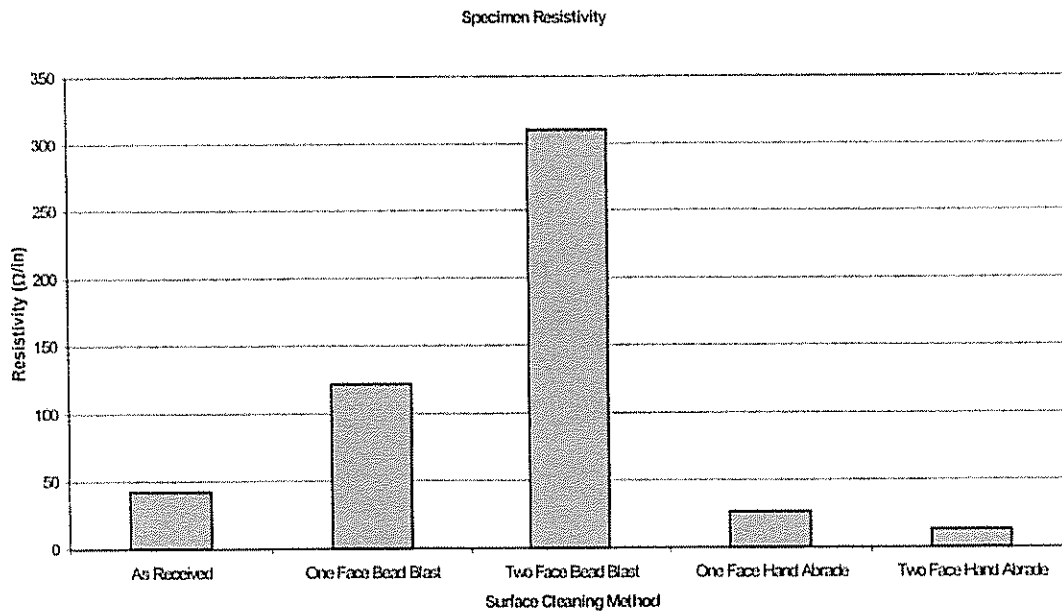
Figure 2.6 Resistivity comparison for composite samples across surface cleaning method.

expected. Figure 2.6 illustrates the range of resistivity measurements for the composite based on the different surface preparation methods.

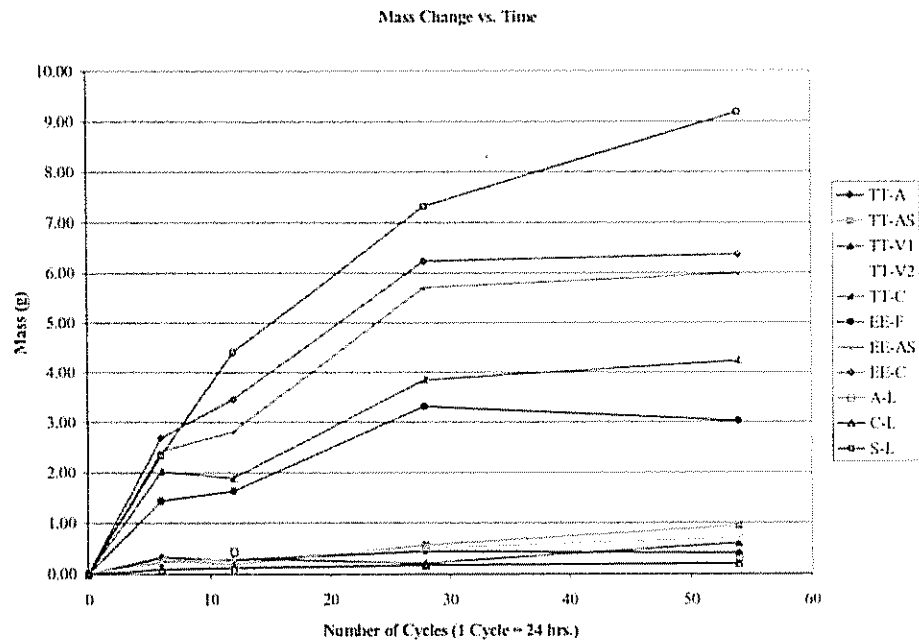
Figure 2.14 Mass change vs. time of exposure samples through 54 cycles.

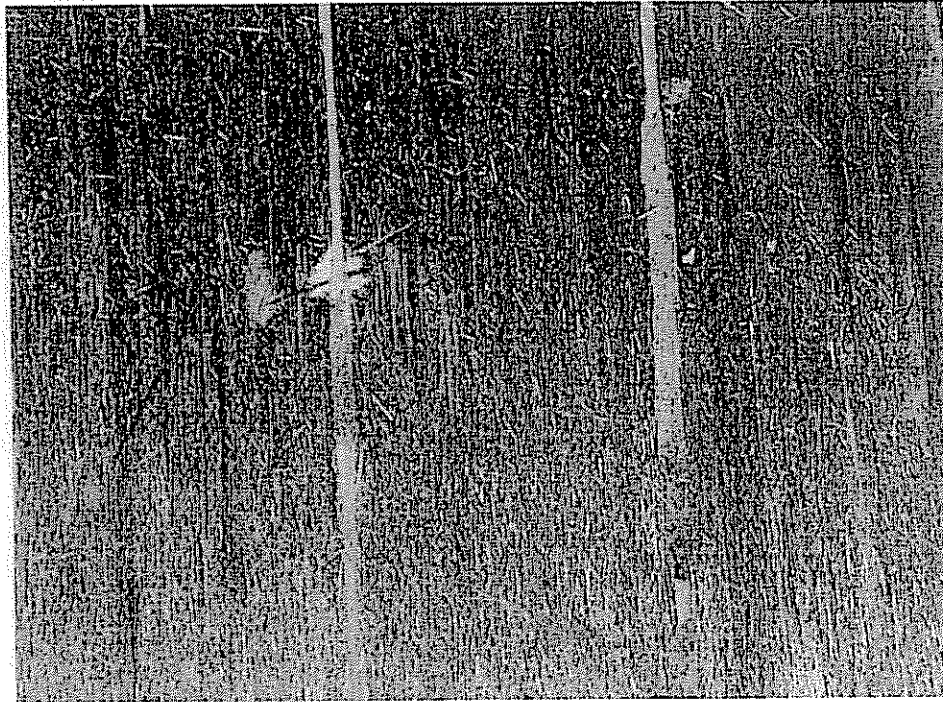
Figure 2.20 Close-up of exposed areas of white metal steel at bond interface of sample TT-A.

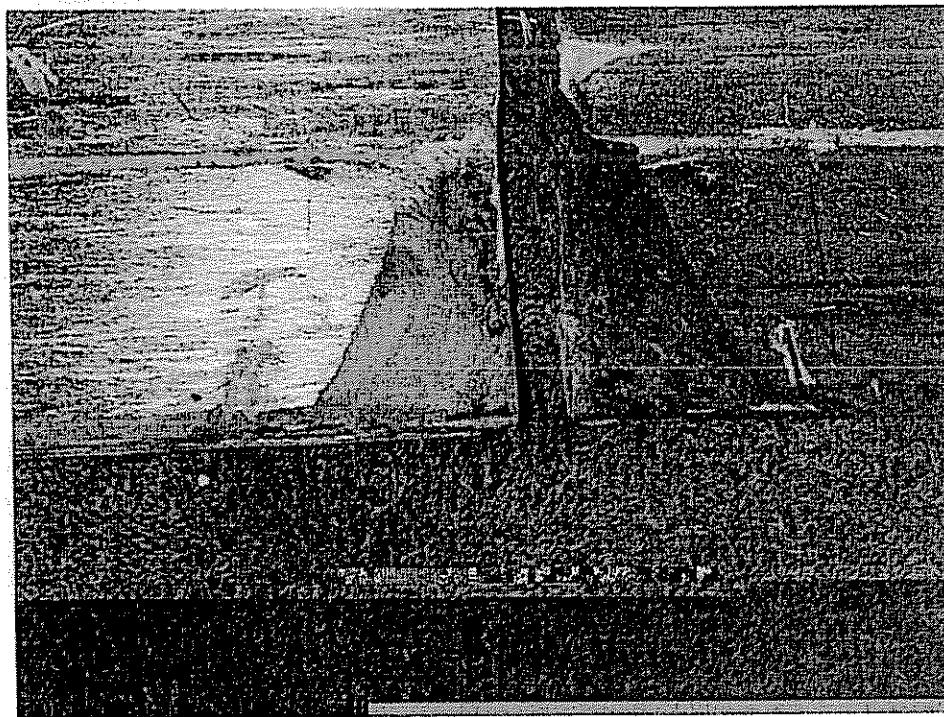
Figure 2.21 Corrosion at steel-composite interface at corner of sample TT-A.

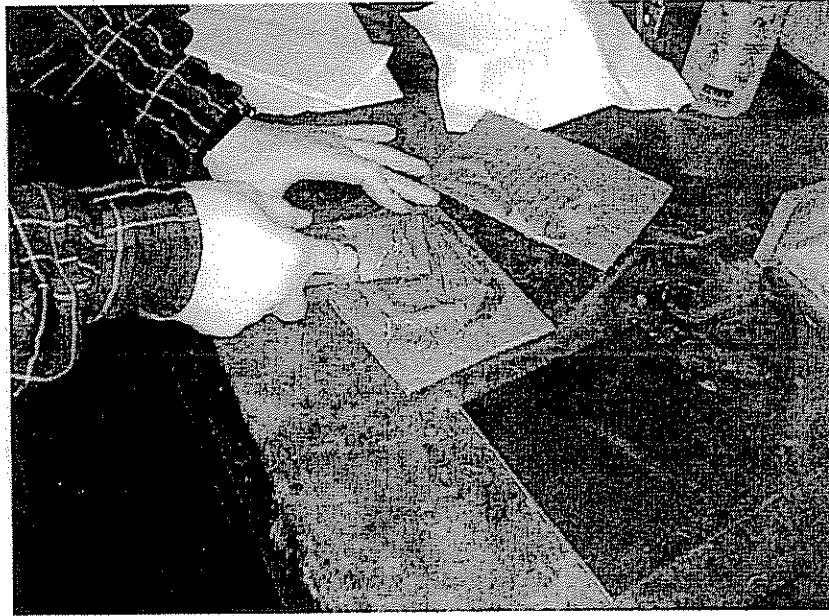
Figure 3.3 Mixing the two-part Ciba-Geigy AV 8113 adhesive.

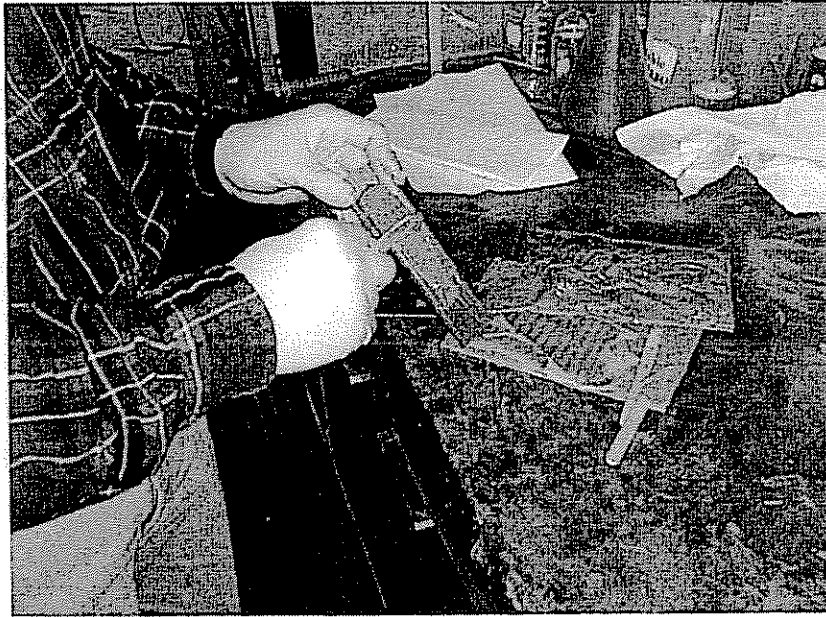
Figure 3.7 Applying the adhesive to a composite strip.

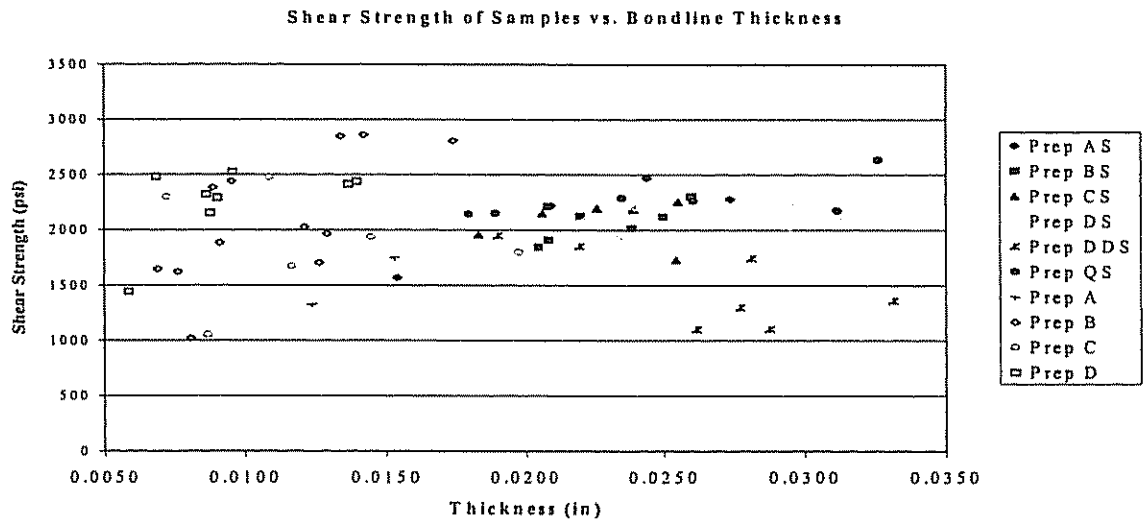
Figure 3.24 Comparison of shear strength vs. bond line thickness across all tested samples.

It can be seen that the samples without the scrim are shown to have bond thickness less than approximately 0.0175 in and those with the scrim exhibit a thickness greater than 0.0175 in. This was to be expected for two reasons. First, the scrim has a thickness of 0.004 in therefore the addition of the scrim would automatically increase the bond line thickness by this amount. Second, the samples without the scrim were fabricated with a layer of adhesive applied only on the steel surface while those with a scrim had a layer of adhesive applied to both adherends. This was done to ensure that the scrim was effectively wet out with the adhesive to guarantee a complete bond as well as complete electrical isolation for galvanic corrosion protection as described in Chapter 2. Therefore the obvious clustering of samples with and without a scrim with respect to bond line thickness was to be expected.

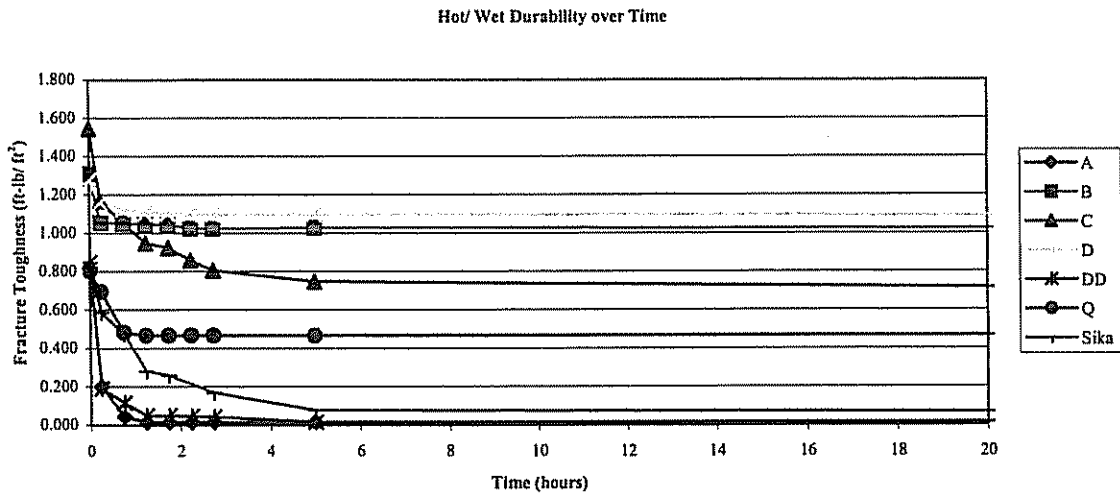
Figure 4.2 Durability over the first 20 hours of exposure for samples in an environment of 122°F and 85% RH.

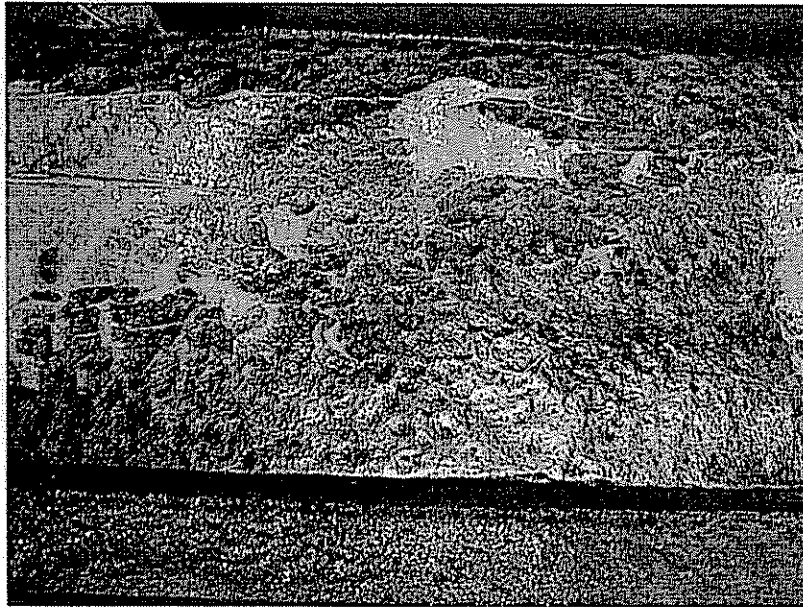
Figure 5.14 Pitted flange surface due to corrosion. Care was required to ensure complete adhesive coverage.

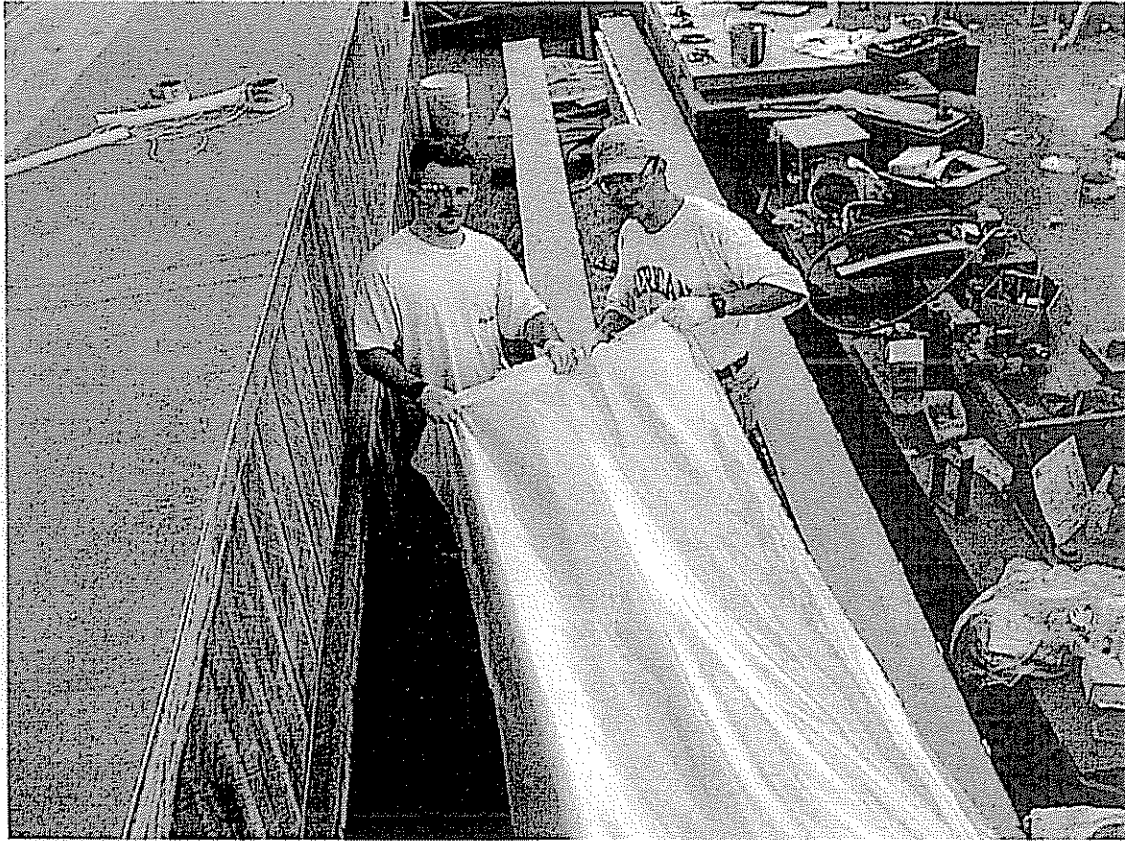
Figure 5.15 Pulling out 120-fiberglass scrim to place in bondline as a galvanic corrosion inhibitor.

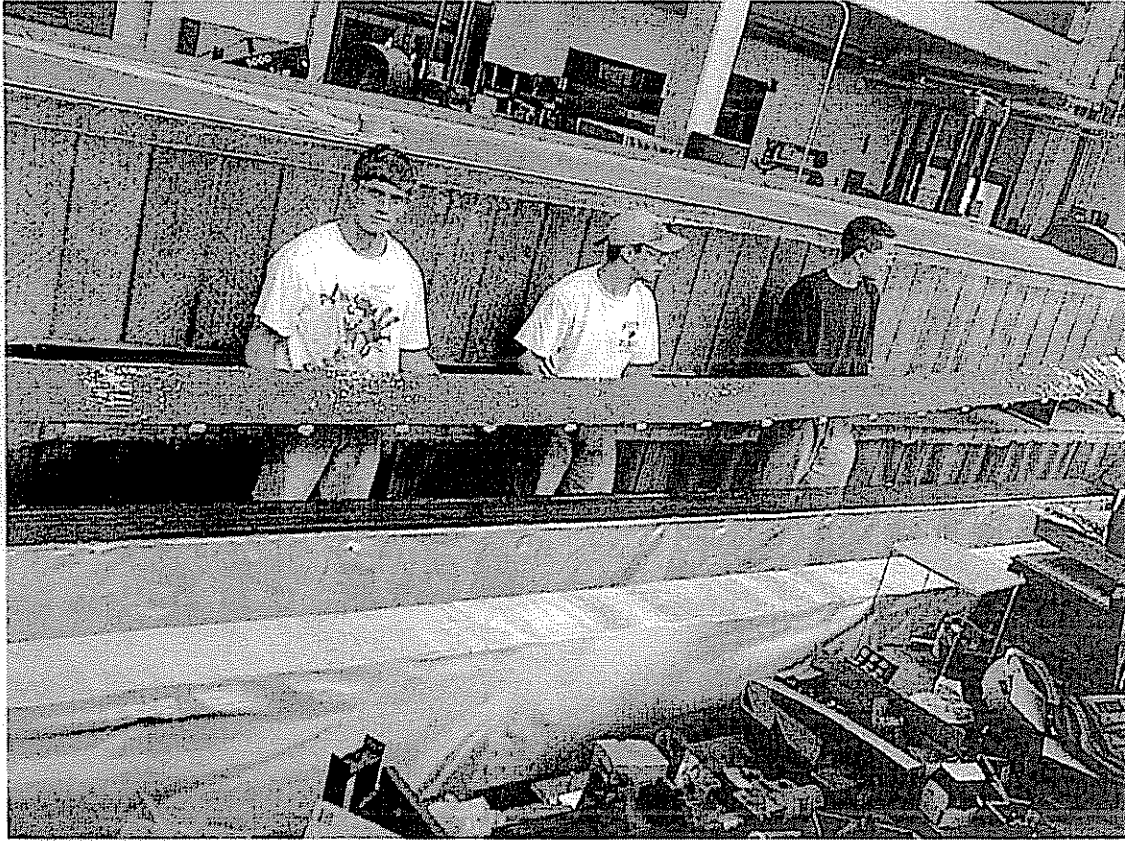
Figure 5.17 Lifting the composite assembly with full coat of adhesive prior to bonding to steel.

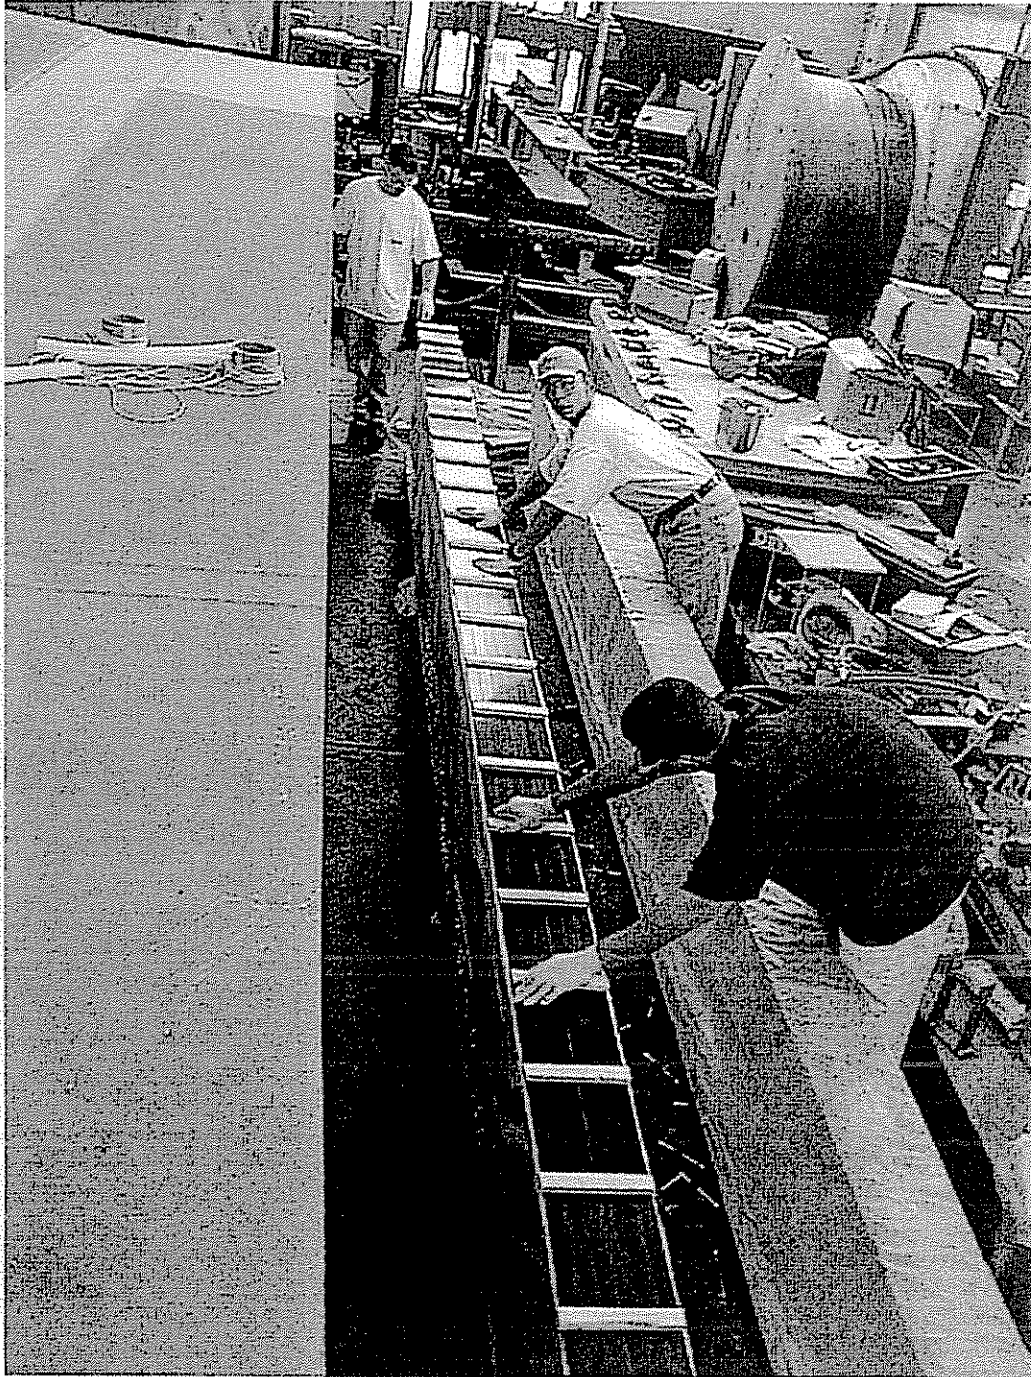
Figure 5.19 The composite assembly in its final location prior to clamping.
