MMFX Rebar Evaluation for I-95 Service Road Bridge 1-712-B

March 2005

**Delaware Center for Transportation
University of Delaware
355 DuPont Hall
Newark, Delaware 19716
(302) 831-1446**

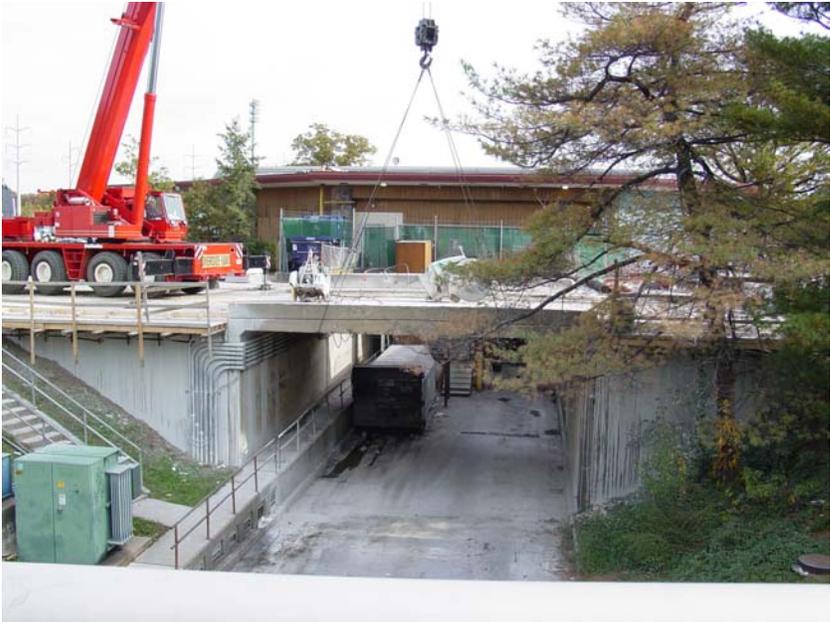
Figure 3.1 Bridge 1-712B Looking North East

As mentioned in section 1.1, bridge 1-712B is located in the I-95 Service area in Newark, Delaware. The bridge carries one way traffic from the west side of the service area to the east side and crosses a delivery road used for the service building and restaurant. The bridge primarily carries car traffic. Trash trucks for the service area also use the bridge frequently. Figure 3.1 shows the bridge and how it is situated.

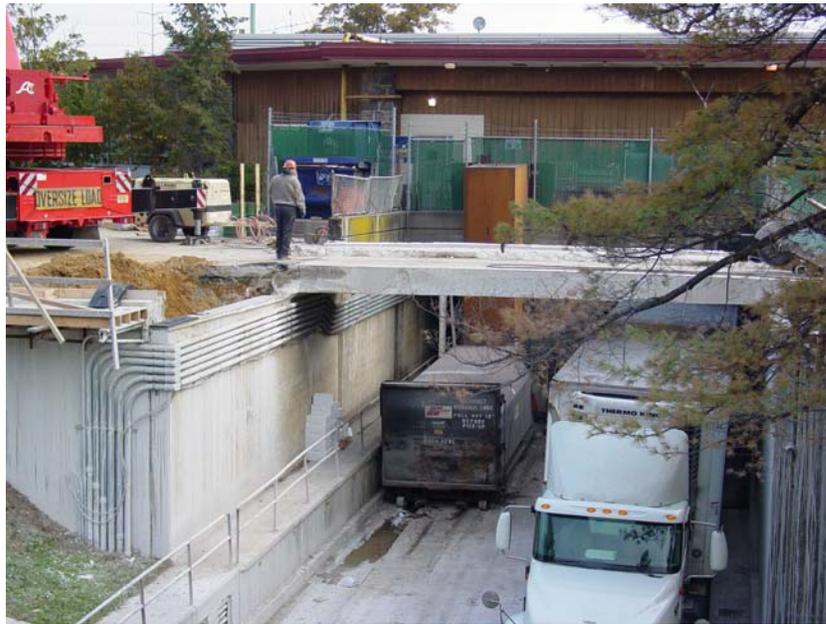
Figure 3.2 Bridge 1-712B with Old Beams Partially Removed

wide concrete beams reinforced with MMFX rebar. The depths of the beams were restricted due to the fact that large trucks use the delivery road beneath the bridge. From the bottom of the delivery road to the bottom the bridge beams is approximately 15 feet. Due to height restrictions, the beams designed had a depth of 15 inches with a 5 inch concrete deck poured on top. Section 3.3 presents the dimensions and design of the beams. The beams that made up the old bridge were saw cut and removed. Figure 3.2 shows the bridge with a few beams removed.

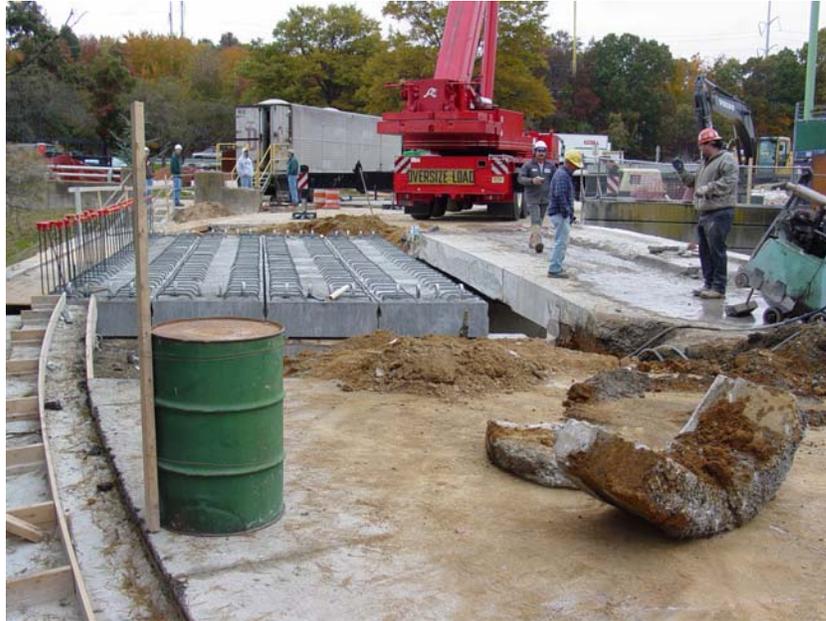
Figure 3.3 New Beams Next to Old Beams

In order to stabilize the walls, once a few of the old beams were removed, new beams were installed. Figure 3.3 shows the new beams sitting next to the old beams.

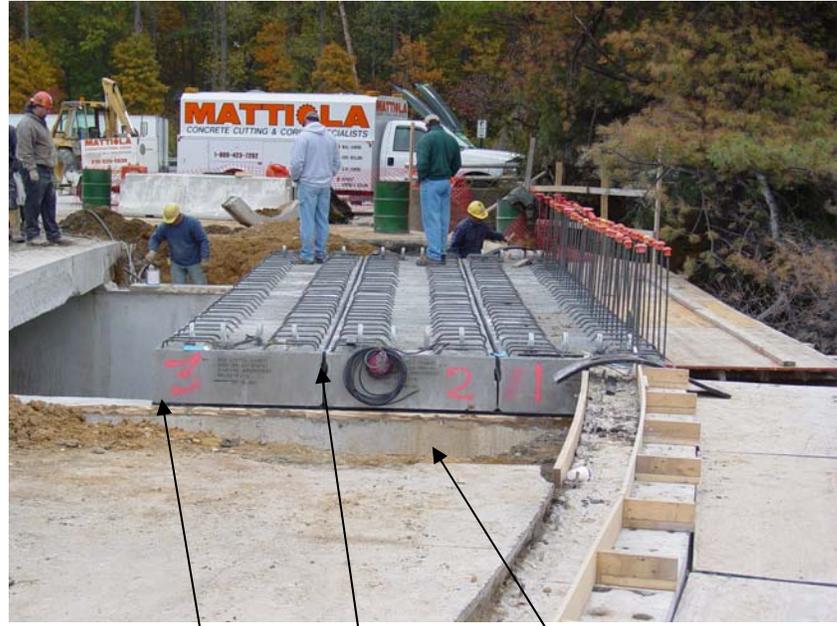
Figure 3.4 Beam, Bearing Pad, and Retaining Wall

The beams span over the delivery road and each end rests on a bearing pad which sits on top of a retaining wall. MMFX dowel bars and rubberized joint filling material connected the beams, bearing pads and retaining wall. The MMFX bars and rubberized joint filler sat in three holes at each end of the beam, bearing pad and retaining wall. Figure 3.4 shows two beams, the bearing pads, and the retaining wall put together.

Retaining Wall Bearing Pad Grouted areas Back of

Shear connectors, placed in the rebar cage of each beam before pouring, attached each beam to the adjacent beams. Metal plates welded to each of the shear connectors joined adjacent beams. A total of 15 shear connectors connected one beam to a neighboring beam. Grout at the top of the beams, also shown in Figure 3.4, and a tie rod placed through the middle of all the beams secured them together. MMFX stirrups protruding 2.5 inches out of the beams connect the 5 in concrete bridge deck to the beams. An MMFX rebar grid placed in the deck is used to control cracking. Concrete parapets poured on either side of the bridge finished the

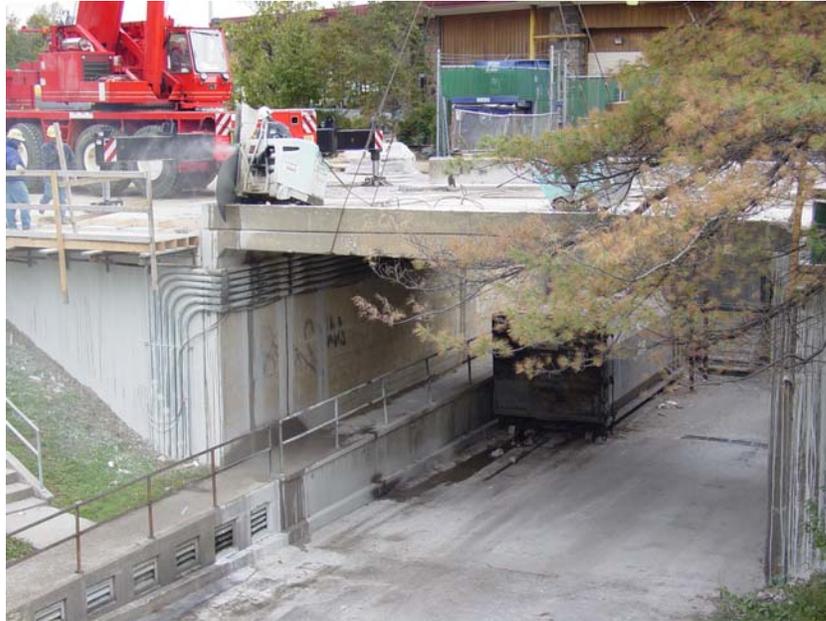
Figure 3.5 Saw Cutting and Removal of Old Beams

structure. Figures 3.5 through 3.9 illustrate different phases of the construction for bridge 1-712B.

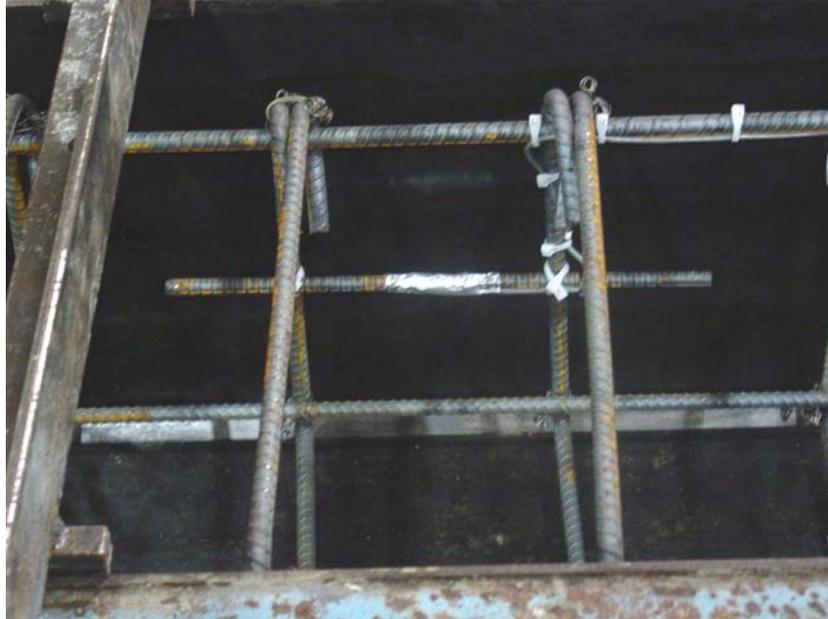
Figure 3.18 Strain Gage Attached to Top of Beam

gages, made by Measurements Group, Inc., had a resistance of $350 \pm 0.4\%$ ohms and a gage factor of $2.095 \pm 0.5\%$ at 24 degrees Celsius. The weldable strain gages were wired in a one quarter bridge and attached to a 16 inch sister bar. The sister bar consisted of a piece of #4 Grade 60 rebar. Each beam had two gages placed in them. The gages are located at the center of the beam at mid width, one next to the flexural reinforcement (approximately 2.5 inches up from the bottom of the beam) and the other placed at the same location but in the compression region of the concrete (approximately 2.625 inches down from the top of the beam). Zip ties attached the gages and lead wires to the rebar cage with the lead wires running out of the end of the beam. Figures 3.17 through Figure 3.19 show the strain gage attached to the sister bar and the strain gages attached to the rebar cage of the beams.

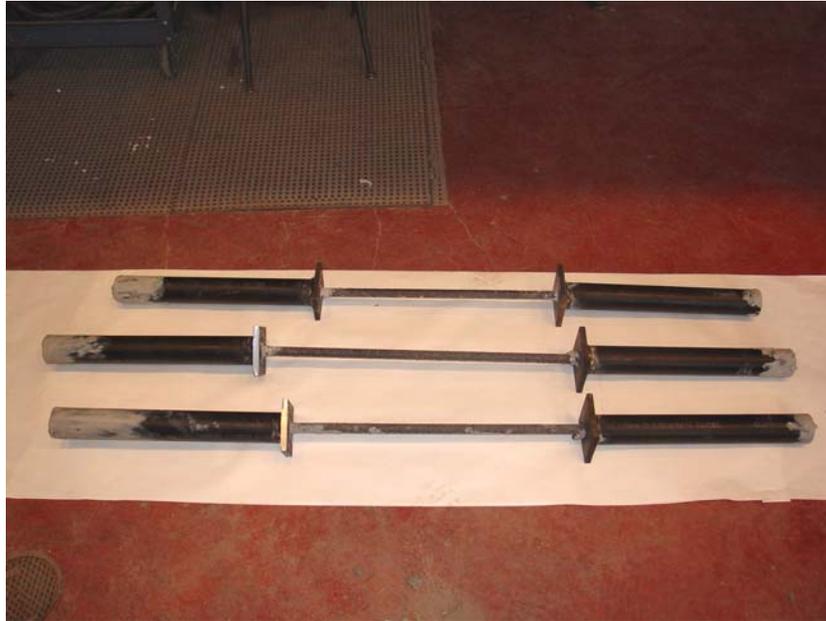
Figure 4.2 CFRP Test Specimens

The CFRP bars were very difficult to test, the bars crushed in the tensile machine grips due to their low compressive strength. Several methods of testing the bars were developed but none of the methods enabled the bars to be tested to failure. The method that produced the best results was by placing an 18 inch steel tube over both ends of the bar. The tube was then filled with Sikadur 31, Hi-Mod Gel epoxy and left to cure. The total length of the test specimen was approximately 5 feet. Figure 4.2 illustrates the CFRP test specimens.

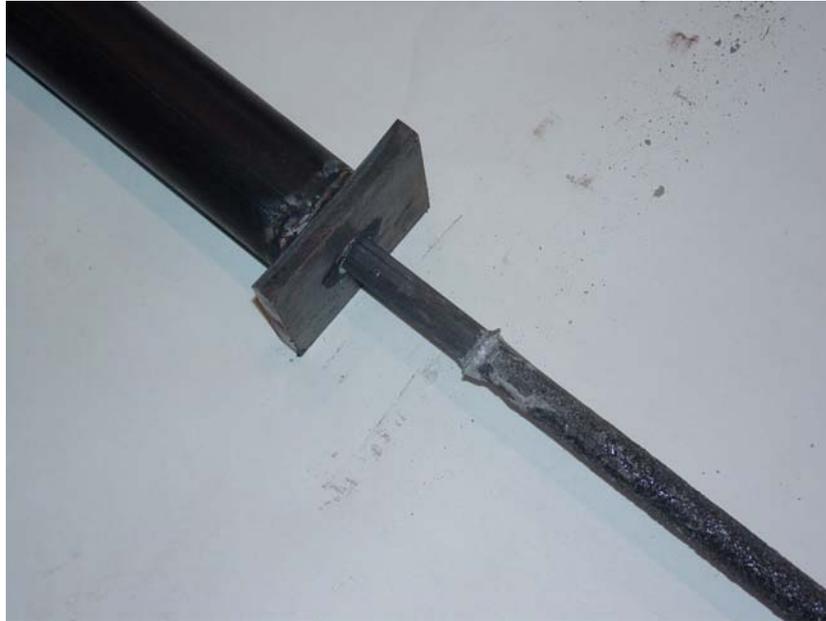
Figure 4.3 Bond Failure of CFRP Rebar

When the CFRP specimens were tested, the bond failed before the bars developed their tensile capacity. The test did yield an average modulus of elasticity for the CFRP bars of 23,233 ksi which can be found in Table 4.2. The manufactures specified fracture stress of 225 ksi is used in all fracture calculations. Figure 4.3 illustrates the slipping and bond failure that occurred during testing.

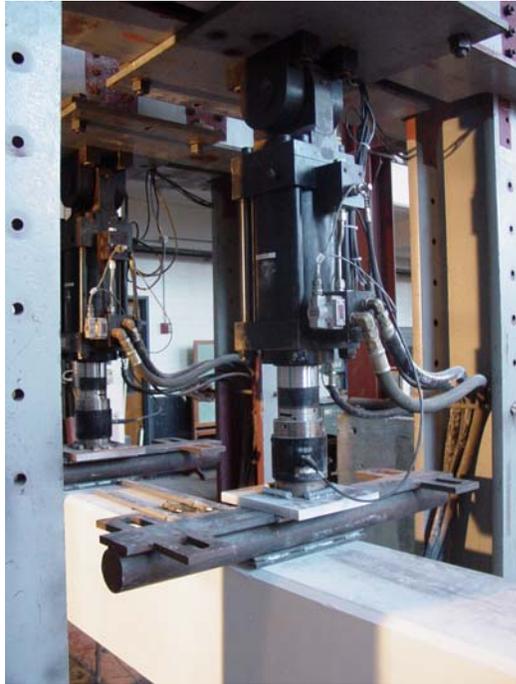
Figure 4.5 Actuator Set Up

The end supports for each beam consisted of rollers sandwiched between plates placed at 8 inches in from the ends of the beams. This created a simple support condition for the beams which is the support condition for bridge 1-712B.

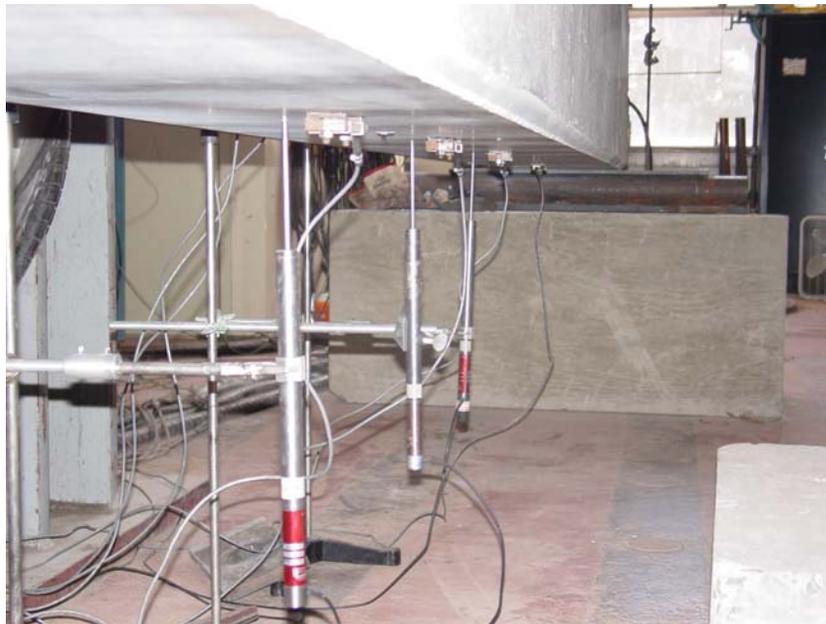
Figure 4.8 LVDT and BDI Set Up

the System 5000 data acquisition system. Figures 4.7 and 4.8 illustrate the location of the LVDTs.

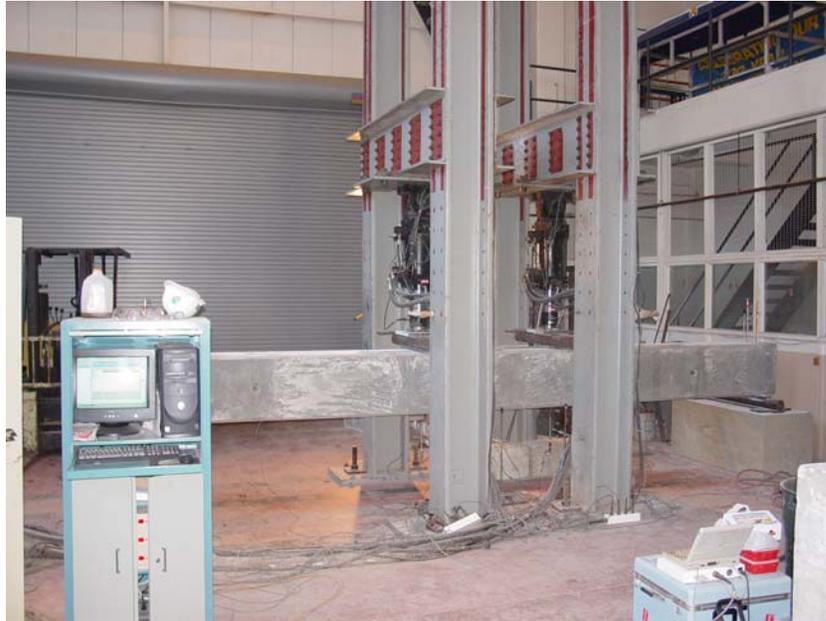
Figure 4.9 Typical Test Set Up

tension concrete cracked. To accomplish this, the standard beam was loaded up to 12 kips per actuator and then unloaded. The two MMFX and CFRP beams were loaded up to 10 kips per actuator and then unloaded. The second load cycle was same as the first. This second load cycle was conducted to make sure that the beam, after cracking, performed in a linear fashion. The third load cycle involved loading the beam to failure. Due to the high loads of the third cycle the BDI gages were removed. The loading for this load cycle was deflection controlled. This means that the actuators loaded the beam at a constant rate of deflection per time (as opposed to the first 2 cycles which used a constant loading rate). This type of deflection control is necessary when loading to failure. However, since the beam and set-up is not a perfect system, it means that for the failure load cycle, the loads in the two actuators are not identical. Each beam was loaded until the center deflection was 7 inches. Due to the failure of the strain gages at higher strains, some data is not available at the later stages of the tests.

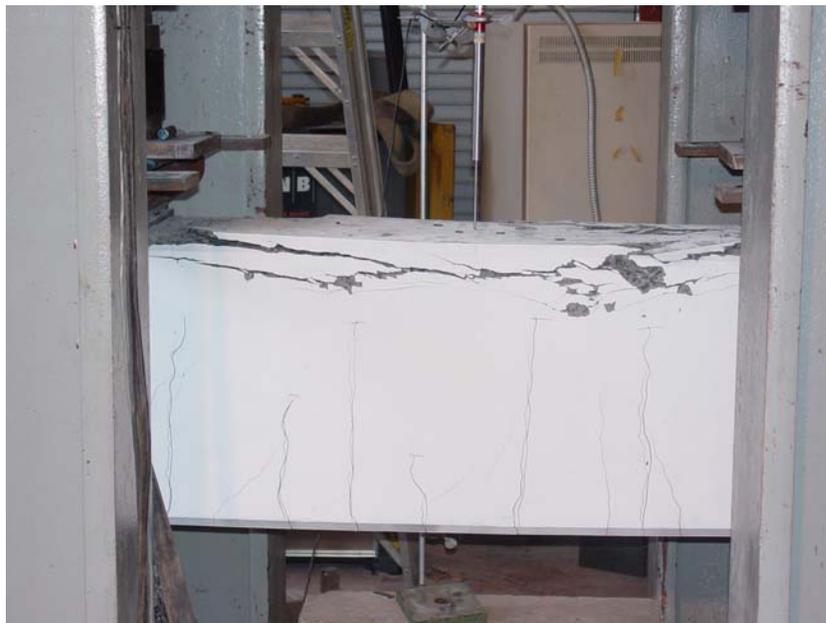
Figure 4.22 Failure of the CFRP Reinforced Beam

Figure 4.22 illustrates the failure of the CFRP reinforced beam.

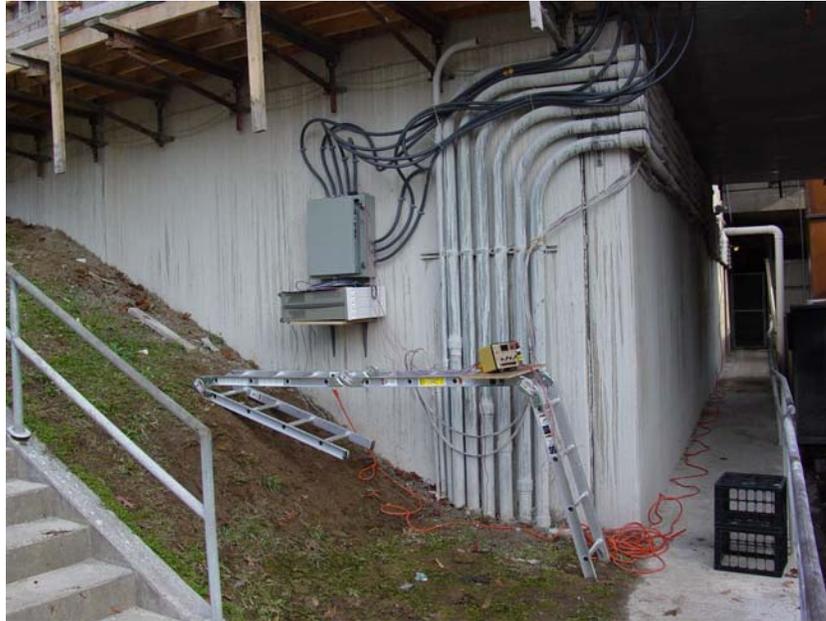
Figure 5.1 Location of the Junction Box

When the seven concrete beams for bridge 1-712B were fabricated, they were all instrumented with strain gages. The strain gages used to instrument the bridge beams consisted of two sister bars in a set up identical to that used for the test beams as explained in section 3.5. One of the two gages was located in the bottom of the beam and the other was located in the top of the beam. Both gages were placed at the mid-span of the beams. The bottom gage was placed in the center of the beams cross section and 2.25 inches up from the bottom of the beam. The top gage was also placed in the center of the beams cross section and 3.25 inches down from the top of the beam. It should be noted that the beams were 15 inches deep with 5 inches of composite concrete deck being added in the field. As such, the top strain gage ends up being 8.25 inches down from the top of the final 20 inch deep beam. The lead wires from the gages were run out of the ends of the beams. Once the beams were placed on the bridge the lead wires were run out of the south edge of the bridge and connected to a permanent junction box that was located on the abutment wall. Figures 5.1 and 5.2 illustrate the location and set up of the junction box.

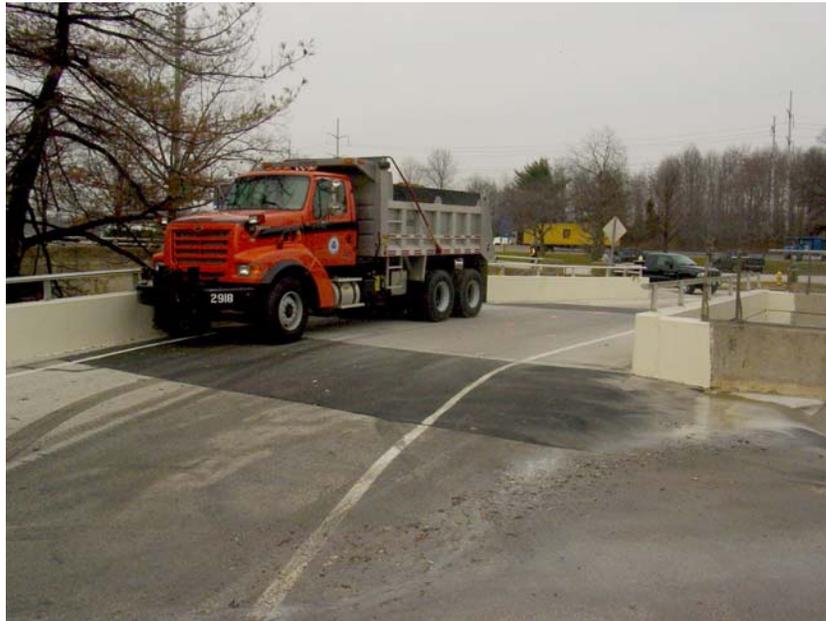
Figure 5.3 Load Test Truck

A diagnostic load test of bridge 1-712B was conducted on March 18, 2003. During the test, the bridge was loaded with a single three axle dump truck filled with sand and weighing 58,060 lbs. The truck's front axle weighed 15,670 lbs. and the two back axles weighed 21,370 and 21,020 lbs. each. Only one truck was used for the diagnostic load test because bridge 1-712B was designed for a single lane load. Figures 5.3 and 5.4 illustrate the truck used for the test and the spacing and weights of the trucks axles.

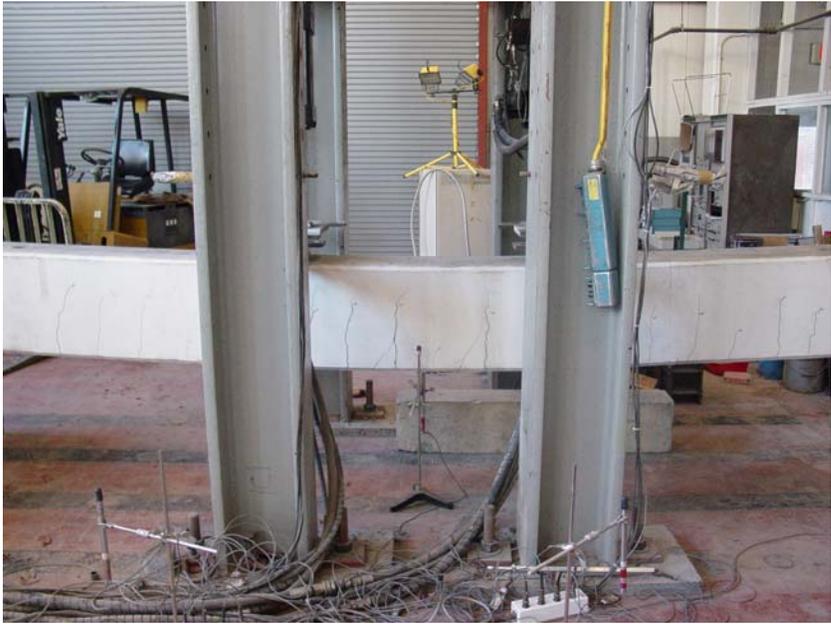
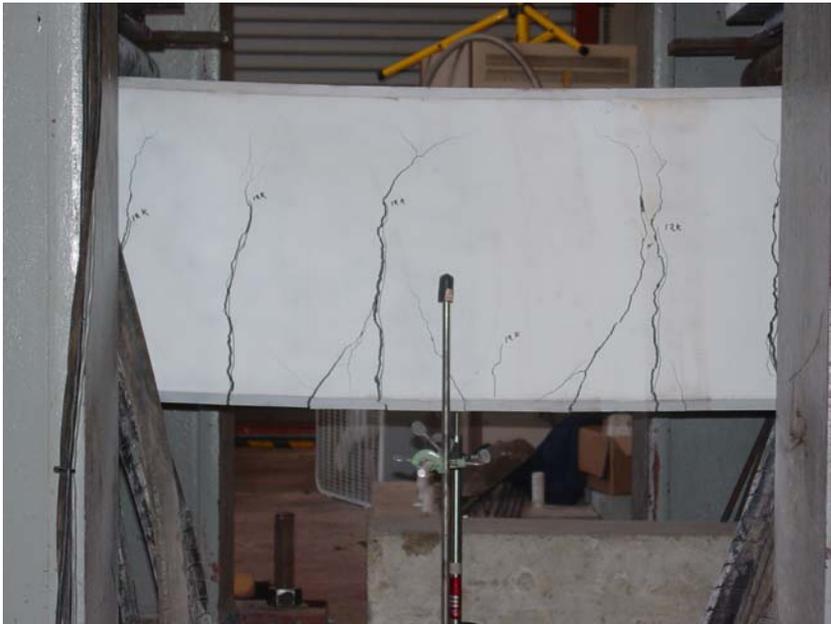
The following pictures were taken during the laboratory testing of the standard beam.

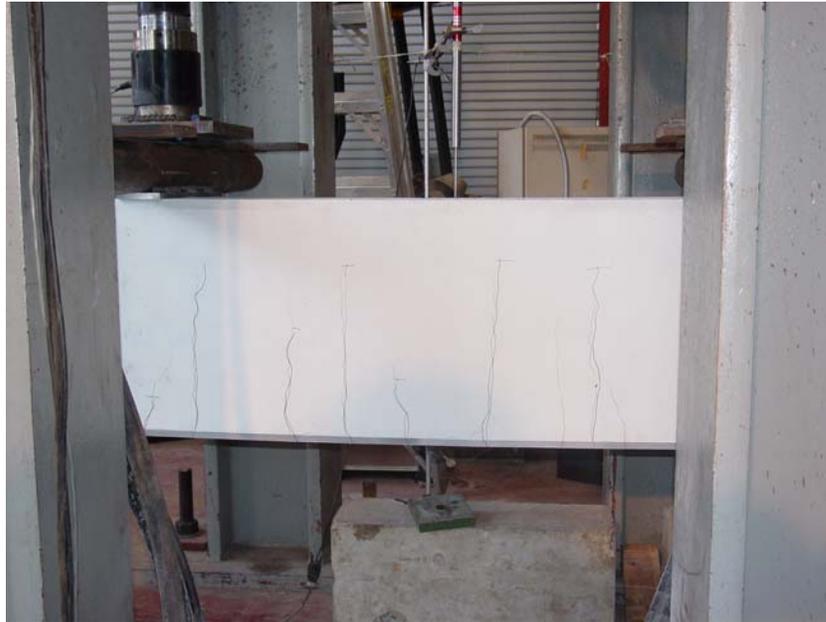
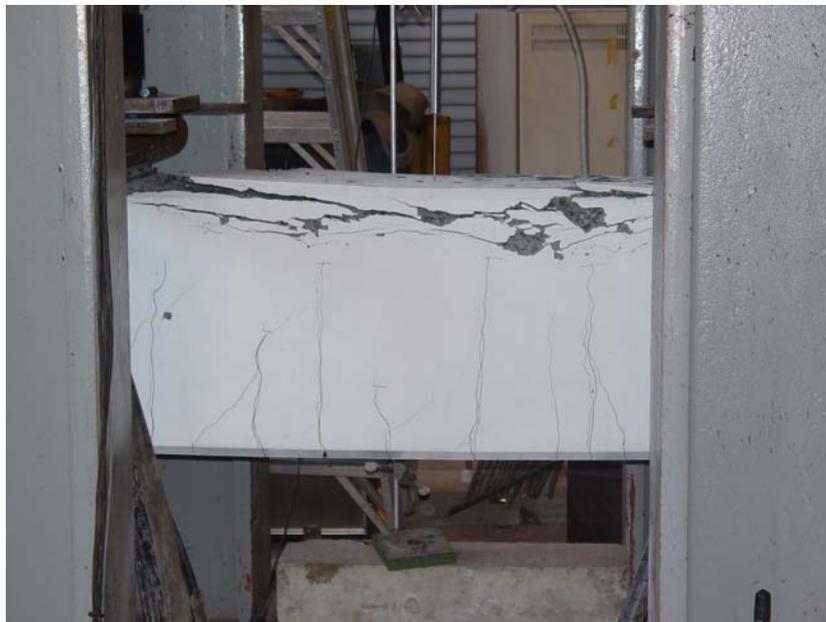
The following pictures were taken during the laboratory testing of the CFRP beam.

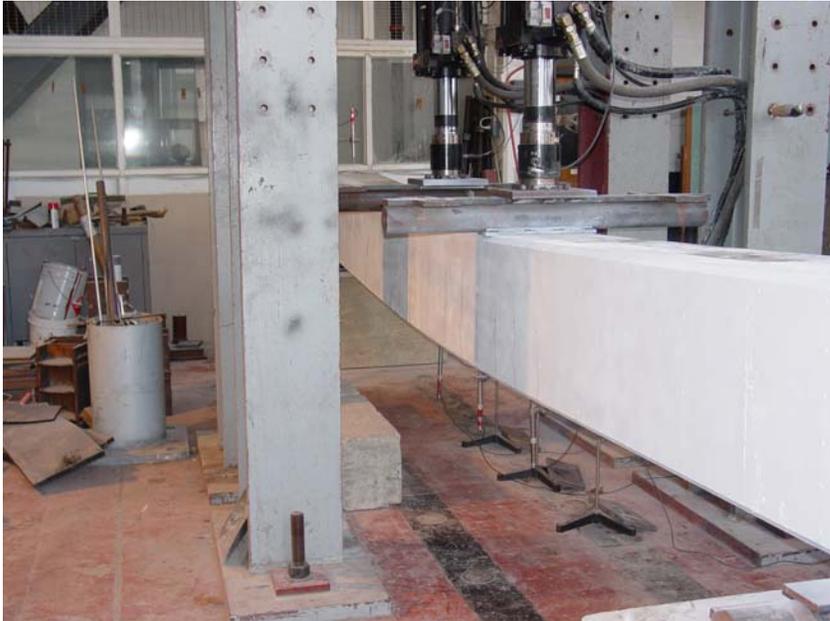
The following pictures were taken during the laboratory testing of the MMFX4 beam.

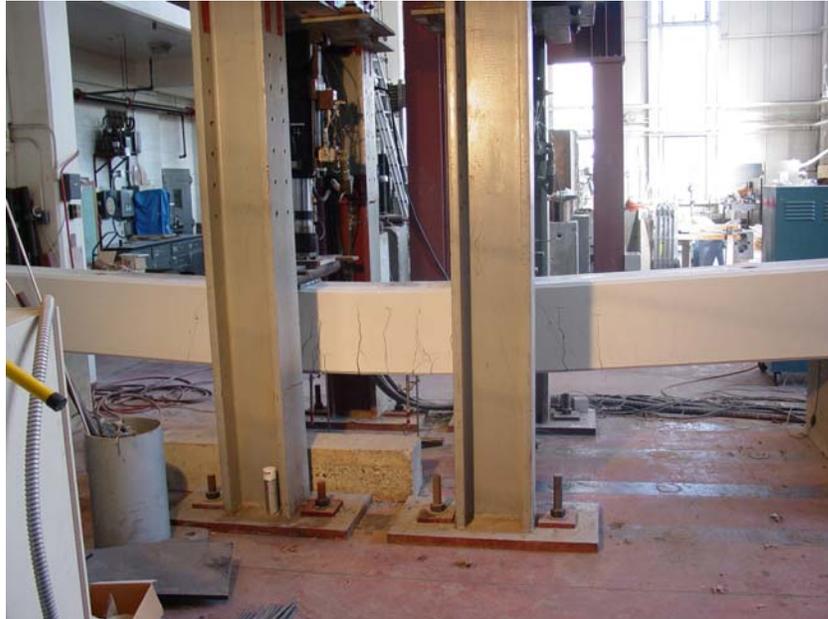
The following pictures were taken during the laboratory testing of the MMFX2 beam.

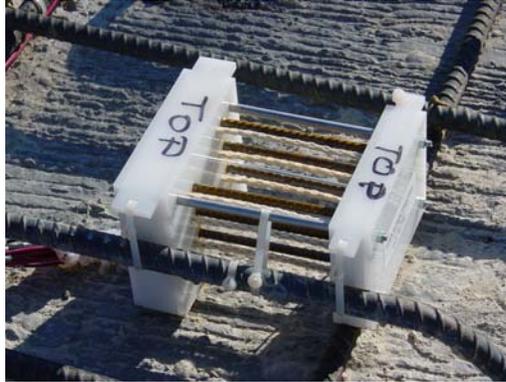
Figure 5 Corrosion penetration monitoring with CPMP

Moisture penetrates into the deck from its top surface. The monitoring data has confirmed that higher bars in the CPMP unit usually have higher voltage.

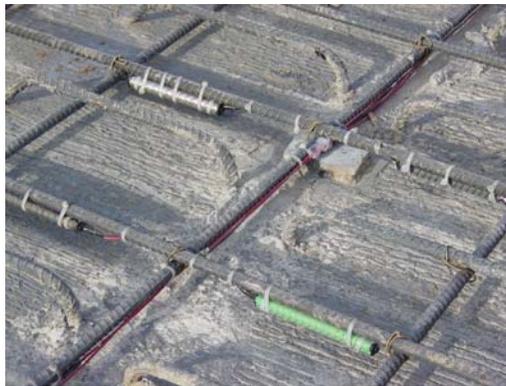
Figure 6 Four types of short rebars. From upper left corner clockwise: stainless clad, MMFX, epoxy-coated, and normal rebar.
