DelDOT Final Report

**NON-DESTRUCTIVE TESTING METHODS TO
EVALUATE THE INTEGRITY OF CONCRETE BRIDGE
DECKS**

Task Number 57-1490

Thomas Schumacher, Associate Professor, PhD, PE (DE)

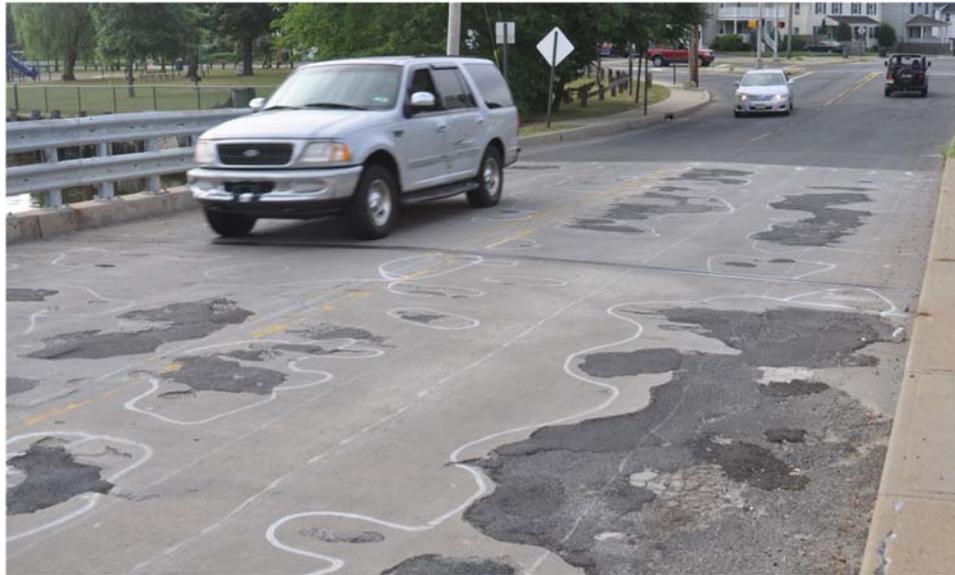
Fig. 1. Photo of a severely deteriorated reinforced concrete bridge deck.

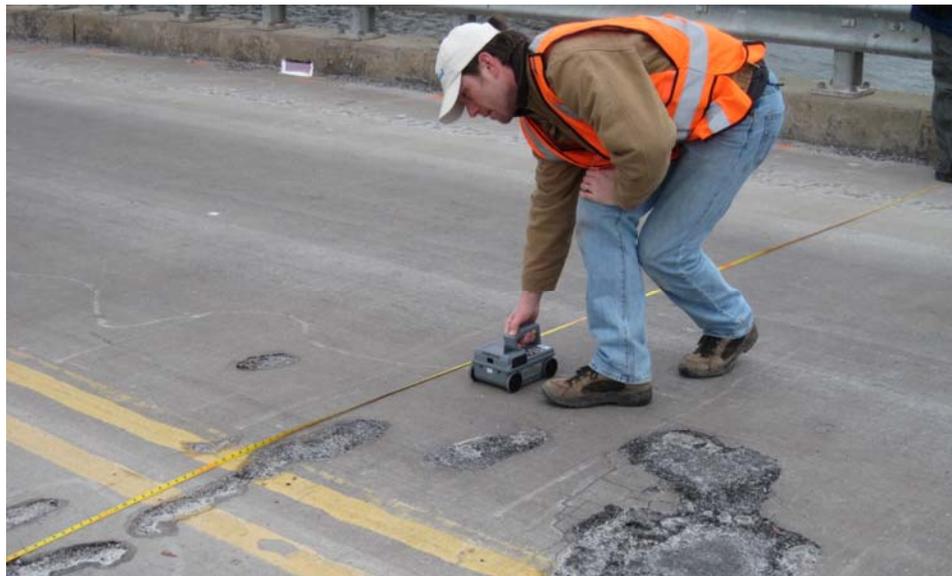
Fig. 2. Scanning of a concrete bridge deck using hand-held ground penetrating radar (GPR) instrument.

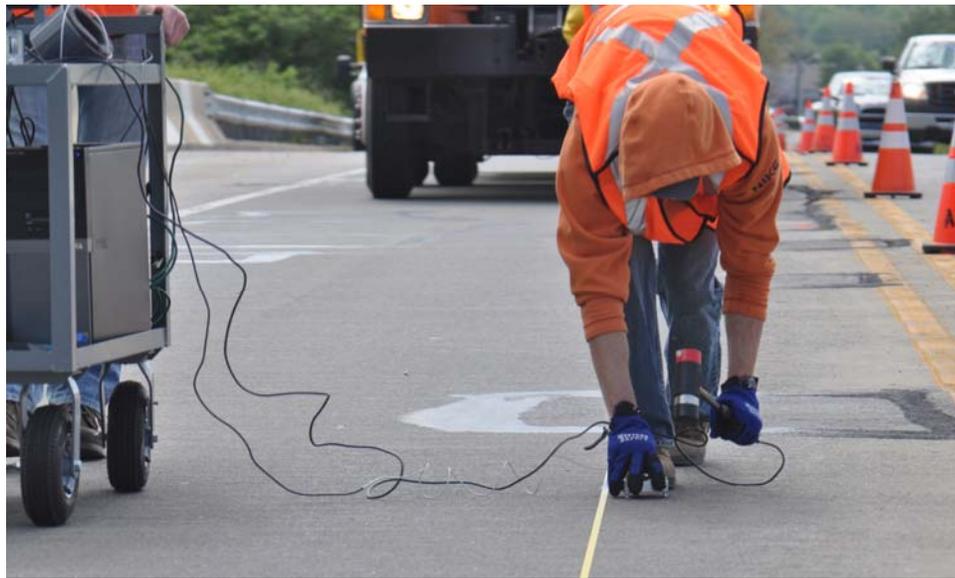
Fig. 3. Impulse response (IR) testing of a concrete bridge deck.

IR testing has been performed for many decades to evaluate deep foundations as well as concrete plates. An example of an ongoing IR test on a concrete bridge deck is provided in Fig. 3. As part of this research, a self-referencing NDT method that builds

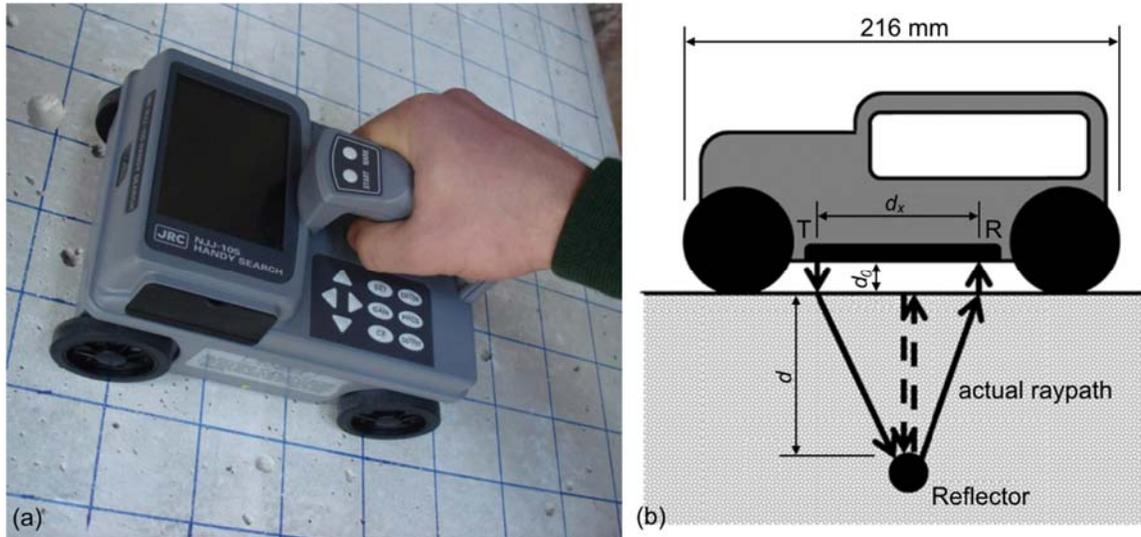
Fig. 4. Hand-held GPR device used in study: (a) photo, (b) elevation view with pertinent dimensions and parameters. T = transmitting antenna, R = receiving antenna. Unit conversion: 216 mm = 8.5 in.

4 (b) is an idealized vertical path (dashed line) and actual (full line) raypath. The horizontal off-set of the two antennas, $d_x = 38$ mm and the stand-off distance, $d_0 = 4.1$ mm (0.161 in), though this configuration is regarded as ground-coupled, nonetheless. The GPR device records a signal (or A-scan) every 2.5 mm (0.1 in) for a duration of 8 ns at a sampling rate of 64 GHz. Due to the physical length of the device, no data is recorded at the beginning and end of a scan over a distance of 216 mm/2 = 108 mm (8.5 in/2 = 4.25 in).

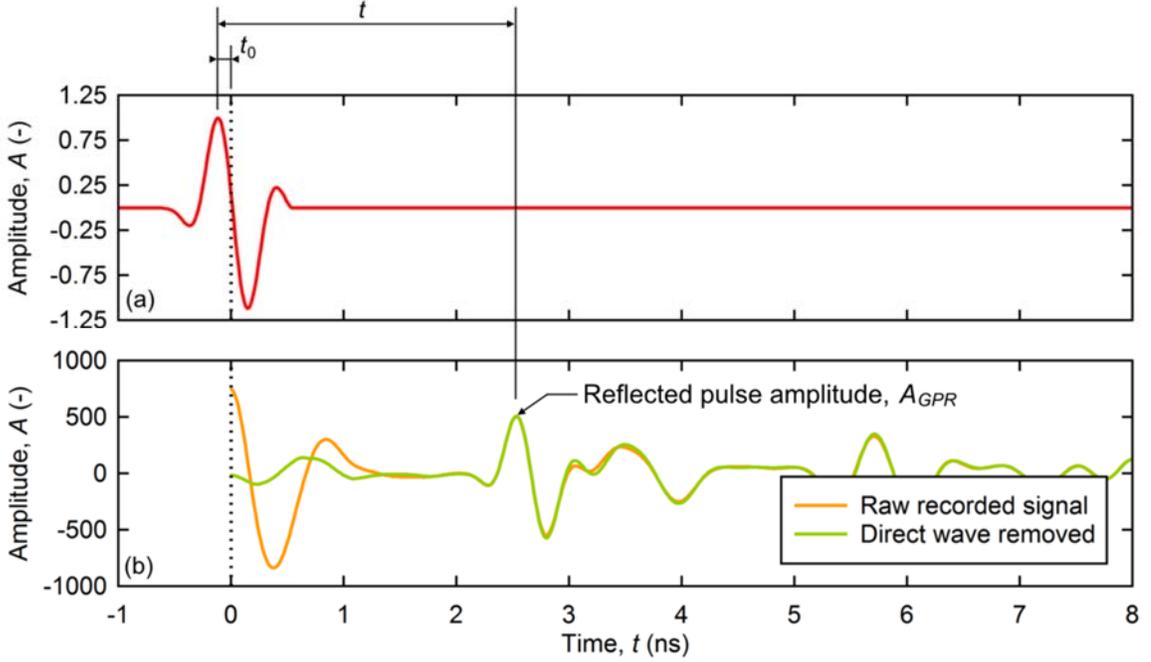
Fig. 5. Examples of (a) normalized transmitted pulse and (b) received sample signals. The reflected pulse amplitude, A_{GPR} corresponds to the first peak in the waveform. Comment: The transmitted signal was created based on observed received signals.

Fig. 5 (a) shows the normalized transmitted pulse and Fig. 5 (b) a sample of a recorded signal from a steel reflector, which has a peak frequency of approximately 1.6 GHz. The direct wave, which travels along the small air gap, was removed by subtracting a reference A-scan taken without any reflectors. The location of interest on the received signal is labeled in Fig. 5 (b). The total pulse travel time, t corresponds to the actual raypath shown in Fig. 4 (b).

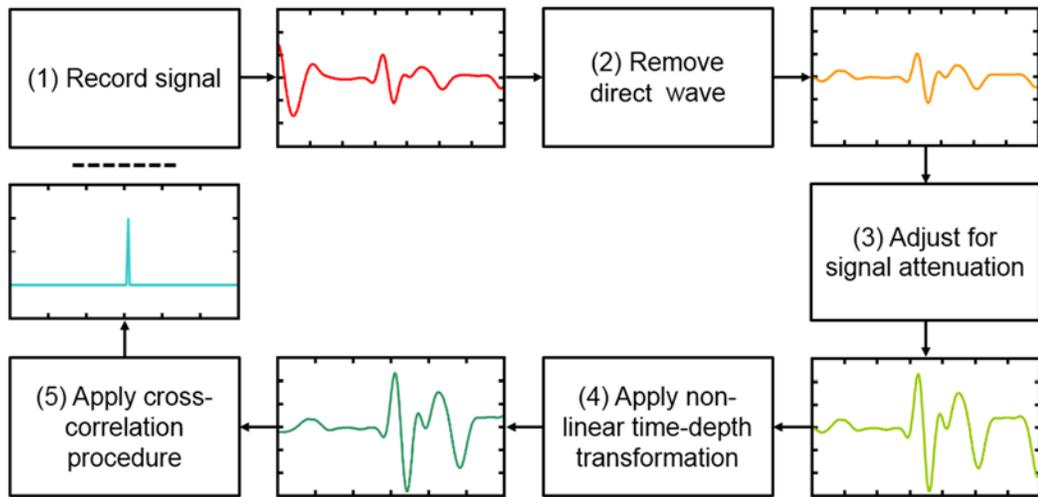
Fig. 6. Overview of proposed data processing steps illustrated on an A-scan.

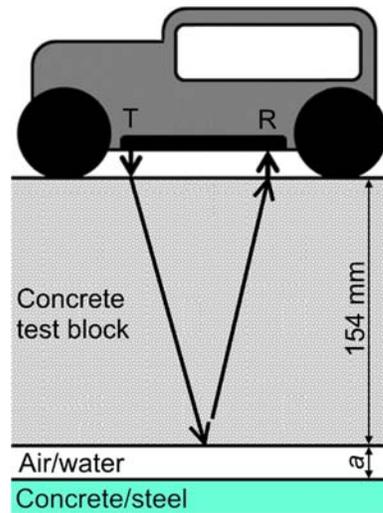
Fig. 7. Illustration of test setup for basic tests on unreinforced concrete block.

- Concrete–water–concrete: the concrete block was placed directly on top of a wetted second concrete block, i.e., $a \approx 0$.
- Concrete–air: the concrete block was tested without anything behind it, i.e., $a = \infty$.
- Concrete–steel: the concrete block was placed on top of a 50 mm (0.97 in) thick structural steel plate with an air gap, a varying from 0 to 12.7 mm (0 to 0.5 in).

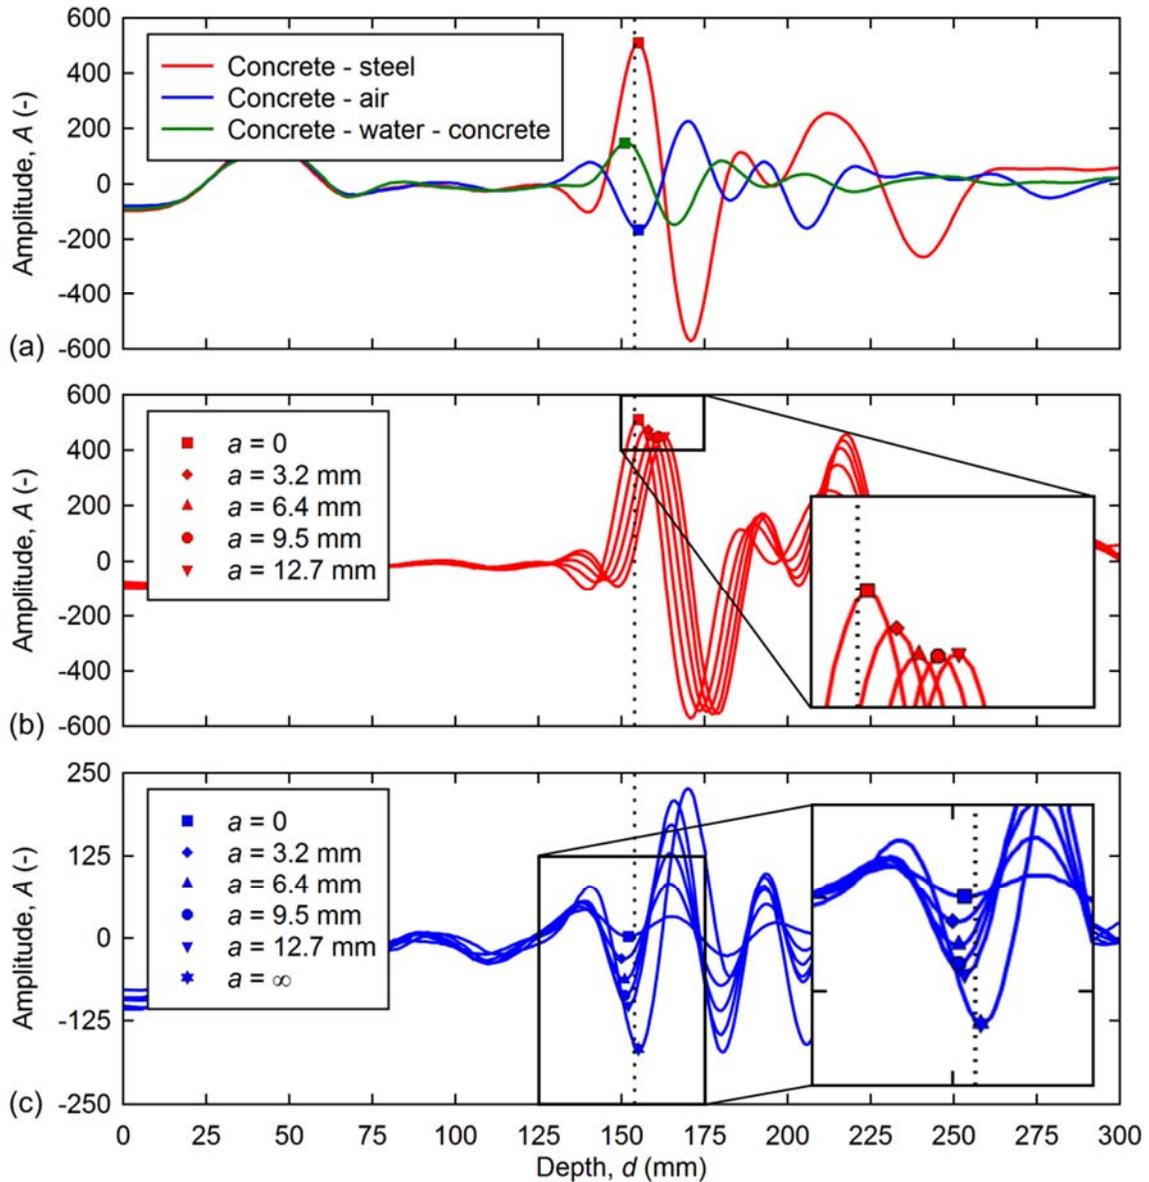
Fig. 8. Selected A-scans collected from concrete test block: (a) Different back wall materials, (b) concrete on steel with variable air gap, and (c) concrete on concrete with variable air gap. The vertical dotted line at $d = 154$ mm (6.06 in) represents the thickness of the concrete test block. Relative dielectric constant, $\epsilon_r = 6.4$. Unit conversion example: 12.7 mm = 0.5 in.

Fig. 8 shows selected A-scans from the concrete block tests. Fig. 8 (a) shows the received signals for three different scenarios: steel, air, and water as reflectors. The data processing steps used for this analysis were Steps 1, 2, and 4, employing a dielectric constant, $\epsilon_r = 6.4$. As can be observed, the polarity (positive and negative first pulse for steel/water and air, respectively) as well as the amplitudes (qualitatively judged) comply with theory as calculated using Eq. 2. In Fig. 8 (b) the concrete block was located on top of the steel plate. For this case, the amplitude of the reflected pulse remains approximately the same, but the pulse is aligned with the location of the steel plate. The slight decrease in reflected pulse amplitude is a result of the increased travel distance in the air gap. Fig. 8 (c) shows the scenario where the concrete block was located on top of another concrete block with a varying air gap. It can be observed that the first pulse is negative and approximately at the same location for all configurations indicating that the reflection occurs at the back wall of the concrete block. For the case where there is no concrete block, i.e., $a = \infty$, a small time delay is present compared to the other signals. This could be due to the destructive interference between the signals reflected from the bottom surface of the first and the top surface of the second concrete block. Overall, the increasing air gap corresponds to an increasing reflection amplitude.

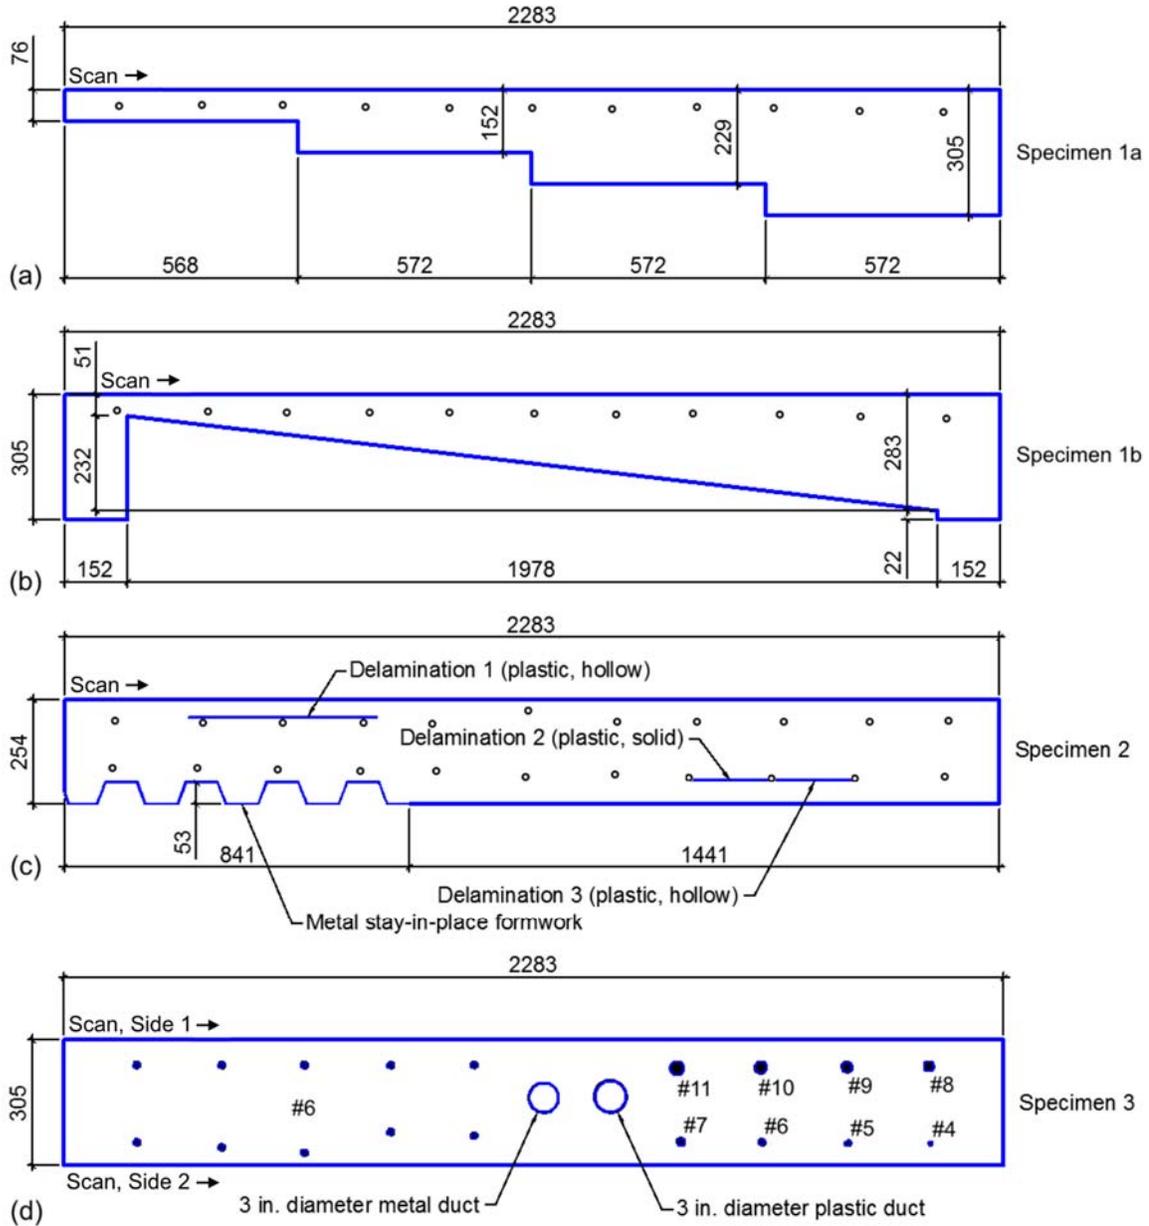
Fig. 9. Drawings of laboratory mock-up specimens: (a) and (b) lightly reinforced (top layer) specimens with variable thickness, (c) bridge deck specimen with artificial delaminations and stay-in-place formwork section, and (d) bridge girder specimen with variable rebar dimensions and concrete cover and two empty post-tensioning ducts. All dimensions are in (mm). Unit conversion example: 305 mm = 12 in.

place formwork. Specimen 3 was built to represent a realistic concrete bridge girder with varying rebar dimensions and concrete cover as well as two empty post-tensioning ducts. Fig. 9 (d) shows the overall geometry of the specimens. A normal weight concrete typical for bridge applications was used with a target cylinder compressive strength of 34.5 MPa (5000 psi). At the time the data for this study were collected, the specimens were approximately 3.5 years old and had been exposed to the weather in Newark, DE for one calendar year. For Specimens 1 and 2, the locations of the \varnothing 13 mm (#4) reinforcing bars were estimated using an Eddy-current-based rebar locator. The reinforcing bars for Specimen 3 could be measured directly as the bars extend past the physical boundary of the specimen. The specimens were scanned on the top surface, except for Specimen 3, which was scanned on both sides. All specimens have a width of approximately 1000 mm (40 in). Note that Specimen 1 consists of two parts of approximately 500 mm (20 in) width with 1a and 1b having four discrete thicknesses and a smoothly varying thickness, respectively. To avoid interference of longitudinal rebars (oriented parallel to the scanning direction), they were first mapped using the same hand-held GPR device. The actual scans were then collected between two such bars.

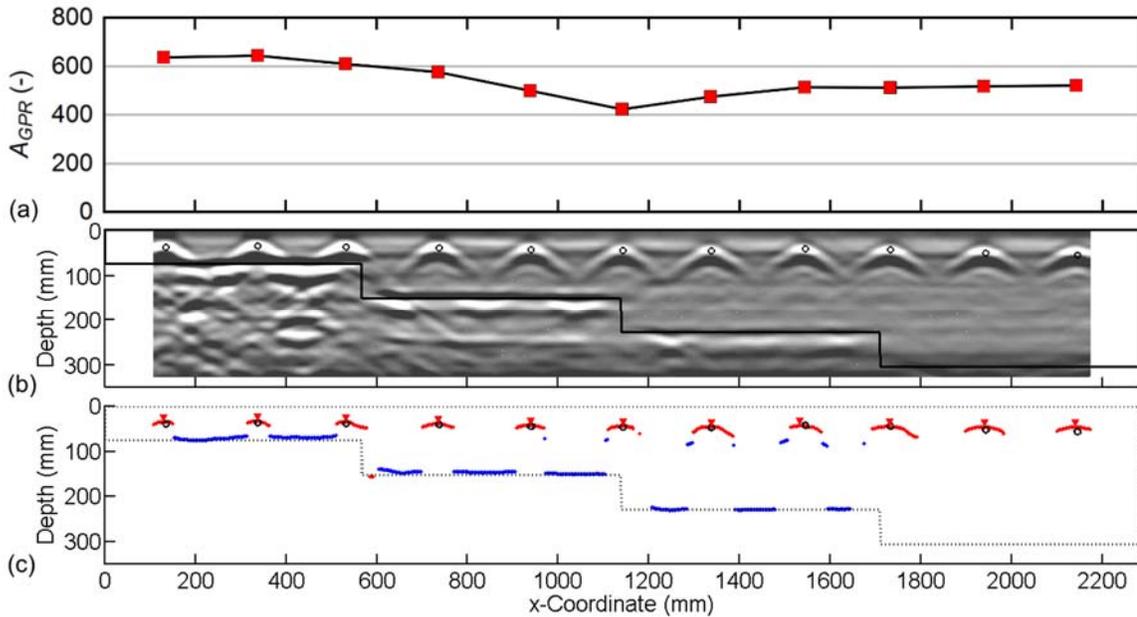
Fig. 10. (a) Reflected pulse amplitude from rebar, (b) B-scan, and (c) cross-correlation results for Specimen 1a. Relative dielectric constant, $\epsilon_r = 8.0$. Unit conversion example: 305 mm = 12 in.

and the cross-correlation result achieved by applying data processing Steps 1 through 5 is illustrated in (c). Red and blue dots correspond to positive (e.g., steel reflector) and negative (e.g., delamination or geometric boundary), respectively. The actual specimen outline is also shown for reference in (b) and (c). Additionally, for round reflectors (= rebars and ducts) resulting in a hyperbola in the B-scan, the automatically picked point corresponding to the top of the rebar corresponding to the concrete cover is indicated by a red ‘▼’ in (c).

The reflected pulse amplitudes for Specimen 1a [dimensions see Fig. 9 (a)] are approximately between 400 and 600 [Fig. 10 (a)]. The B-scan [Fig. 10 (b)] clearly shows the steel rebars as well as the back walls up to a thickness of 229 mm (9 in) representing the thickness of the specimen. The cross-correlation results [Fig. 10 (c)] predict the location and polarity accurately. It can be observed that the back walls are not predicted continuously. The reason for this is that only the first clear reflection was included in data processing Step 5. The results for Specimen 1b [dimensions see Fig. 9 (b)] are very similar (Fig. 11). Also, the reflected pulse amplitudes in the regions where the specimen is less than approximately 100 mm (4 in) are notably higher.

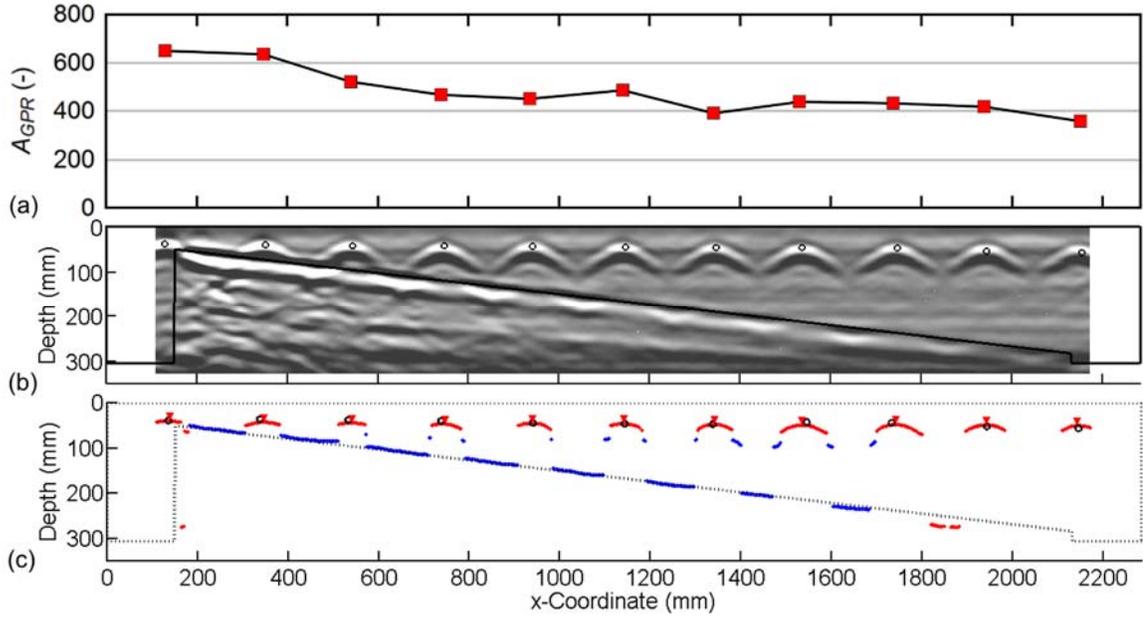
Fig. 11. (a) Reflected pulse amplitude from rebar, (b) B-scan, and (c) cross-correlation results for Specimen 1b. Relative dielectric constant, $\epsilon_r = 8.0$. Unit conversion example: 305 mm = 12 in.

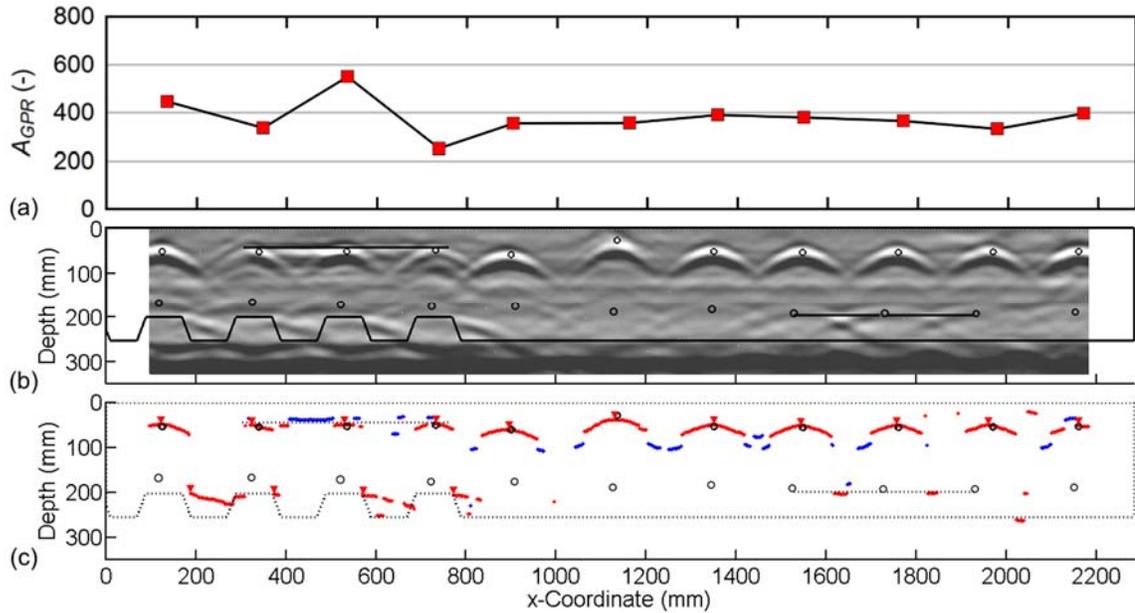
Fig. 12. (a) Reflected pulse amplitudes from rebars, (b) B-scan, and (c) cross-correlation results for Specimen 2, Side 1. Relative dielectric constant, $\epsilon_r = 9.0$. Unit conversion example: 305 mm = 12 in.

In Fig. 12, the results for Specimen 2, the bridge deck mock-up specimen [dimensions shown in Fig. 9 (c)] are presented. The reflected pulse amplitudes [Fig. 12 (a)] show more scatter as they lie between approximately 200 and 600. It can be observed that the shallow delamination is clearly visible in the B-scan [Fig. 12 (b)] and is also correctly predicted, with respect to both location as well as polarity, using the herein proposed cross-correlation procedure, although not across the entire length [Fig. 12 (c)]. The deep delamination, however, is identified in two spots to be steel. The reason for this was that a steel wire was used to hold the delamination in place at that location. As a result, no attempts are made to make any conclusions with respect to this delamination. The stay-in-place formwork is also picked up but not in its entirety because it is on the bottom surface and sheltered by the two reinforcement layers. The only point that was clearly identified is the top right corner of each rib resulting in the start of hyperbola.

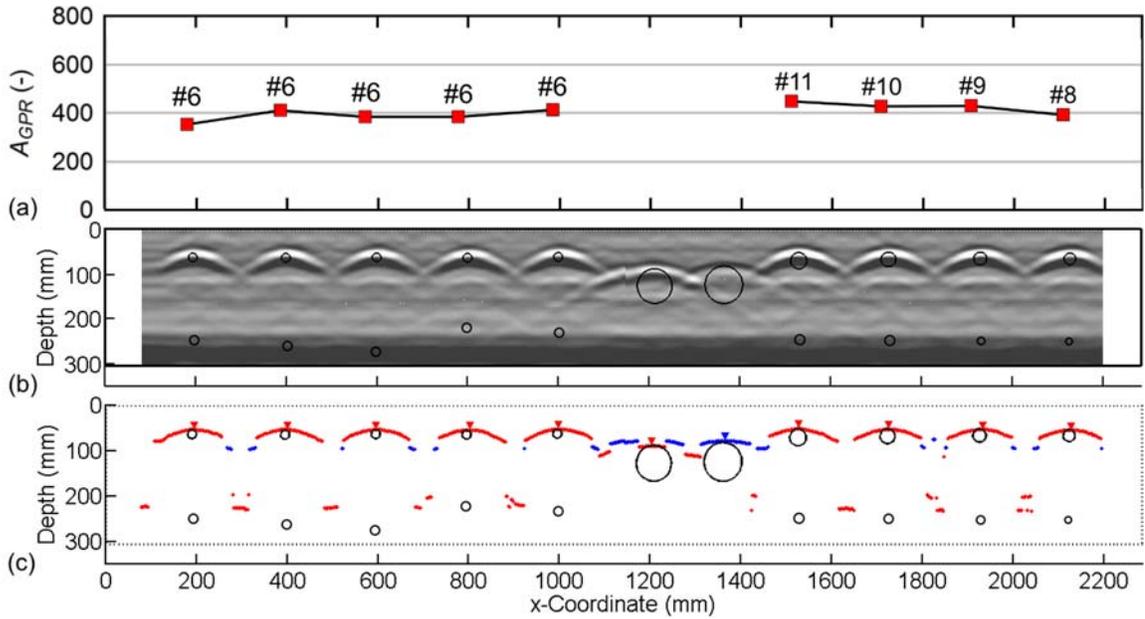
Fig. 13. (a) Reflected pulse amplitudes from rebars, (b) B-scan, and (c) cross-correlation results for Specimen 3, Side 1. Relative dielectric constant, $\epsilon_r = 10.5$. Unit conversion example: 305 mm = 12 in.

Figs. 13 and 14 show the results for Specimen 3, the bridge girder mock-up specimen [dimensions see Fig. 9 (d)]. As can be observed, the locations as well as polarity of the rebars and ducts - the empty plastic duct is shown in blue - are correctly predicted by the proposed cross-correlation procedure [Figs. 13 and 14 (c)]. There is also a strong correlation between the #6 steel rebars and the depth [Fig. 14 (a)]. The size of the rebars having a constant depth is present but not very strong [Fig. 13 (a) right and Fig. 14 (a) left]. Relationships between estimated and actual rebar depth as well as reflected pulse amplitude and depth are investigated in greater detail in Fig. 16.

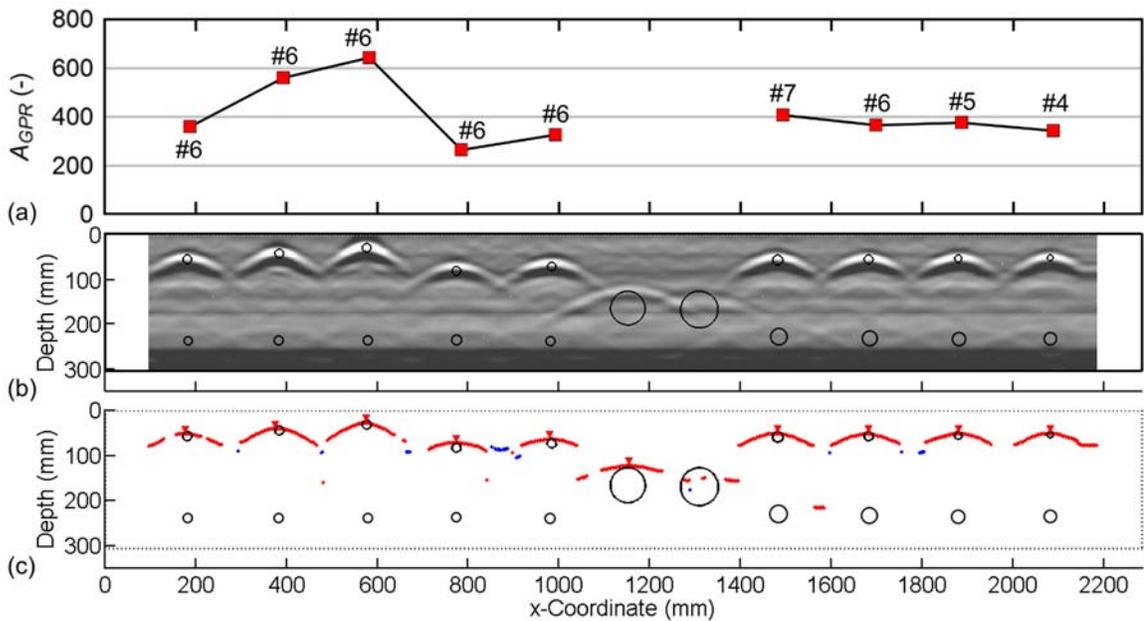
Fig. 14. (a) Reflected pulse amplitudes from rebars, (b) B-scan, and (c) cross-correlation results for Specimen 3, Side 2. Relative dielectric constant, $\epsilon_r = 10.5$. Unit conversion example: 305 mm = 12 in.

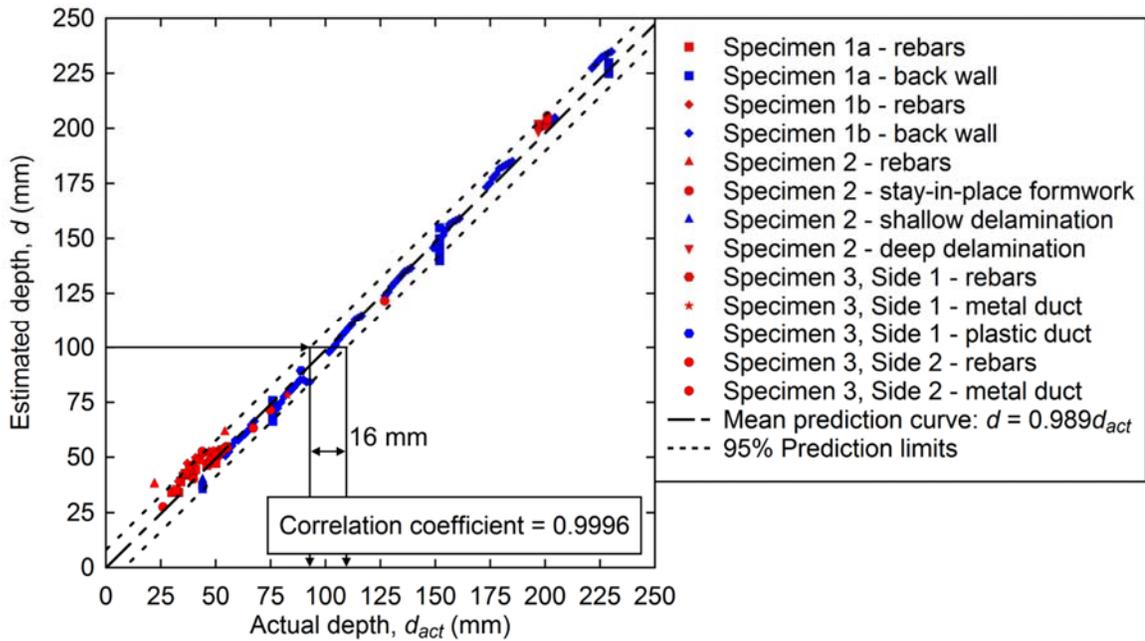
Fig. 15. Correlation of actual vs. observed depth for all laboratory mock-up specimens. The dashed-dotted and dotted lines represent mean and 95% prediction limits, respectively. Unit conversion example: 250 mm = 9.84 in.

In Fig. 15, the correlation between estimated and actual reflector depth are compared for all three specimens using the points predicted from the cross-correlation approach [shown in Figs. 10 to 14 (c)]. The data in red and blue represent reflections from steel reflectors and concrete back walls, respectively. For the steel rebars, only one point was automatically picked (smallest depth corresponding to concrete cover) and for the specimen thickness, the entire series of points was picked and is included. It can be observed that the depth of reflectors in concrete can be estimated with reasonable accuracy [16 mm (0.63 in) at the 95% prediction limits] using the proposed analysis procedure and if the correct relative dielectric constants are used.

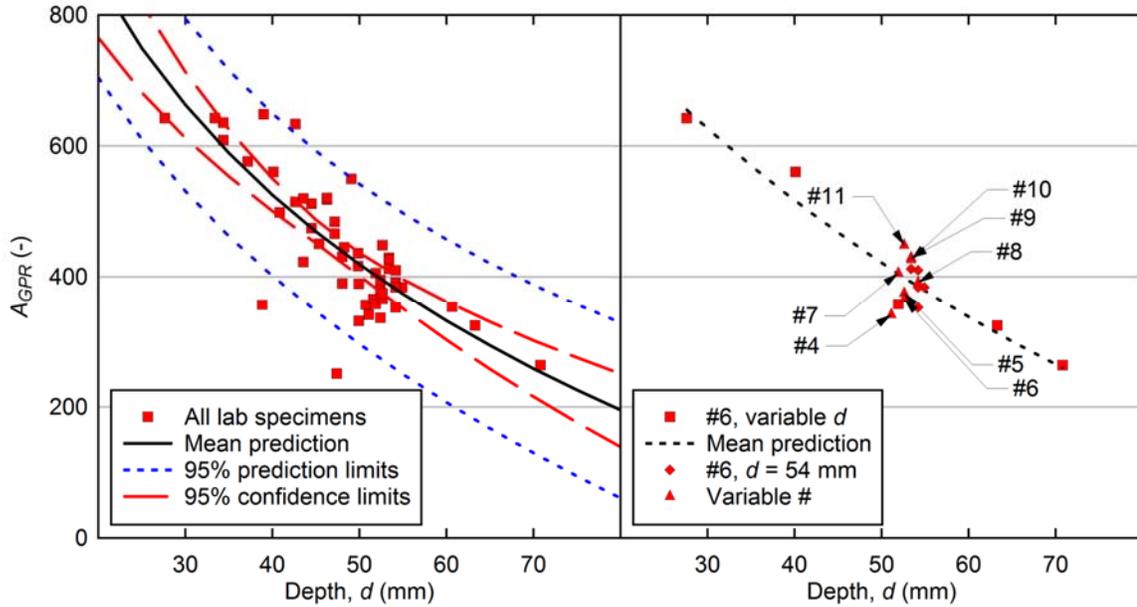
Fig. 16. Reflected pulse amplitudes from rebar vs. depth for (a) all three lab specimens and (b) for #6 rebars in Specimen 3. Unit conversion example: 70 mm = 2.76 in.

Fig. 16 shows the correlation between reflected pulse amplitudes and rebar depth for all three laboratory specimens. Fig. 16 (a) shows all data with an exponential curve fit and 95% prediction and confidence limits. In Fig. 16 (b), only the results from Specimen 3 are shown. It can be observed that there is a very strong correlation between rebar depth (or: concrete cover) and reflected pulse amplitude. Additionally, a trend for larger rebars to create a larger reflected pulse amplitude can be observed but due to significant scatter it is not recommended that this relationship is used to predict reflector depth.

- A trend between reflected pulse amplitude and reflector depth can be observed but scatter is significant, i.e., this relationship should not be used to predict reflector depth.

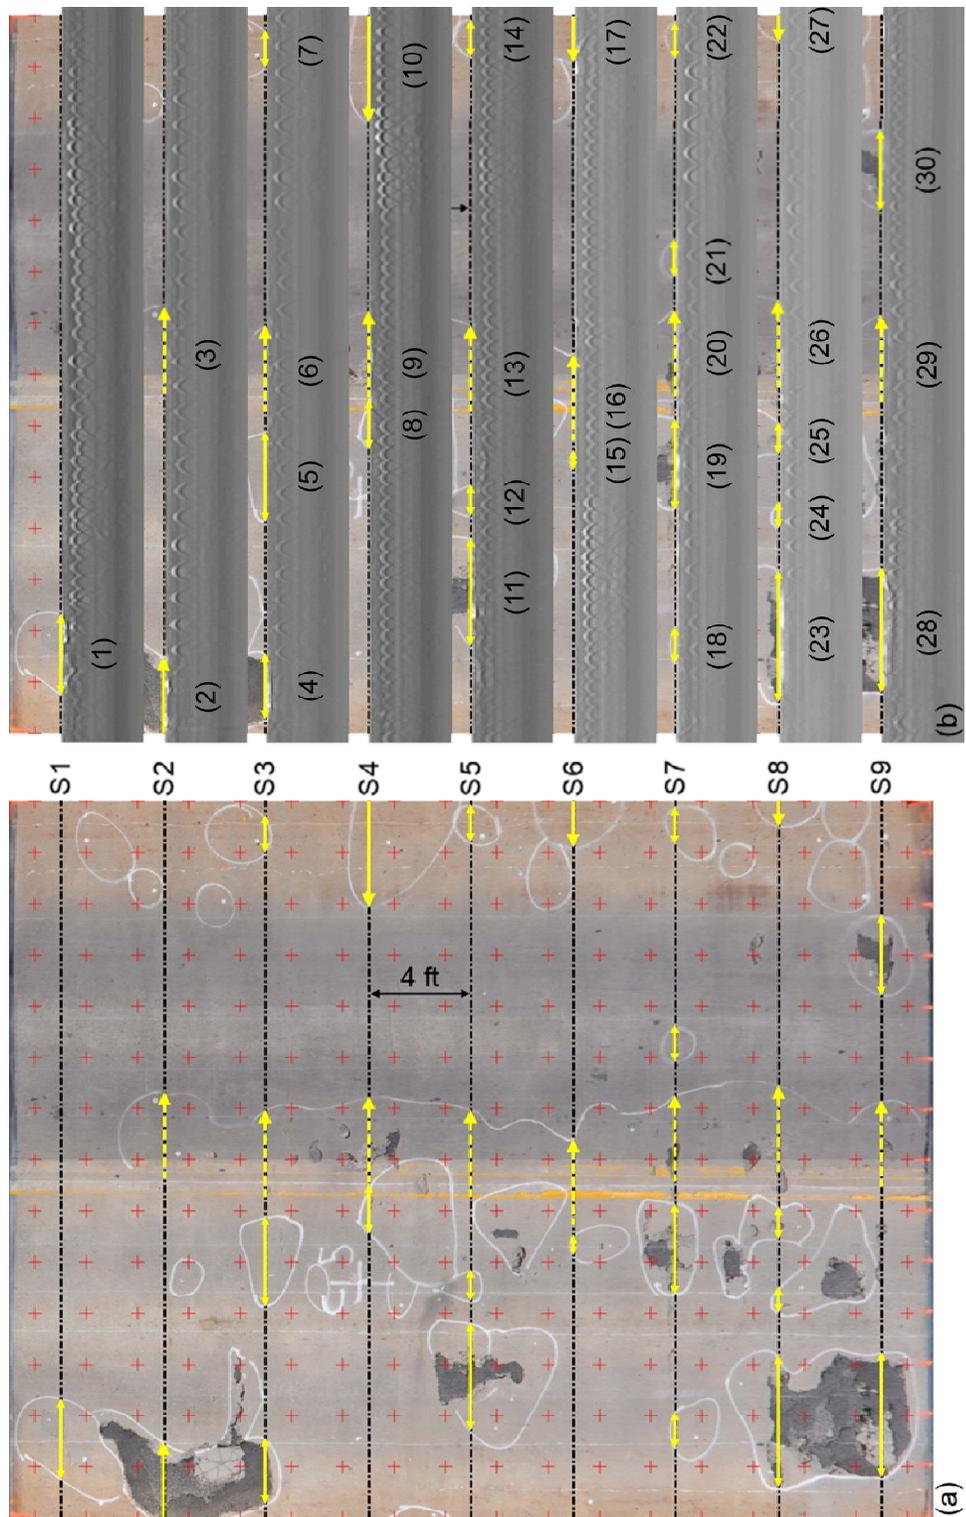
Fig. 17. GPR results for Deck #3: (a) Plan view of deck and (b) B-scans. Yellow arrows mark lines on the scans that had been determined as delaminated by hammer sounding.

Nine GPR B-scans collected on the in-service bridge (Deck #3) introduced in Section 3.4.1 are shown in Fig. 17. This deck exhibited significant deterioration due to the harsh environment it had been experiencing. A prior visual inspection along with hammer sounding revealed delaminated areas, which are marked as white lines. Multiple areas of cover loss existed that had been filled with bituminous asphalt. Those obvious areas of deterioration, i.e., areas (2), (4), (9), (11), (19), (20), (23), (26), (28), and (30), are not further discussed. Some locations where the rebar reflections are missing or heavily distorted coincide with the presence of delaminations, as they were found by hammer sounding, i.e., areas (1), (3), (6), (17), (23), and (29). Ambiguous or missed areas of delamination include: (5), (7), (8), (10), (12) through (16), (18), (21), (22), (24), (25), and (27). Variations in the brightness (or strength) of the rebar reflections can be related to deterioration (ASTM 2008). This approach is not discussed here because it requires a different type of GPR equipment. The reader is referred to Celaya et al. (2014) where measurements from this same bridge are reported and discussed.

Overall, the GPR B-scans taken by the hand-held instrument provide useful information regarding the location and depth of rebars and can in some cases help to identify delaminations. Factors that affect the detectability are rebar condition (e.g., level of corrosion), thickness and status of delamination crack, e.g., whether it is dry or saturated with water.

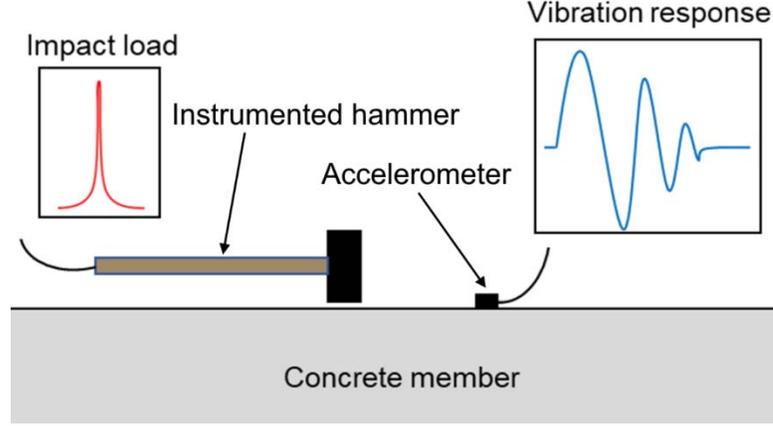
Fig. 18. Illustration of test setup used in this study.

The proposed method is based on the vibration response of a reinforced concrete bridge deck and produces a nonlinear vibration index (NVI) for each test point on the member. The same instruments and general test procedure used for impulse response (IR) testing and vibration-based methods apply: An instrumented hammer is used to create an impact at a specific test point and the vibration response at a nearby location is measured with an accelerometer (see Fig. 18). For an introduction to IR testing and traditional IR parameters used to characterize damage in concrete plates, the reader is referred to Clem (2013). The proposed method requires applying at least two impact forces with different amplitudes for each test point and measuring their vibration responses separately. The basic concept is that for a test point on an ideal undamaged linear-elastic structural system, varying the amplitude of the impact force does not result in a change in the FRF. On the other hand, a test point on a system that contains damage exhibits nonlinear characteristics, which result in different FRFs for impact forces of different amplitude. The frequency ranges of the FRFs need to be within the linear operating range of the measurement system.

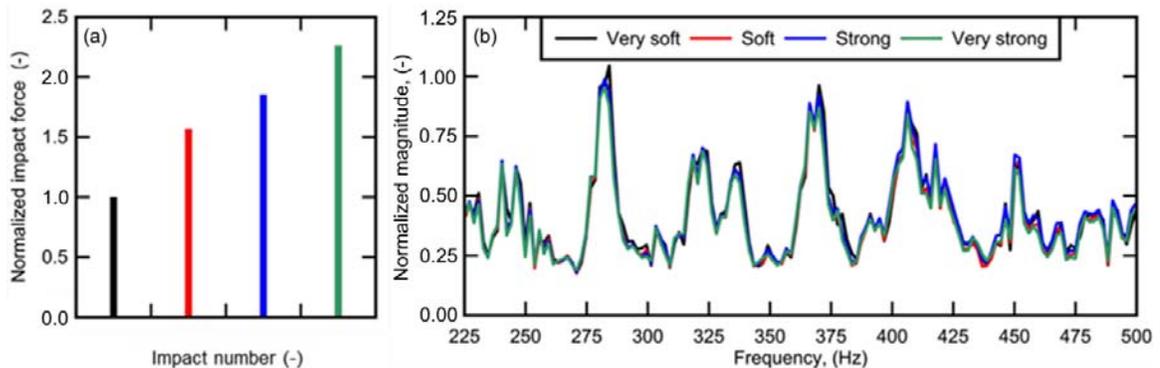
Fig. 19. Sample FRFs for test point A1 [see Fig. 24 (a)] on the selected bridge deck.

In the herein proposed method, a test point on a bridge deck without damage is assumed to represent an ideal linear-elastic structural system, i.e., the FRF does not change with an increase in the amplitude of the impact force. This is illustrated in Fig. 19, where the FRFs of four impact forces with increasing amplitude [Fig. 19 (a)] are shown for test point A1 [see Fig. 26 (a)] on the tested bridge deck (introduced in Section 3.4.1). From Fig. 19 (b), it can be observed that increasing the applied impact force, even doubling it, does not result in significant visible differences between the FRFs, indicating system linearity, which in turn implies that no damage is present in the system. The hypothesis is that if any area of a bridge deck deviates from linearity, some type and level damage can be assumed to be present. The observed nonlinearity is assumed to be caused by cracking and crack boundary interaction. Note that all other potential sources of nonlinearity must be controlled, i.e., minimized (see Section 3.4.3). Also, the selected frequency range ($f_1 = 225$ to $f_2 = 500$ Hz) was determined by trial and error and is application dependent. More details are provided in Section 3.4.2.

Group A represents two test points that were not found to have any form of degradation by visual inspection. Fig. 19 shows the FRF for test point A1, as well as the peak impact forces. Recall from the discussion in Section 3.3, although the impact force was more than doubled, this only had a very minor effect on the FRF, which implies the system is linear. Fig. 20 shows the R^2 -frequency relationship for test point A1, which is close to 1, indicating near linear behavior. Similarly, the R^2 -frequency relationship of test point A2 is also not significantly affected by the increase of the impact force, as can be observed in Fig. 29 (a). Since any structure will demonstrate a certain level of nonlinearity, 3% can be interpreted as the uncertainty in the NVI value for non-degraded concrete in this study. The concrete core taken near test point A2 is further proof that this location is in healthy condition, i.e., not showing any delamination, as can be seen in Fig. 30 (a). In conclusion, areas on the bridge deck that do not show signs of nonlinear vibration behavior can be considered healthy, i.e., free of degradation or delaminations, which supports the basic idea behind the proposed method.

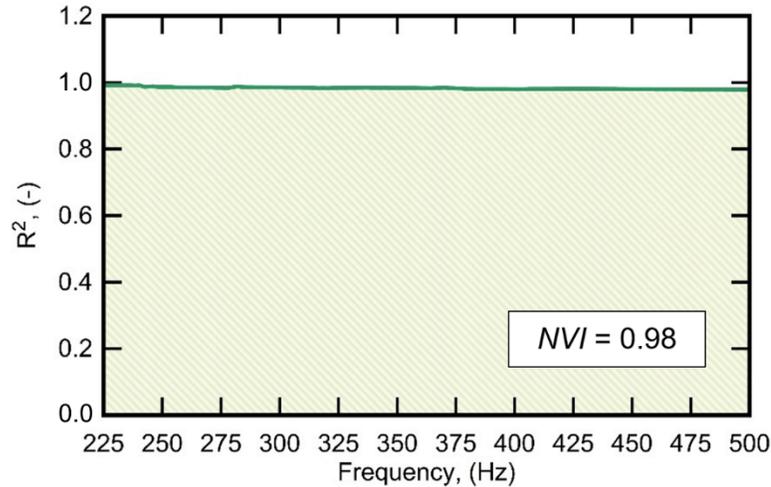
Fig. 20. Sample R^2 -frequency relationship for two FRFs [very soft and very strong from test point A1, see Fig. 26 (a)] vs. frequency and corresponding NVI.

Fig. 20 shows a sample of the coefficient of determination, R^2 as a function of frequency. This coefficient was determined by comparing the FRFs of the very soft and very strong impact forces shown in Fig. 19 (b). Finally, the normalized area under the coefficient of determination-frequency curve represents the NVI, which for this case is 0.98. This value confirms that the system shows a very high degree of linearity at this test point, which was consistent with visual inspection results.

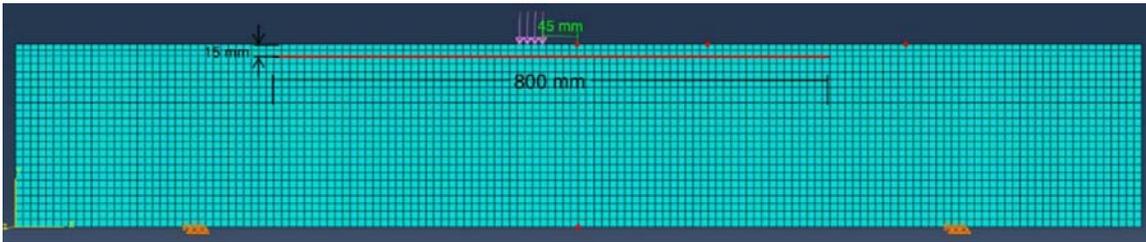
Fig. 21. Illustration of the 2D finite element (FE) model for Model 2. The red line indicates the delamination (gap). The red point at the surface indicates the acceleration measurement point. The purple arrows indicate the distributed force applied on the deck.

Two separate beam models were created: Model 1 refers to the concrete beam without delaminations, i.e., the intact (or reference) beam. Model 2 has the same geometry as Model 1 beam but with a delamination, which was modeled as a gap with the following dimensions: Width = 0.5 mm (0.02 in), length = 800 mm (31.5 in), located about the center of the beam at a depth of 15 mm (0.59 in) (see Fig. 21). To capture interactions of the delamination boundaries during vibration, these surfaces were modeled as contact elements. In both models, eight impact forces were applied to each of the beams where the peak value of the impact force varied from 0.5 to 15 kN (0.112 to 3.37 kip). This range was selected based on the actual forces employed in the field (see Section 3.4). Note that impact forces reported herein are total force and equivalent distributed forces as applied to the FE models can be calculated as force/0.04 m. A dynamic explicit step routine with a time step of 10 μ s and a total simulation time of 1 s was used. The dynamic response of all 16 simulations was analyzed and is discussed in the following subsection.

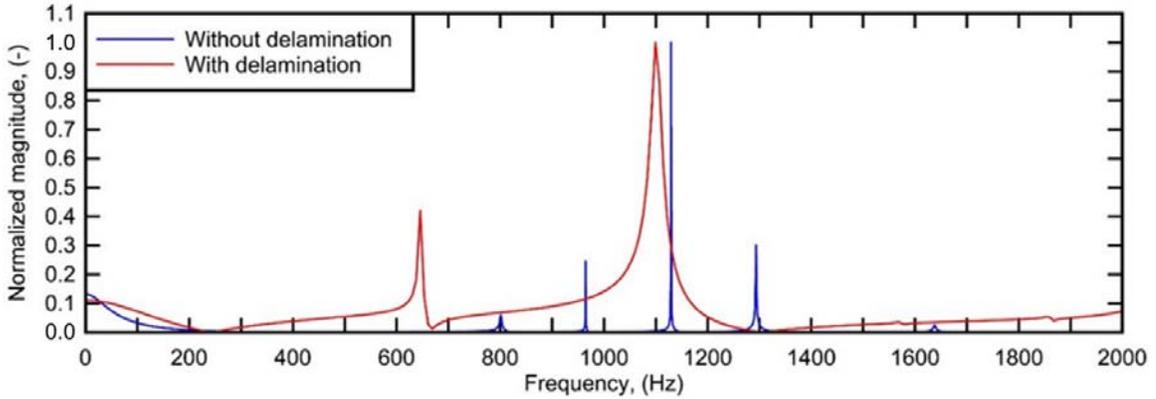
Fig. 22. Two sample FRFs for deck models with and without delamination; amplitude of impact force = 4 kN (0.9 kip).

Fig. 22 shows the FRFs of the simulated beams with and without delamination, i.e., Model 2 and Model 1, respectively, due to an impact force with an amplitude of 4 kN (0.9 kip). While it is expected that the natural frequencies of the beam change because of the delamination, the interpretation of the results is not straight forward. As can be seen in Fig. 22, the FRFs look very different for the two models. Not only is there no consistent shift between individual peaks, they also do not have corresponding matches, and exhibit notable differences in their half-power bandwidths. The latter implies higher inherent damping in the system. In conclusion, a delamination has a significant effect on the measured vibration response. However, because the proposed method is self-referencing, this is not relevant.

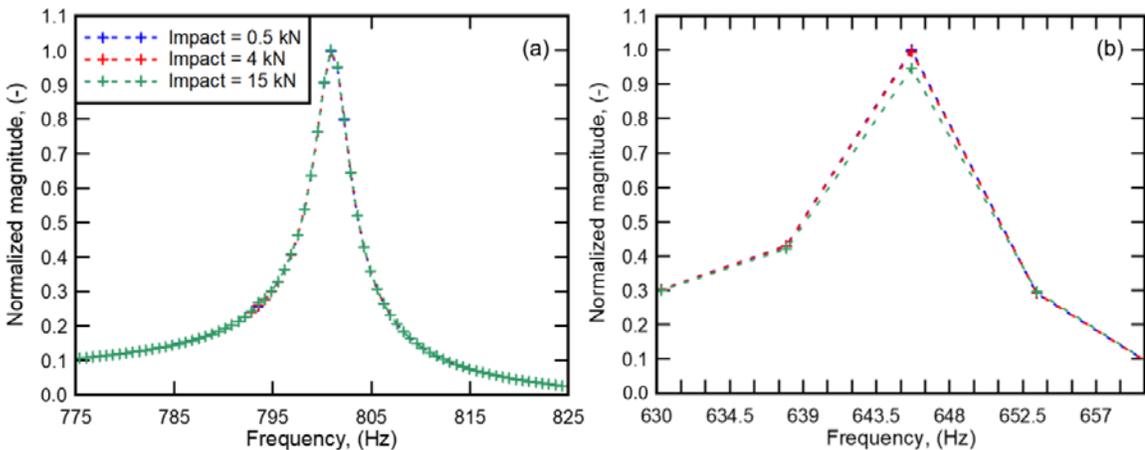
Fig. 23. Three sample FRF peaks (first peak) for impact forces with amplitudes, 0.5, 4 and 15 kN (0.112, 0.9, and 3.37 kip): (a) Model 1 (without delamination, reference) and (b) Model 2 (with delamination).

As can be observed in Fig. 23 (a), the FRF response of the beam model without delamination for a select peak does not change due to an increasing impact force with amplitudes ranging from 0.5 to 15 kN (0.11 to 3.37 kip). On the other hand, increasing the value of the impact force does cause notable changes in the FRFs of the beam model with a delamination. This effect manifests as a change in the magnitude of the selected FRF peaks where the magnitude decreases with increasing impact force, as can be observed in Fig. 23 (b).

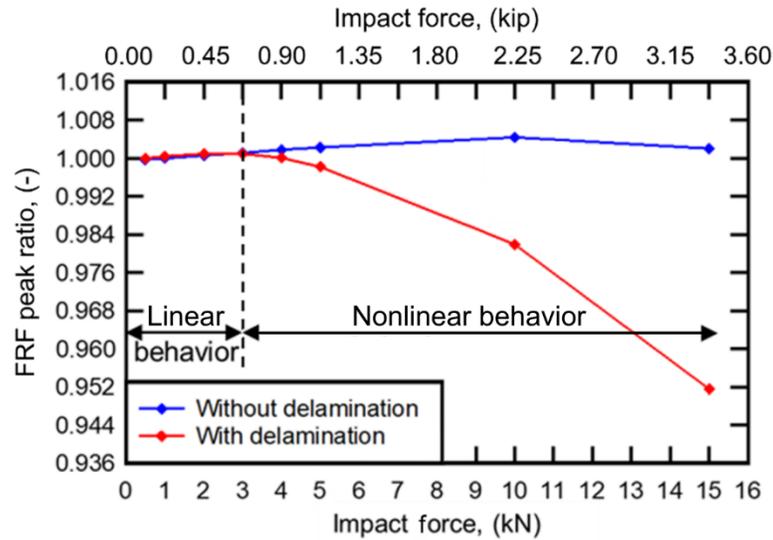
Fig. 24. FRF peak ratio vs. peak impact force value for the two FE models.

Fig. 24 shows a comparison of the FRF peak ratios, which corresponds to the FRF peak value normalized with the FRF peak value for the smallest impact force of 0.5 kN (0.112 kip), for both beam models. For Model 1 (reference case), it can be observed that there is a minute increase in the peak response, which can likely be attributed to the nonlinear

material response of concrete (see Section 3.4.3 for further discussion). Model 2 (delamination case), however, shows a clear decrease in the peak response after the force exceeds approximately 3 kN (0.674 kip). This behavior can be associated with contact interaction of the lower and upper boundaries of the simulated delamination when the vibration amplitude of these boundaries exceeds the width of the delamination. The numerical simulations show that changes of the FRF are sensitive to the presence of a delamination. It can be speculated that other types of damage and degradation have a similar but smaller effect.
