DelDOT Final Report

**NON-DESTRUCTIVE TESTING METHODS TO
EVALUATE THE INTEGRITY OF CONCRETE BRIDGE
DECKS**

Task Number 57-1490

Thomas Schumacher, Associate Professor, PhD, PE (DE)

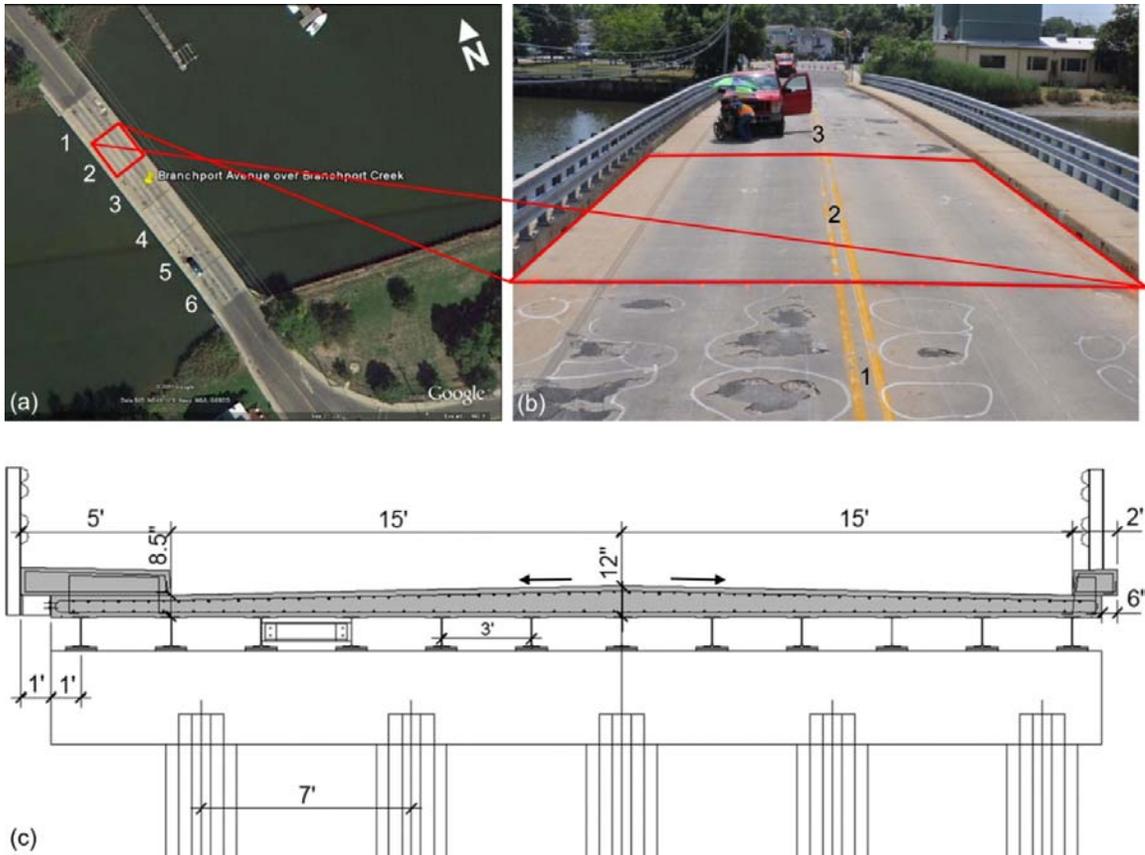
Fig. 25. Branchport Avenue Bridge in Long Branch, NJ: (a) Google map image showing plan view and selected deck (#2) used as part of this study, (b) photo of Deck #2 from a driver's perspective, and (c) bridge cross-section with dimensions in (in = " and (ft = ').

A steel-concrete composite bridge located in Branchport, NJ, USA was selected to evaluate the proposed method's ability to detect damaged areas in an in-service reinforced concrete bridge deck. The bridge, presented in Fig. 25, has a total length of 65.8 m (216 ft) and is 11.3 m (37 ft) wide. The superstructure consists of six 11.0 m (36 ft) long two-span sections with steel girders carrying a 216 to 305 mm (8.5 to 12 in) thick reinforced concrete deck, as shown in Fig. 25 (c). Due to the harsh environment combined with exposure to chlorides from seawater and deicers, the bridge exhibited severe distress when it was visually inspected in July 2011. Five of the six deck sections were found to have severe surface damage, showing visible signs of spalling, potholes, and in some locations the steel rebars were exposed. The deck selected for this study (#2, highlighted in Figs. 25 (a) and b) showed no visual distress and hammer sounding revealed only two small areas potentially having delaminations [see Fig. 26 (a)].

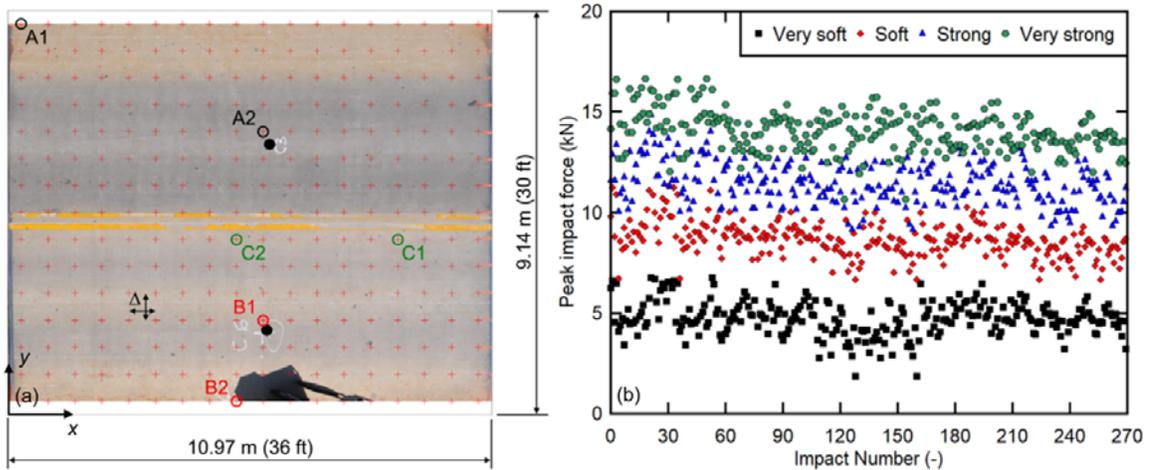
Fig. 26. (a) Plan view photo of Deck #2 with test grid (red '+'), $\Delta = 0.61$ m (2 ft), locations of sample test points A1, A2, B1, B2, C1, and C2, and extracted concrete cores (full black circles). (b) Peak impact forces for all 270 test points. Unit conversion: 20 kN = 4.5 kip.

hard-plastic hammer tip [± 22.2 kN-peak (5000 lb-peak)]. It is equipped with a piezoelectric load cell connected to a signal amplifier/conditioner to measure the generated impact force. The vibration response was measured using a capacitive MEMS accelerometer (Silicon Designs-Model-2260-010) that has a flat frequency response within 3 dB over the range of 0 to 1 kHz. Both input (force) and output (acceleration) signals were recorded using a high-speed transient recorder (Elsys, Model TraNET 204s) with a sampling frequency of 500 kHz.

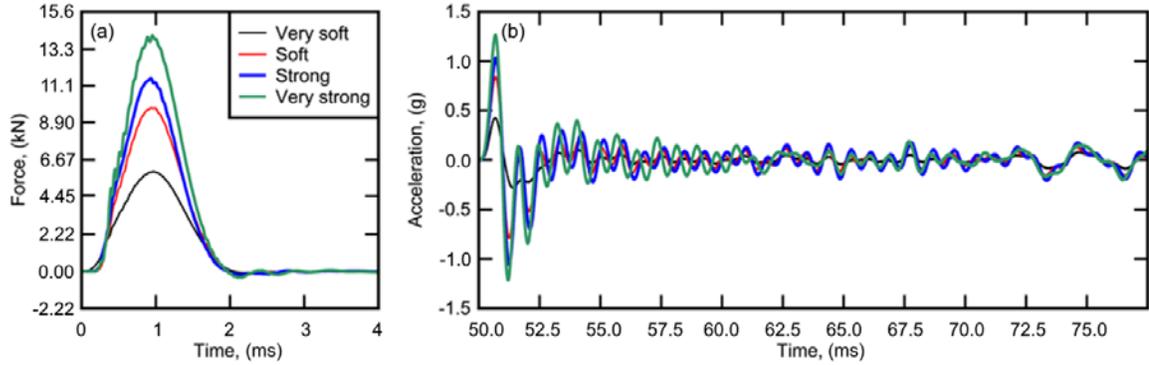
Fig. 27. Samples of (a) four impact forces and (b) corresponding acceleration responses for one select test point. Unit conversion: 15.6 kN = 3.5 kip.

Fig. 27 shows sample time histories of four impact forces with different levels of amplitude and the corresponding acceleration responses for one select test point.

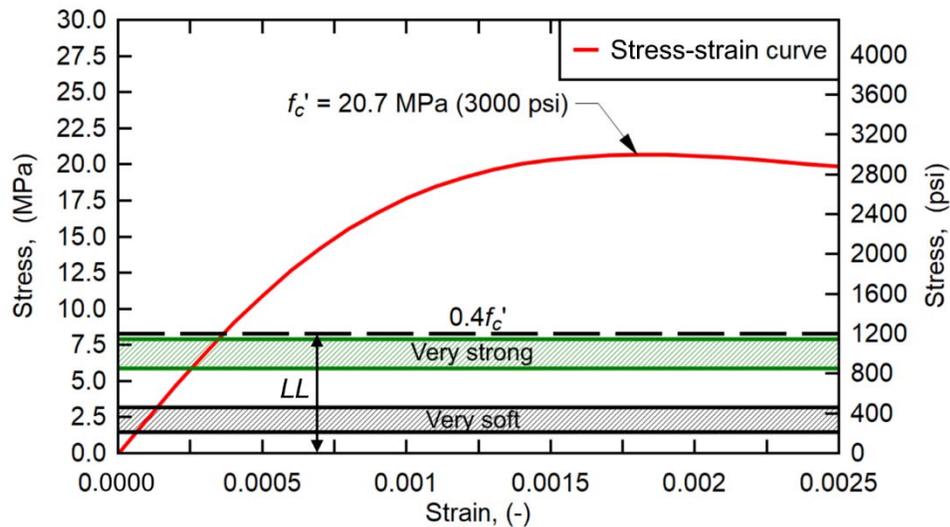
Fig. 28. Theoretical Stress-Strain relationship and actual generated stress ranges due to “very soft” (grey area) and “very strong” (green area) impact forces (ranges span mean \pm two standard deviations). The black dashed horizontal line represents the suggested linear limit (*LL*).

Fig. 28 shows this stress-strain relationship, which assumes a conservative concrete compressive strength, $f_c' = 20.7$ MPa (3,000 psi). It can be observed that all generated stresses lie within the suggested linear limit (LL) of 40% of f_c' (shown as black dashed line) (fib 2010). The ranges of generated stresses for “very soft” and “very strong” impact forces spanning the means +/- two standard deviations taken from data shown in Fig. 26 (b) are provided for reference. To conclude, effects due to material nonlinearity can be assumed to have a negligible effect on the proposed nonlinearity parameter, NVI.

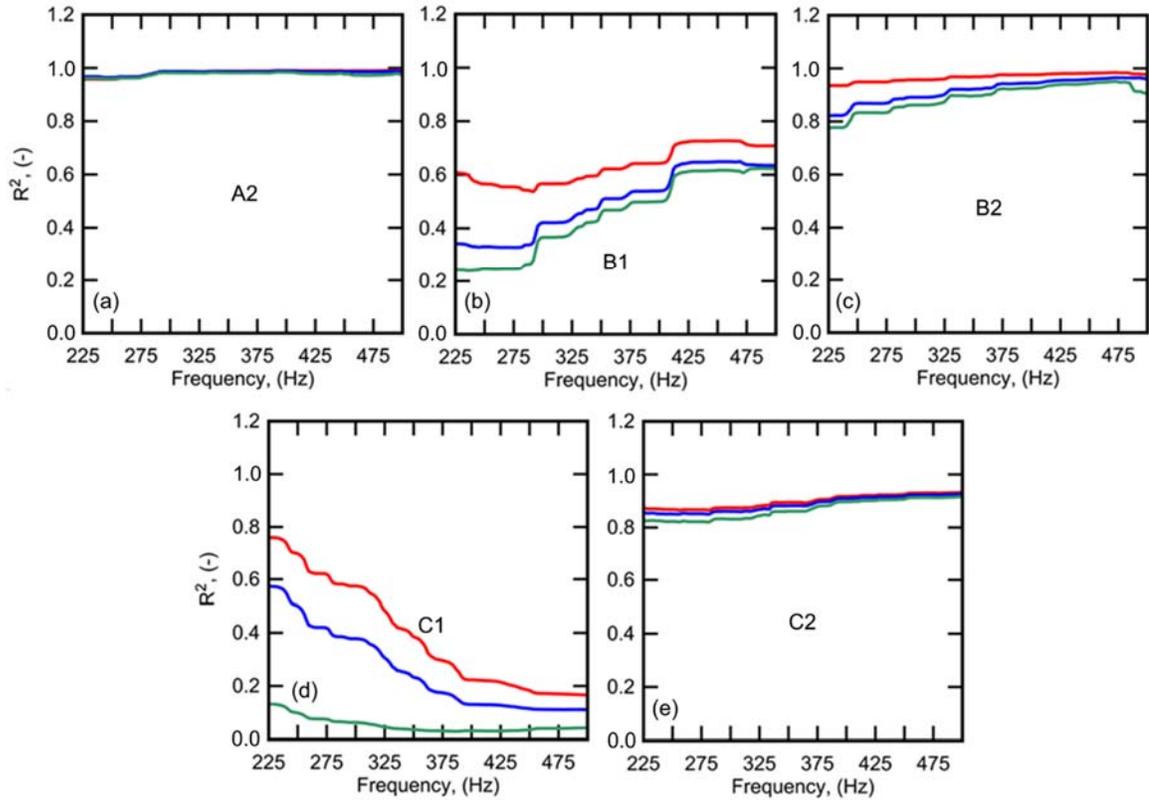
Fig. 29. R^2 - frequency relationships for test point A2 (a), B1 (b), B2 (c), C1 (d), and C2 (e). Locations of these test points are shown in Fig. 26 (a). Photos of extracted cores corresponding to (a) and (b) are shown in Fig. 30. Note that the R^2 - frequency relationships for test point A1 is shown in Fig. 20.

Group B represents two test points that were marked having delaminations by means of chain drag. The R^2 - frequency relationships for the Group B test points are presented in Figs. 29 (b) and (c). It can be observed that the responses are significantly affected with increasing impact force, leading to low R^2 functions. Additionally, along with an increase in the amplitude of the impact force, the change in the R^2 - frequency relationship increases,

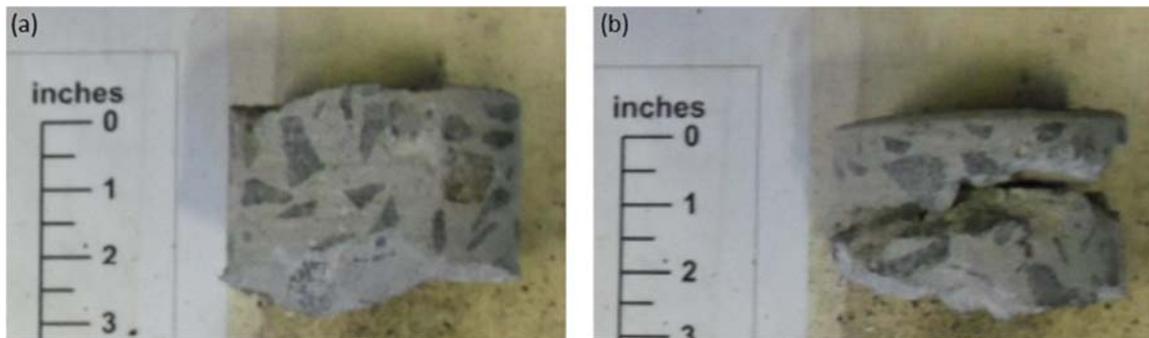
Fig. 30. Photos of extracted concrete cores: (a) Core 1 (near A2) and (b) Core 2 (near B1).

resulting in a decrease in the NVI value, as shown in Table 1. This response is distinctly different from the one found in Group A. These results also match the core taken near test point B1, which shows a horizontal crack at a depth of approximately 25 mm (1 in) [see Fig. 30 (b)]. In conclusion, the Group B results further confirm that the proposed method can detect delaminations. The NVI values for test point B2 are not as low as for B1, which is where visual inspection found a small, delaminated area [see Fig. 26 (a)].

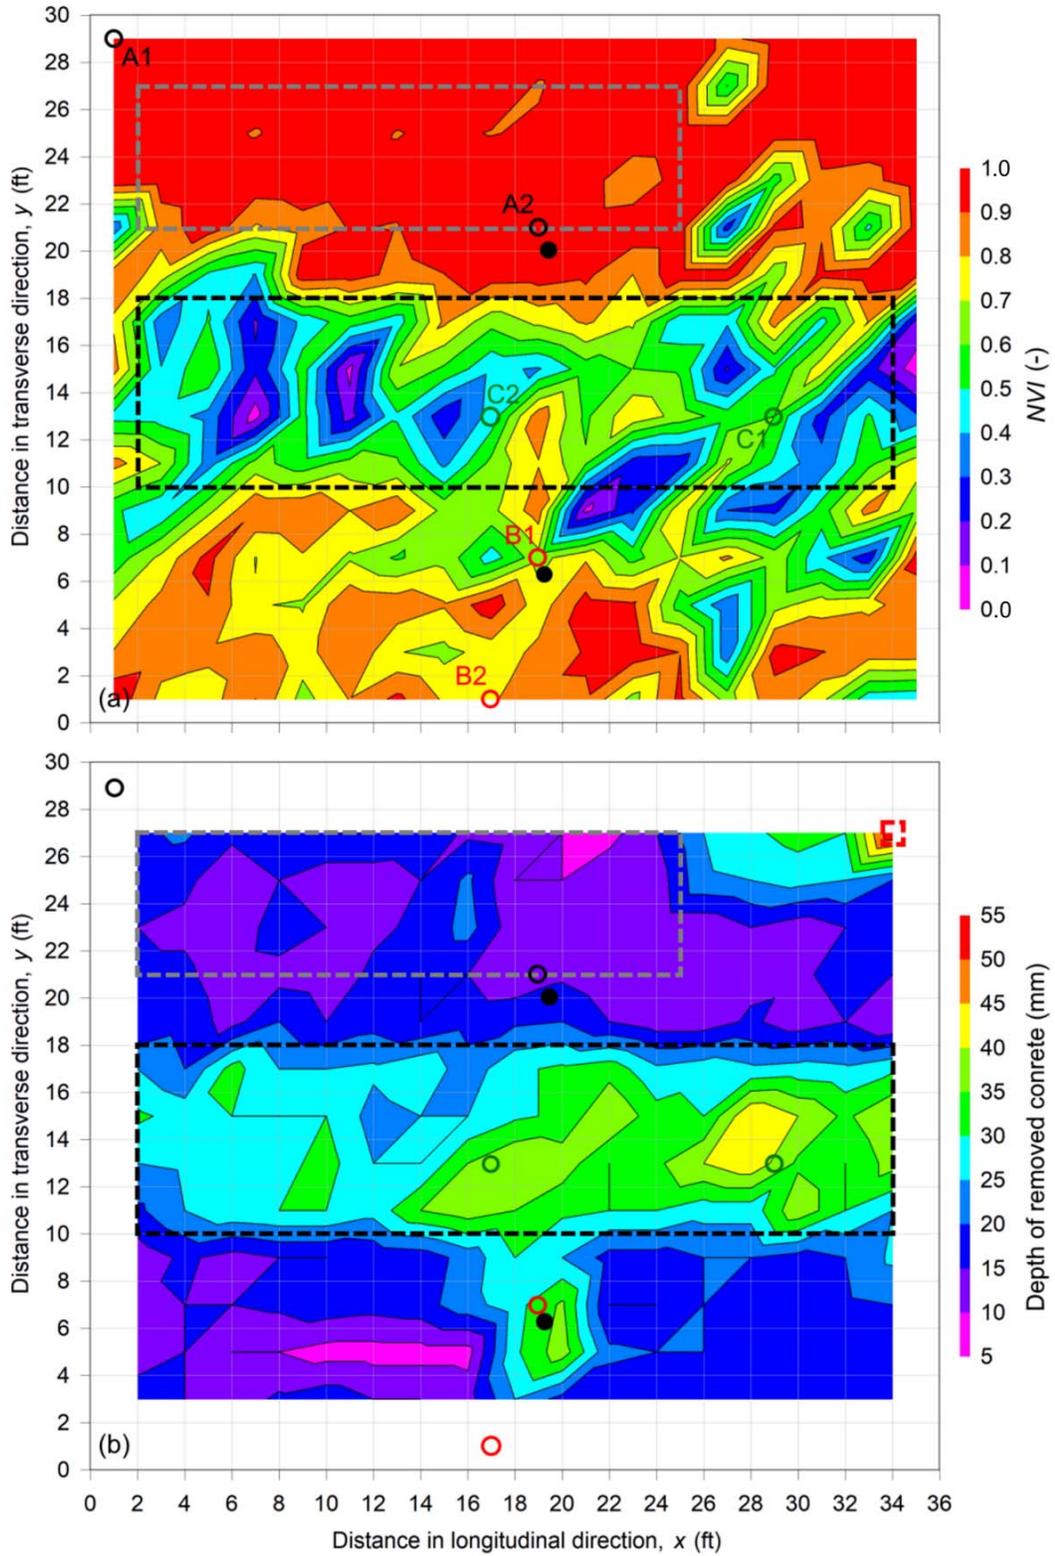
Fig. 31. Contour plots for (a) NVI values and (b) depth of removed concrete for Deck #2. Circles depict select test points discussed in more detail in Section 3.5.1. Unit conversion:

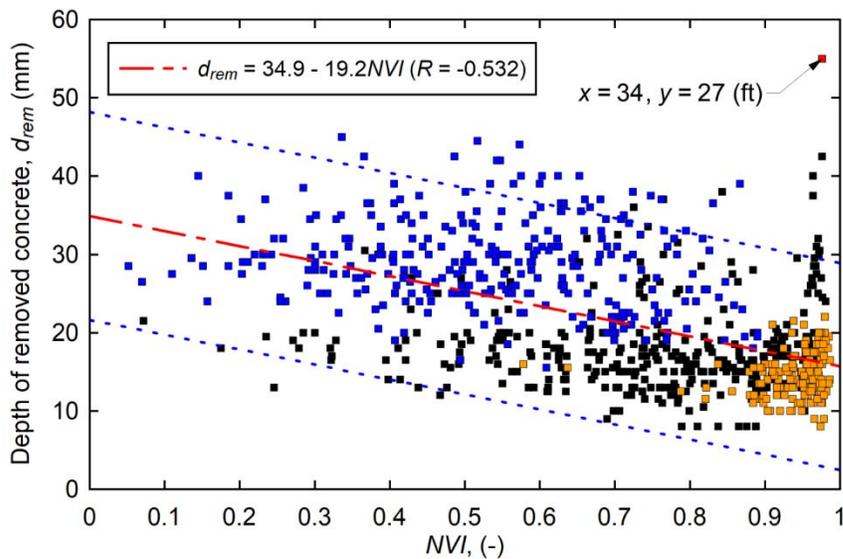
Fig. 32. NVI - Depth of removed concrete vs. NVI correlation plot. Orange and blue dots correspond to data points from within the grey and black dashed boxes, respectively, shown in Fig. 31. The red dash-dotted line and blue dotted lines represent the mean prediction curve and 95% prediction limits, respectively. Unit conversion: 1 ft = 0.305 m.
