**APPLICATIONS OF ADVANCED
COMPOSITES TO STEEL BRIDGES:
A CASE STUDY ON THE
ASHLAND BRIDGE
(DELAWARE-USA)**

MARCH 2005

**Delaware Center for Transportation
University of Delaware
355 DuPont Hall
Newark, Delaware 19716
(302) 831-1446**

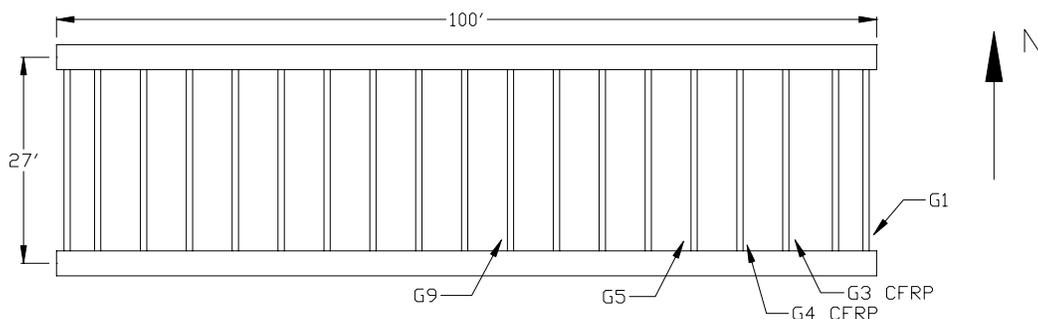
Diagnostic load tests were performed on the Ashland Bridge before and after rehabilitation. The pre-test was conducted on June 13, 2002, and the post-test on June 24, 2003. In both tests, strain transducers were used to measure the strain on selected floor beams and on the through girders. Sixteen gages were used for the pre-test and twenty for the post-test. The four extra gages used in the post-test allowed both of the floor beams with CFRP plates to be monitored (only one of these two beams was tested in the pre-test). Fig. 3 shows the floor beams that were instrumented during the testing (G1, G3, G4, G5, and G9). The two floor beams retrofitted with the CFRP plates (G3 and G4) as well as a control floor beam (G5) were each instrumented with four strain transducers. Three transducers were mounted to the underside of the tension flange, two at the ends of the beam and one at mid-span. One transducer was also mounted onto the underside of the compression flange at mid-span of the beam. Instrumentation was also placed on the through girder at mid-span, the quarter span, and near the end bearings.

Fig. 3 – Locations of Instrumented Floor Beams (1 foot = 0.3048 m).

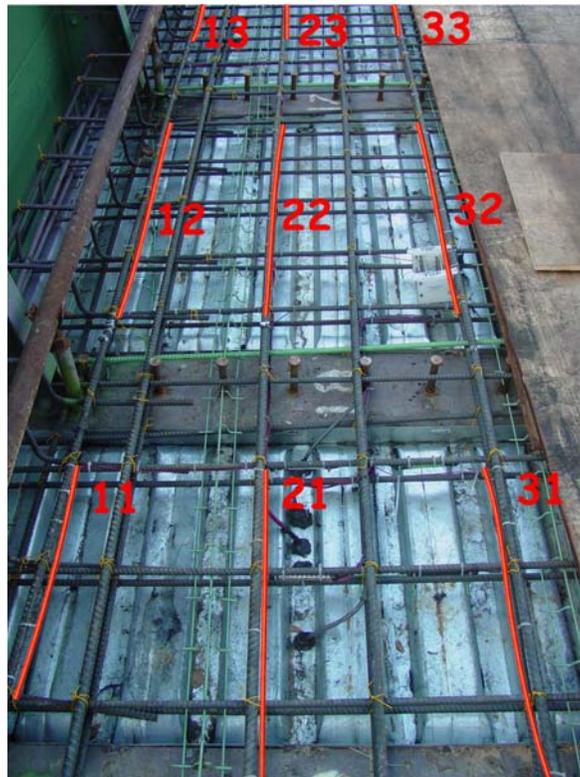
For the retrofit of Bridge 1-119, two floor beams were retrofitted with CFRP plates on the bottom of the tension flange and the concrete deck was replaced in two sections on November 25 and December 2. Figure 7 shows a photo of the bridge deck before pour. V2000 corrosion sensors are highlighted in the figure. Their exact locations are shown in Figures 8 and 9. An instrumentation box located underneath the bridge provides access to all these and other sensors.

Fig. 7 – Bridge deck before pour. V2000 sensors are highlighted in the picture.

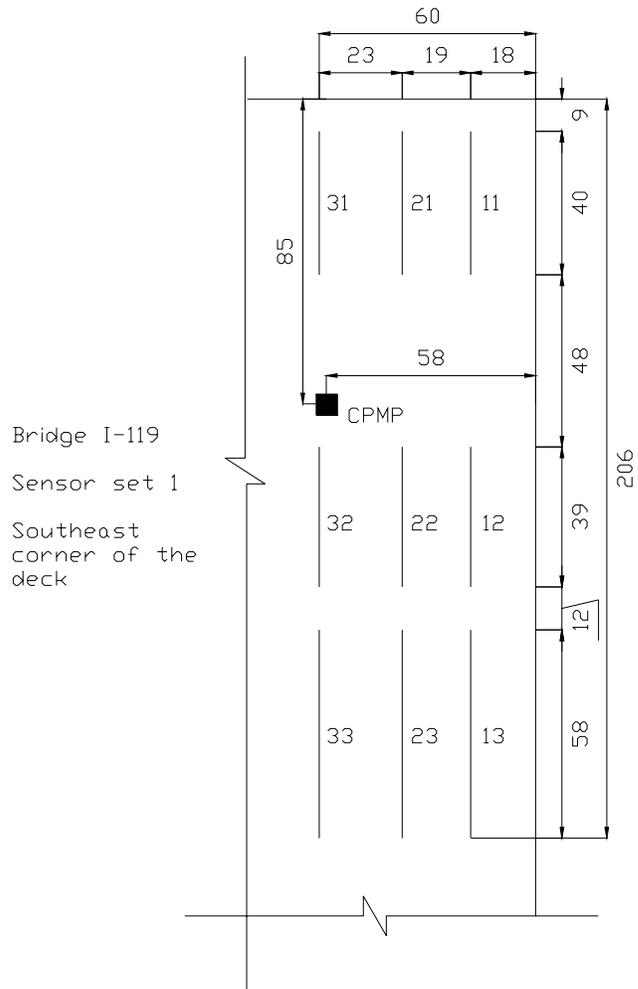
Fig. 8 – Location of the first set of V2000 sensors and CPMP unit

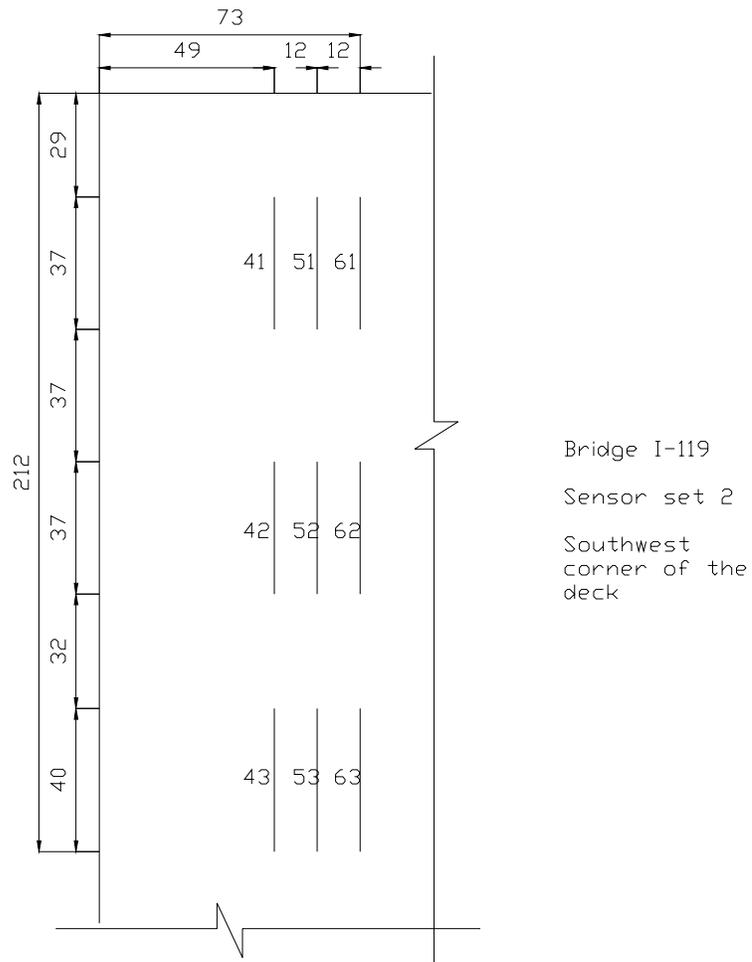
Fig. 9 – Location of the second set of V2000 sensors.

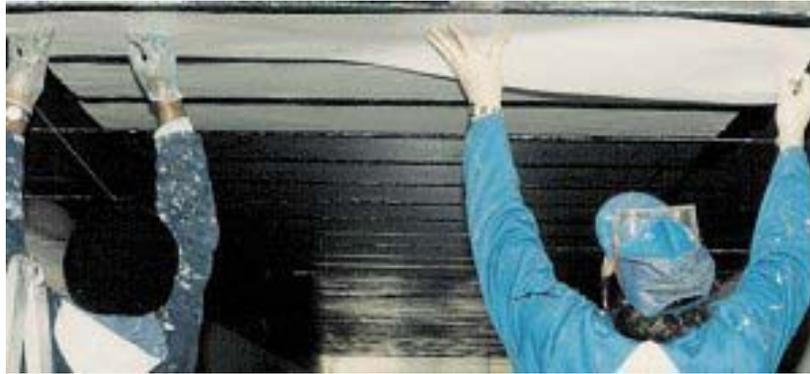
The proposed rehabilitation involves casting a new concrete deck that will act compositely with the floor beams and also attaching CFRP sheets to the underside of the floor beams, with the hope of increasing stiffness and durability. An adhesive bound the laminates to sheets of glass fabric, which were in turn bound to the steel beams. The glass fabric, which will be discussed in the next section, was used to prevent corrosion between the steel and composite laminates. The concrete deck is also being replaced. (Chajes, 2002).

Figure 4 - Attaching composite laminates to the underside of a bridge's floor beams

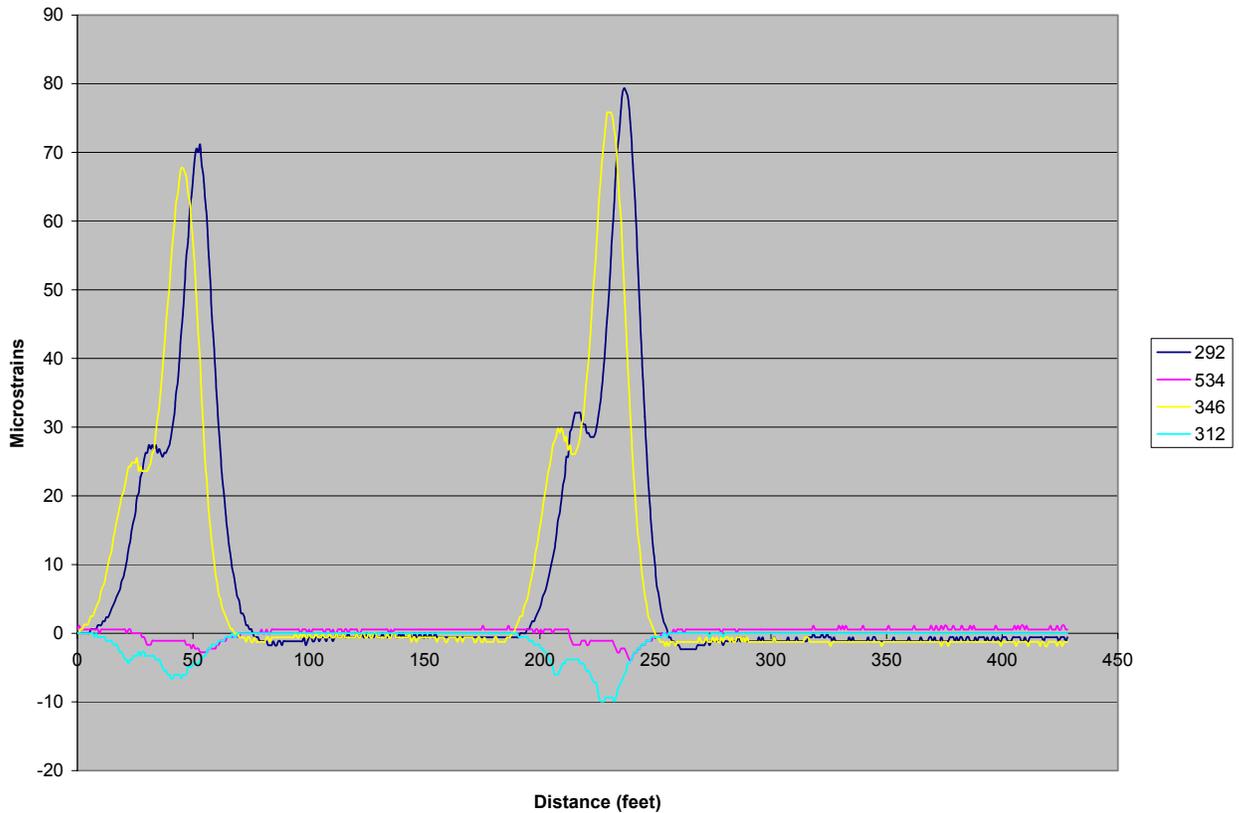
Instead, the top and bottom gauges do not produce identical and flipped curves. Thus, there is only one neutral axis for both the deck and floor beam and it is closer to the center of gravity, and therefore closer to the deck (the top). This means the system must be acting as a composite and should be analyzed as such. The discovery

that it is composite probably means that the floor beams perform better than was suspected by DelDOT. This is most likely because the deck and beam system was probably analyzed as non-composite, adversely affecting the theoretical performance of the bridge.

Figure 11 - Graph showing composite nature of concrete deck and steel floor beams

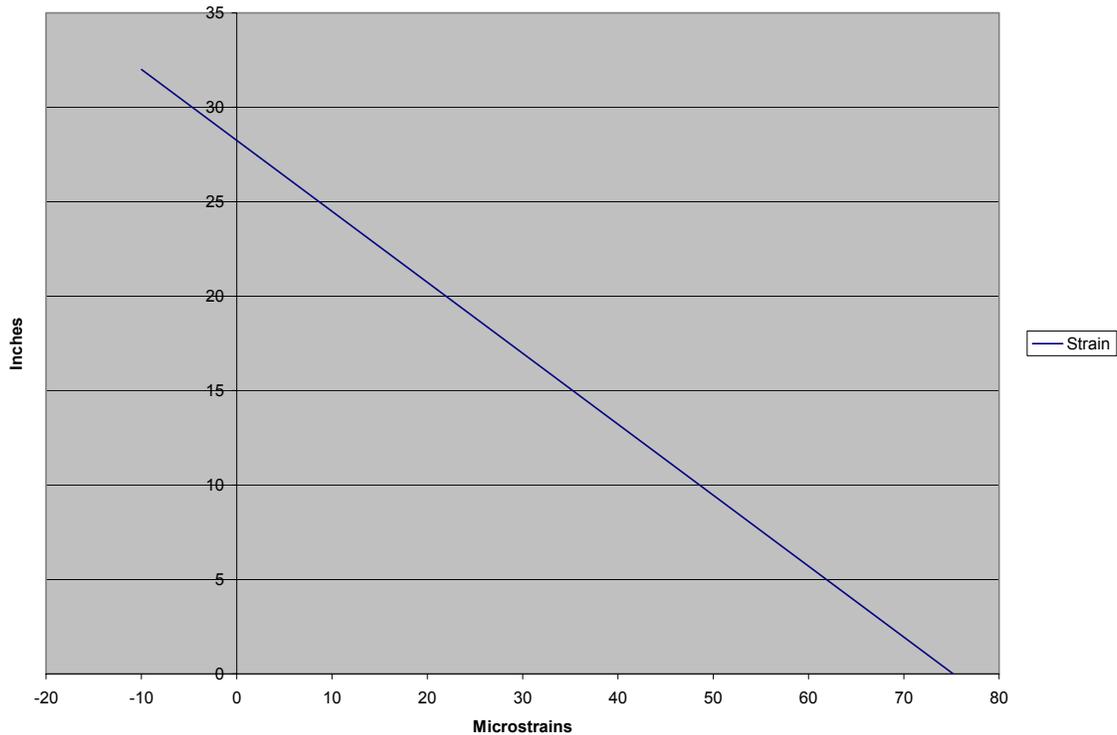
To analytically determine the neutral axis and confirm that composite action exists between the deck and floor beams, graphs of distance from the bottom of the section versus strain are created, such as the one seen in Figure 11. Since strain is linearly variant, it is possible to find the neutral axis for the composite system by finding the y-intercept, or where the strain equals zero (Chajes, 2002). This was done four times with the data obtained from the load test, using companion gauges 292 and 534 and gauges 346 and 312, all on floor beams. Each pair has one gauge on top and one on the bottom of the floor beam. Readings from Path 1 and Path 2 were used for both pairs of gauges. The average neutral axis distance was 28.25 inches from the bottom of the steel beam flange. The total distance from bottom of the flange to the top of the concrete deck is 32 inches.

This finding corroborates the previous statement that the concrete deck and floor beam act as a composite. If the two were not working in composite action, two distinct neutral axes would be seen. Instead, one neutral axis that is obviously closer to the top of the composite system is seen, demonstrating that composite action is occurring.

Figure 12 - Graph of Strain vs. Distance from Bottom of Flange - Neutral Axis is at Y-intercept

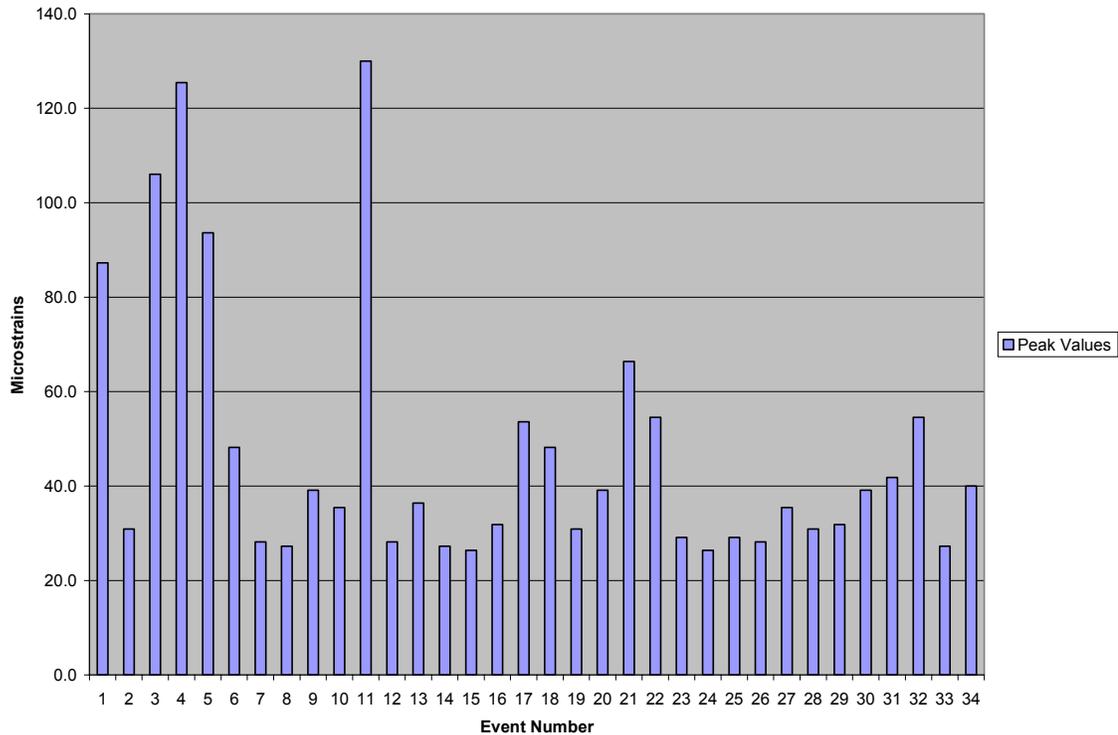
Figure 13 - Histogram of In-service Monitoring Results - Peak Values

Table 8 and Figure 13 demonstrate the frequency of strains above the trigger value because it shows the entire set of data including non-peak strains. We can see from both histograms that there are not many large strains experienced by the floor beams. Thus, the bridge most likely does not carry many large trucks, a factor that may make the possible deterioration of the floor beams less significant.

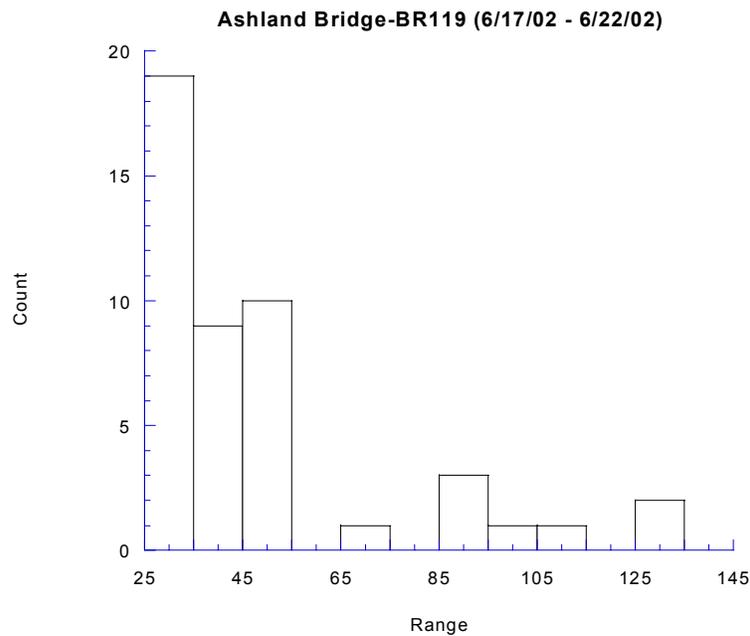
Figure 14 – Histogram of In-service Data Displaying Frequency of Strains in Different Ranges

Figure 13 shows that most of the strains experienced by the bridge are relatively small (less than 50 $\mu\epsilon$), while very few are larger than 100 $\mu\epsilon$.

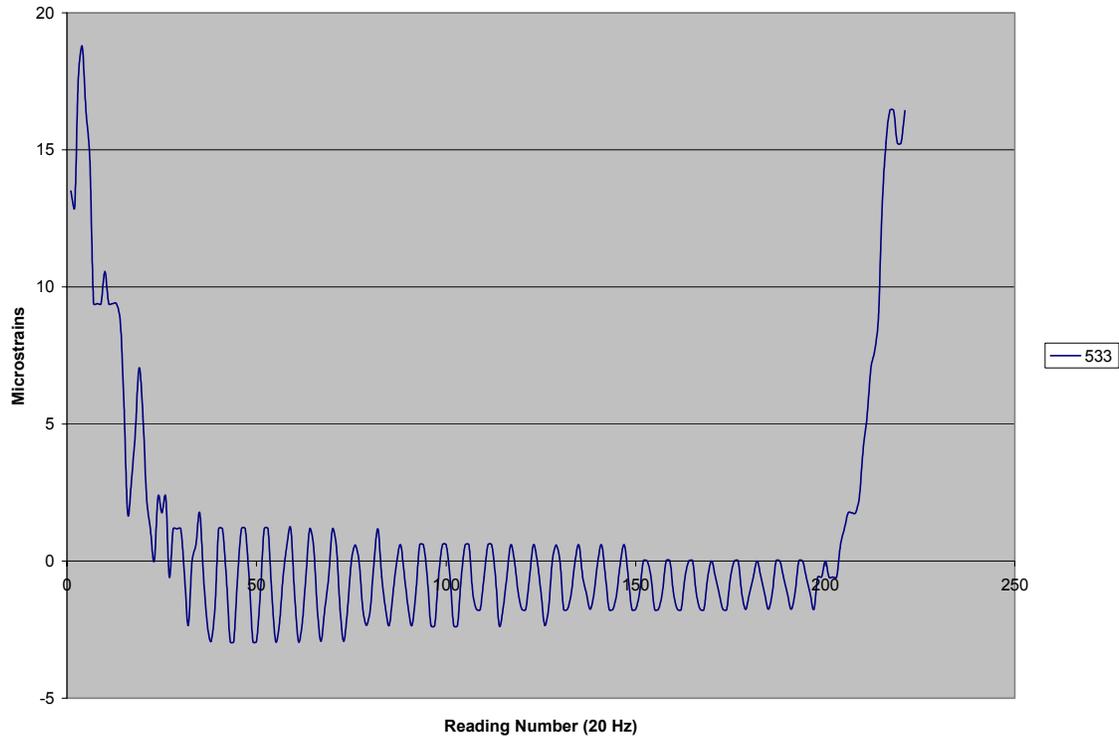
The graph in Figure 14 shows the data used to determine the damping factor of the through girders. The wave-like part of the graph is what was analyzed in the calculations.

Figure 15 - Graph of the set of data used to determine the damping factor of the through girders – Path 6, Gauge 533

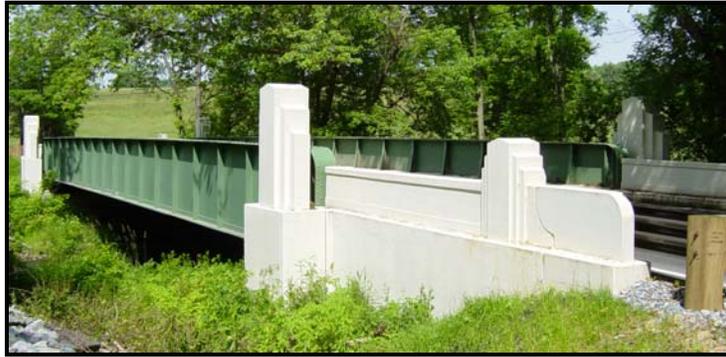
Figure 1. Ashland Bridge, looking North-West

The Delaware Department of Transportation (DelDOT) determined the concrete deck and floor beams showed significant deterioration and as such the Ashland Bridge was deemed structurally deficient. Prior to rehabilitation in June of 2002 the University of Delaware conducted load tests to document the baseline behavior of the bridge. Two floor beams were retrofitted with CFRP plates on the bottom of the tension flange and the concrete deck was replaced in two sections on November 25 and December 2 (Chajes, 2002). The CFRP plates were bonded to the floor beams after the concrete deck was removed and before a new deck was cast. As such, the CFRP plates help the floor beams resist both dead load and live loads. In June of 2003 a post-test was performed to evaluate the effectiveness of the rehabilitation, specifically the performance of the CFRP plates for improvements in strength and stiffness.

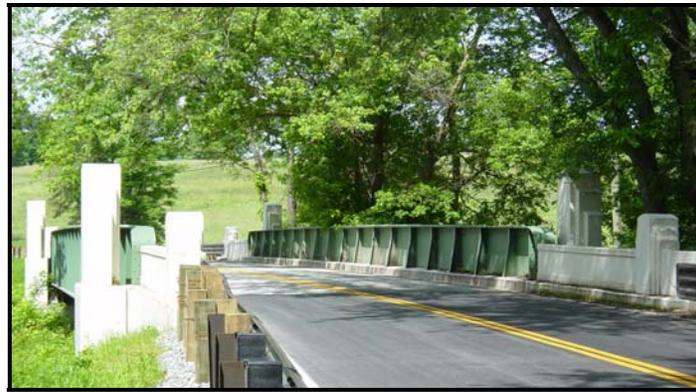
Figure 2. Ashland Bridge, looking East

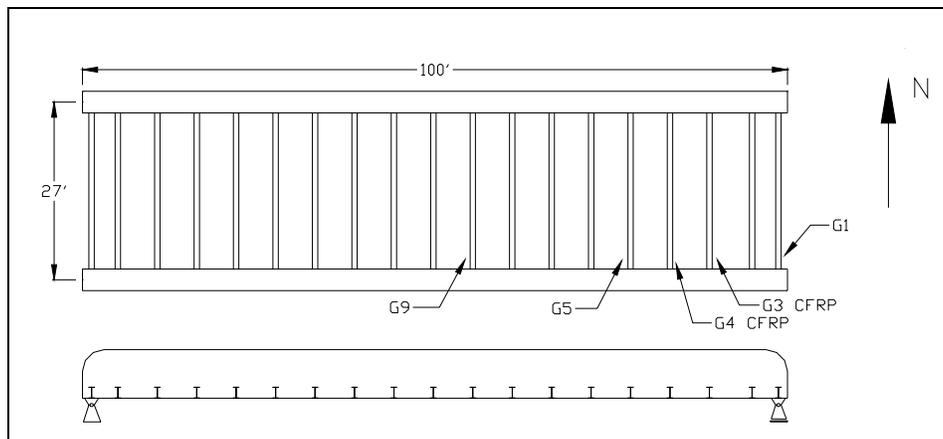
Figure 3. Floor beam layout of the Ashland Bridge.

The span length of the two through girders is 100 feet and the floor beams span 27 feet and carry the concrete deck. There are 19 floor beams (W24 X 100 sections) spaced 6 feet on center on the Ashland Bridge.

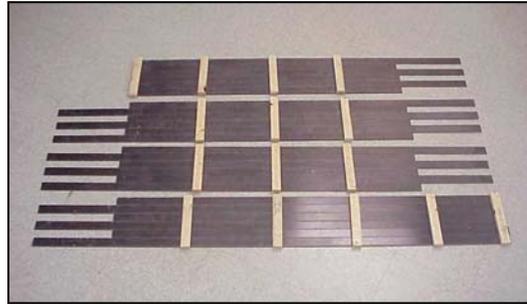
Figure 4. CFRP plate segments.

For the Ashland Bridge, the CFRP plates were applied to the bottom face of two floor beams. The CFRP plates are a composite material composed of unidirectional carbon fibers and a vinyl-ester resin matrix. The plates are 37-mm wide X 5.25-mm thick (1.46 in. X .21 in.) produced in a pultrusion process. The material cost is dependent on the amount of material produced. These plates can be manufactured to any desired length. As such, long, thin plates can be produced and cut to length. Several 37-mm

wide plates were used to make up the full width of the flange for this study because it is less expensive to produce only one size of plate for small projects. The CFRP plate sections used for the rehabilitation can be seen in Figure 4.

In the rehabilitation, nearly the entire length of the floor beam was retrofitted with the CFRP plates. This CFRP plate were divided into four plate segments for simplifying the application procedure. Each segment was five feet length. The width of the final plate was made up of six individual plates. Six inch staggered joints were used for each of the four plate segments. The end connection of each staggered plate was beveled to a 45-degree angle to eliminate peel stresses induced by the joint (Miller 2000). Peel off of the plates is a failure mode that has occurred during plate testing, especially at the maximum moment region of the girders (Liu 2001). Wood blocks were used to keep the larger plate segments together as well as provide a location for clamping. Once assembled, the bonding surface of the plates was sanded to aid with adhesive bonding. Abrasive blasting was used for the floor beam preparation as well as a surface cleaning solvent. Glass fiber fabric was used as the intermediate layer. The plates were applied in individual plate segments using two-part epoxy, clamped in place and allowed to cure for 24 hours at ambient temperature. Once cured, the excess adhesive was removed from the plates.

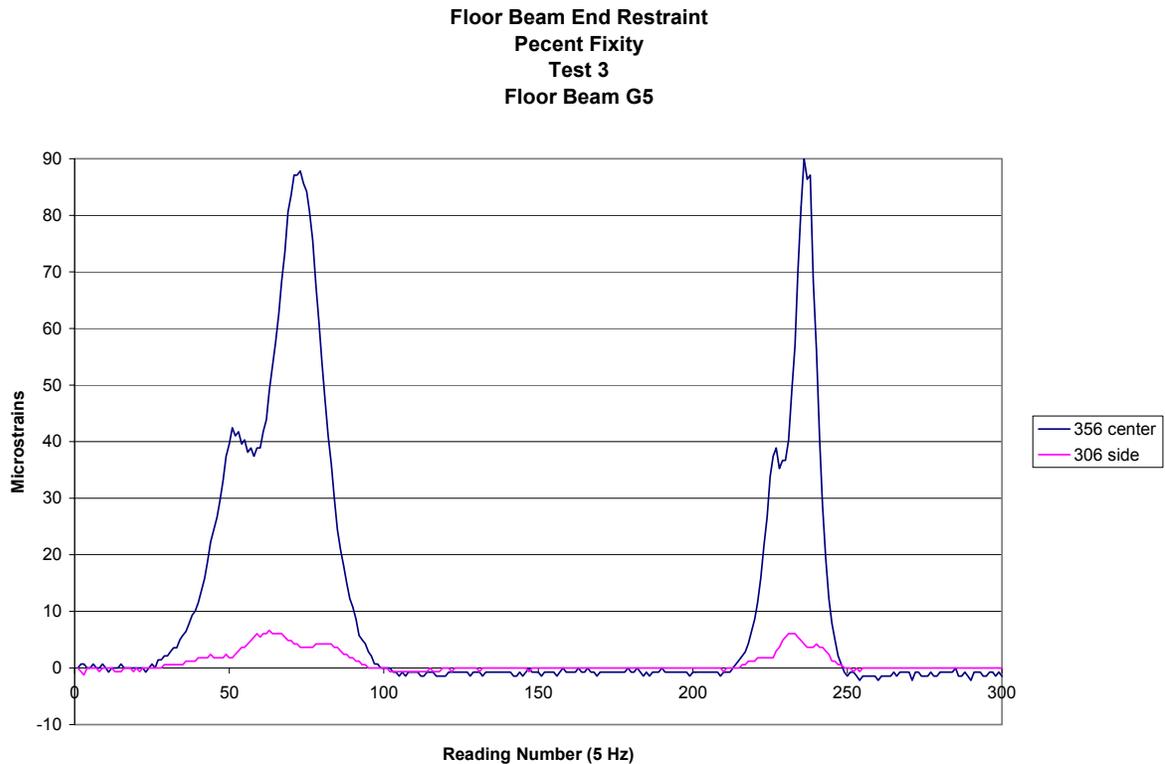
It is accurate to model the floor beams as simply supported because very little end restraint was observed during testing. This amount of end restraint was found by calculating the percent fixity of the floor beams. The very small amount of support fixity exhibited by the Ashland Bridge means the floor beam behave like a simply supported beam. One hundred percent fixity means the ends are acting as if they were fixed and not free to rotate. The percent fixity was found by taking the ratio of the strain at the edge of the beam to the strain at the center of the beam when the center gage peaked. In completely fixed connections the end span strain and support strain are equal in magnitude and opposite in sign. Figure 11 can be used to evaluate support fixity of the control floor beam G5. Note in the figure that the strains at the ends of the floor beams are close to zero and not in compression. As such, there is apparently no end fixity. The reason the gages do not read zero strain is that they were not placed directly at the floor beam end. They were placed 21 inches inside from the through girder.

Figure 11. Support fixity: control floor beam G5

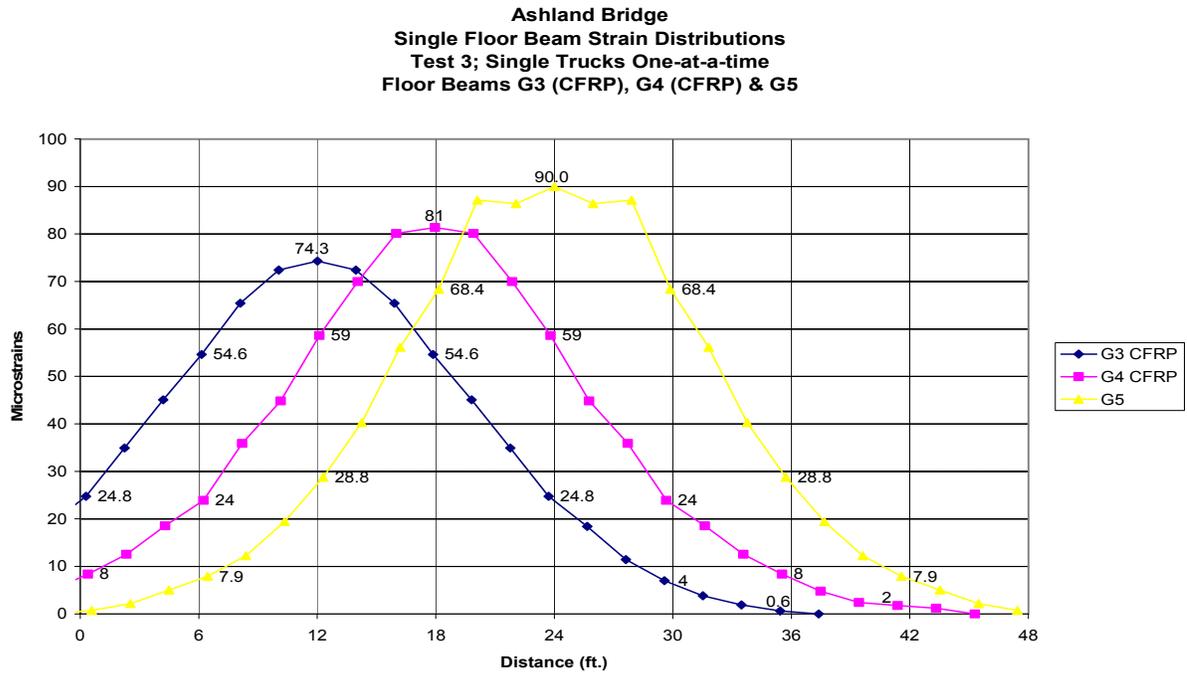
Figure 12 shows the distribution of strain due to the weight from the rear axle group to individual floor beams as the test truck travels across the bridge. Shown in this graph is the distribution for the three instrumented floor beams during Test 3. This distribution of strain was evaluated using only the rear axle group. To help to isolate the effect of the rear axle group, only the strain values collected after the peak strain value was reached were used for distribution calculations. The data was also shifted from a time-strain plot to a distance-strain plot. To accomplish this the speed at which the truck was traveling was determined and the time-scale was changed to distance (corresponding to the location of the rear axle group). This method of determining strain distribution was found to be reliable and not significantly influenced by the presence of the front axle weight because the axle spacing is more than 14 feet. At this spacing the results show that very little strain from the front axle is going to be distributed into the floor beam. This can be seen in the figure. Once a distance of 12 feet or two floor beams is surpassed, little strain is distributed into the instrumented floor beam.

From Figure 12, the percentage of the peak strain from the total strain due to the rear axle group on individual floor beams was found to be on average 32%. Retrofitted floor beams G3 and G4 peaked at $74.3 \mu\epsilon$ and $81 \mu\epsilon$ respectively during Test 3 which consisted of a single truck crossing down the middle of the bridge. An idealized simply-supported model was used to find the maximum moment due to the center truck loading. This moment was converted to strain using Hooke's Law and then scaled by 32%. This yielded $70 \mu\epsilon$ which is in close agreement with what the beam actually experienced. In general the rehabilitated floor beams G3 and G4 increased in stiffness and their load distributions were slightly higher than the control floor beam G5. Similar analyses

Figure 12. Load distribution to single floor beams.

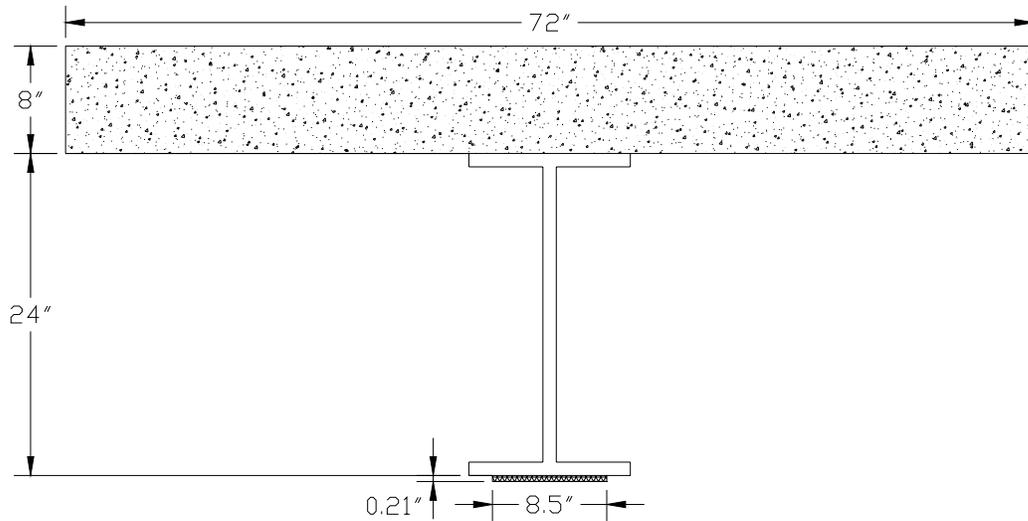
The expected change in strain due to the rehabilitation was found using simple mechanics of materials relationships and the concept of transformed sections. The sections were converted into equivalent steel sections. This analysis estimated a decrease in strain of 6% should have occurred. Shown in Figure 13 is the cross section of the floor beam-concrete deck-CFRP composite system. The dimensions indicated were used in the transformed section analysis. Properties for the analysis are included in the Table 6 and Figure 13 is shows the cross-section before transformation.

Figure 13. Transformed Section Analysis Cross-Section.
