**Winterthur/University of Delaware
Program in Art Conservation**

Conservation Report

Accession #: 2001.0017.0024

Object: [Portrait of an Unidentified Woman with Cut Bangs Curled About the Forehead]

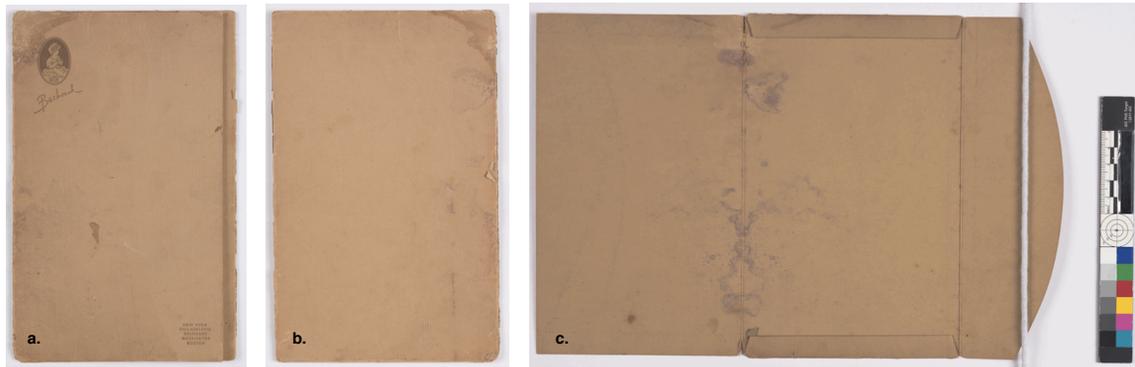
Figure 1 – Jacket a) exterior front cover, b) exterior back cover, and c) interior unfolded.

The photograph is housed in a simple tri-fold jacket constructed of paper-based materials (Figure 1). The outer flap extends out 12.3 cm from left side while the inner flap (with a curved border) extends out 6 cm from the right side at its widest point. There is nothing present to hold the photographic print in place on the interior (print freely floats once encapsulated, Figure 2).

The jacket exterior is made of a tan, ribbed decorative facing paper with a logo consisting a cameo framed portrait of a woman in three-quarter view with the initials 'WKB' and 'Bachrach' in script printed in the upper left-hand corner of the front cover. Five cities – New York, Philadelphia, Baltimore, Washington, and Boston – are printed in the lower right corner.
